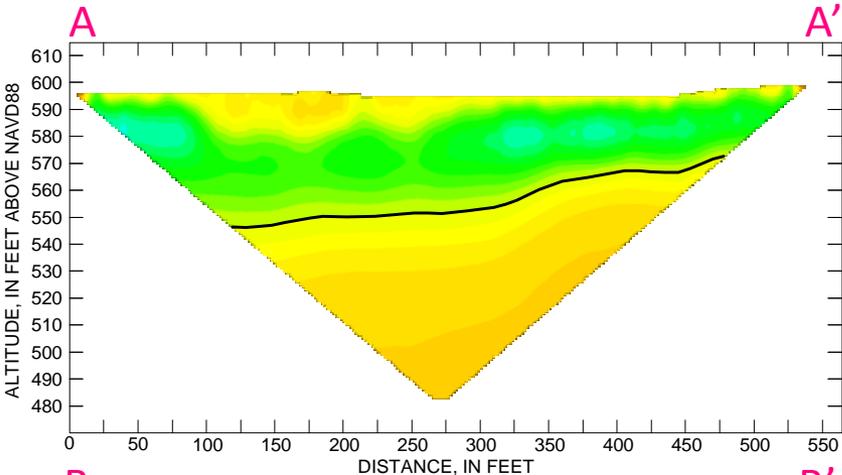
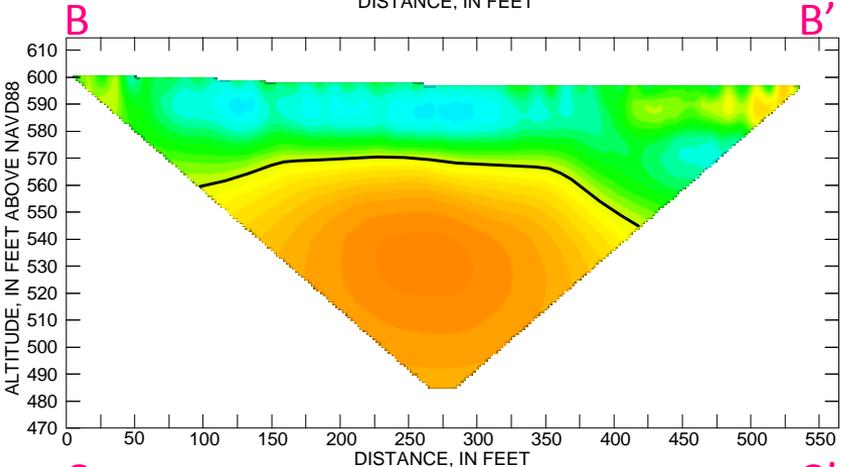
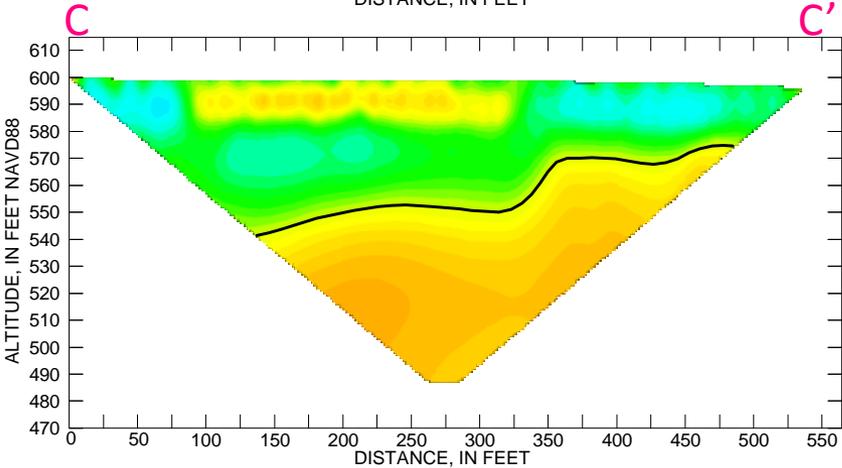
Site #1

Bedrock is consistent across the site.
 No apparent horizontal or vertical anomalous features exist.

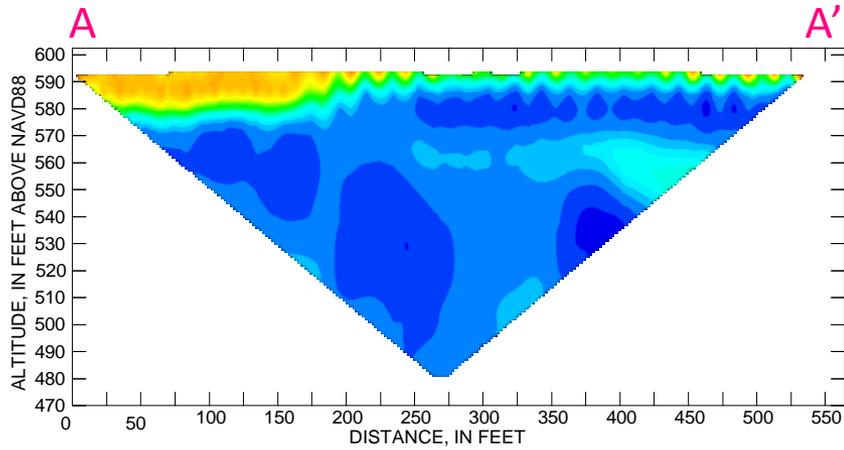
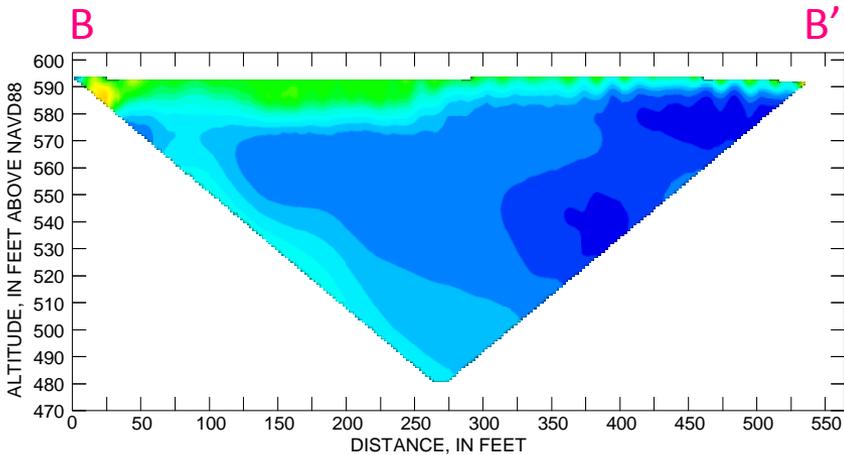
Site #2

Bedrock is most likely absent at this site. SB-08 which is right next to the two profiles showed fill from surface to a depth of 30 feet and never hit bedrock. DC profiles appear to show that the fill continues down to more than 100 feet. There is a possibility that the near surface low resistive clays and silts are drowning out the highly resistive bedrock which may explain the small resistivity increase at an altitude of about 520 feet above NAVD88.

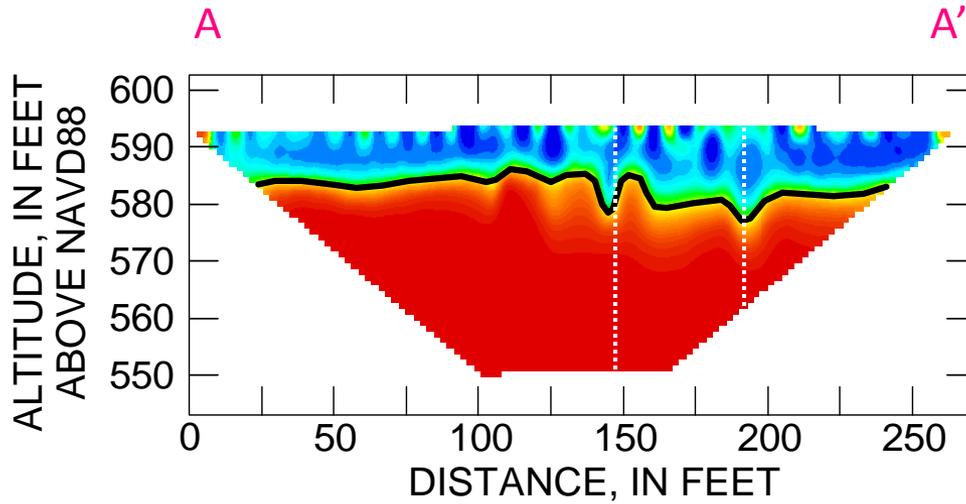
Site #3

Bedrock can be observed across the whole profile with a bedrock altitude of about 584 feet at the beginning of the profile and drops to an altitude of 580 feet at approximately 160 feet from the beginning of the profile.

There are two vertical anomalous features found in the profile with the first feature found at about 145 feet from the beginning of the profile and the second feature found at about 192 feet from the beginning of the profile. These features may represent small vertical fractures within the bedrock with the first feature being a more prominent than the second feature.

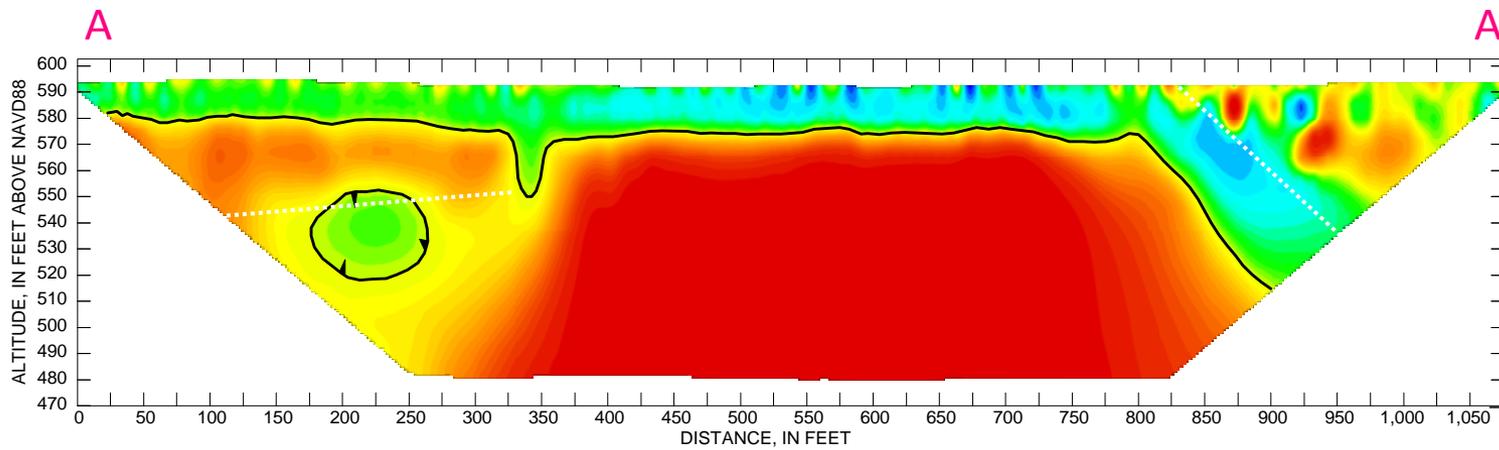
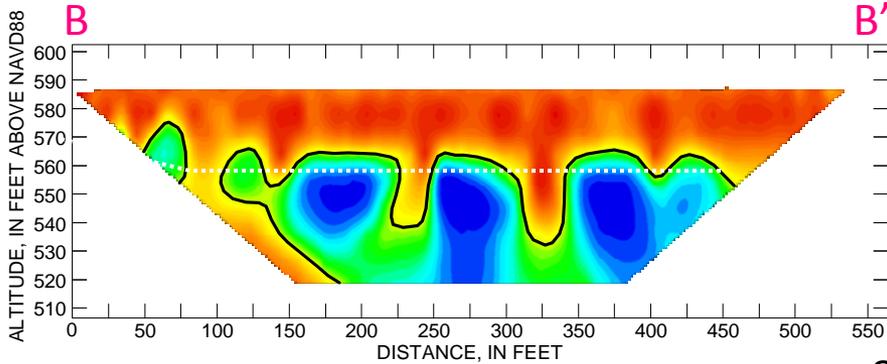
Site #4

There are many observable anomalous features (white lines) found at this site.

Profile 8 (A-A')

There is a vertical anomalous feature at about 340 feet along the profile. There is also a horizontal anomalous feature at an altitude of about 540 feet above NAVD88 which starts at the beginning of the profile and ends at the vertical anomalous feature found at 340 feet. There is also a diagonal anomalous feature found at about 820 feet along the profile with an approximate angle of about 25 degrees from the land surface. These anomalies could be associated with fractures but at the beginning of the profile. There was a power line running parallel with the profile from the beginning of the profile to about 350 feet along the profile. There was also a thunderstorm near the area during collection of the last segment of the profile from about 820 feet to the end of the profile. Both external sources of energy could have skewed the results. However, due to the anomalous features found at the nearby profiles, these features cannot be ignored.

Profile 9 (B-B')

There is a horizontal anomalous feature found across the total length of the profile at an approximate altitude of 562 feet above NAVD88 with the anomalous feature rising up to an approximate altitude of 571 feet above NAVD88 near the beginning of the profile. The darker blue zones found in the profile could represent larger fractures or a more weathered zone comprised of multiple fractures.

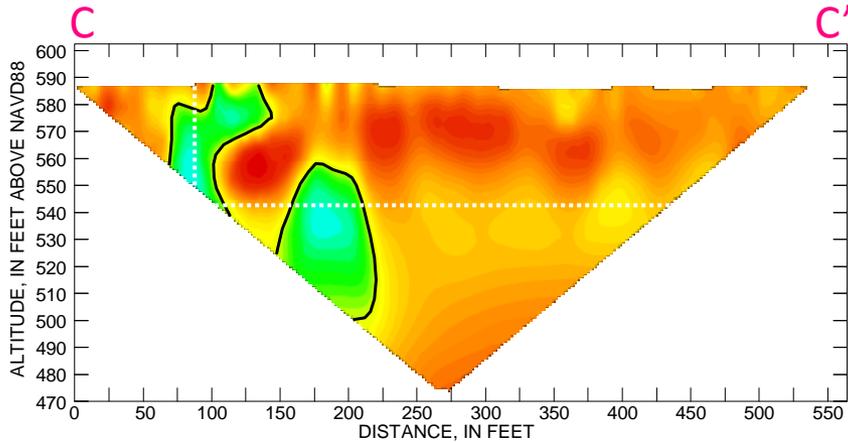
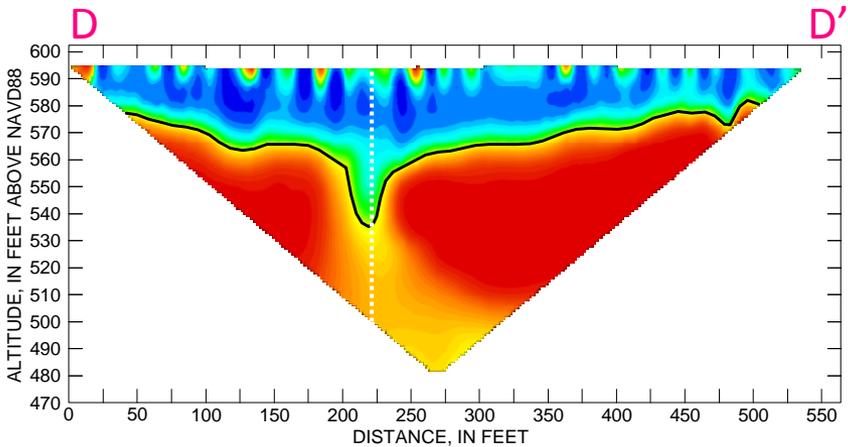
Site #4 (cont.)

Profile 10 (C-C')

There is a horizontal anomalous feature found across the total length of the profile with the feature being more prominent (less resistive and more blue and green in color) near the beginning of the profile and becoming less prominent (more resistive and more yellow and orange in color) towards the end of the profile. This could represent a fracture or fracture zone that decreases in size toward the end of the profile (or further north on the site). There is also a vertical anomalous feature found at about 85 feet from the beginning of the profile.

Profile 11 (D-D')

There is a vertical anomalous feature found at approximately 220 feet from the beginning of the profile. This feature could be representative of a vertical fracture found at the site, but the profile was collected near (within 5 feet) from a chain linked fence which could skew the results. But similar to Profile 8, this feature cannot be ignored due to the other anomalous features found on nearby profiles.

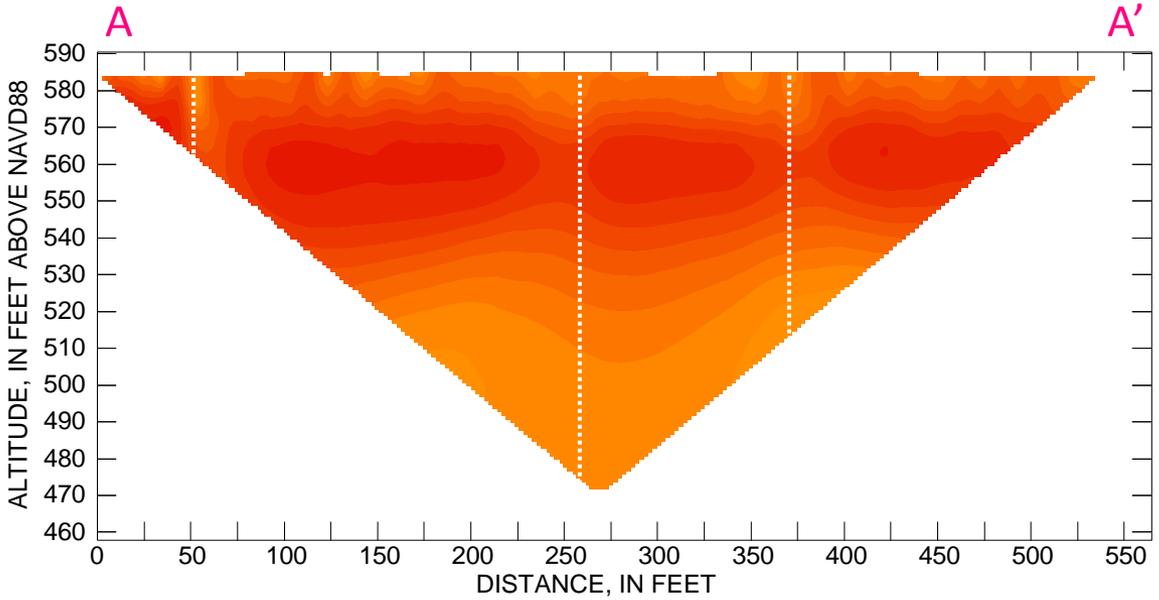
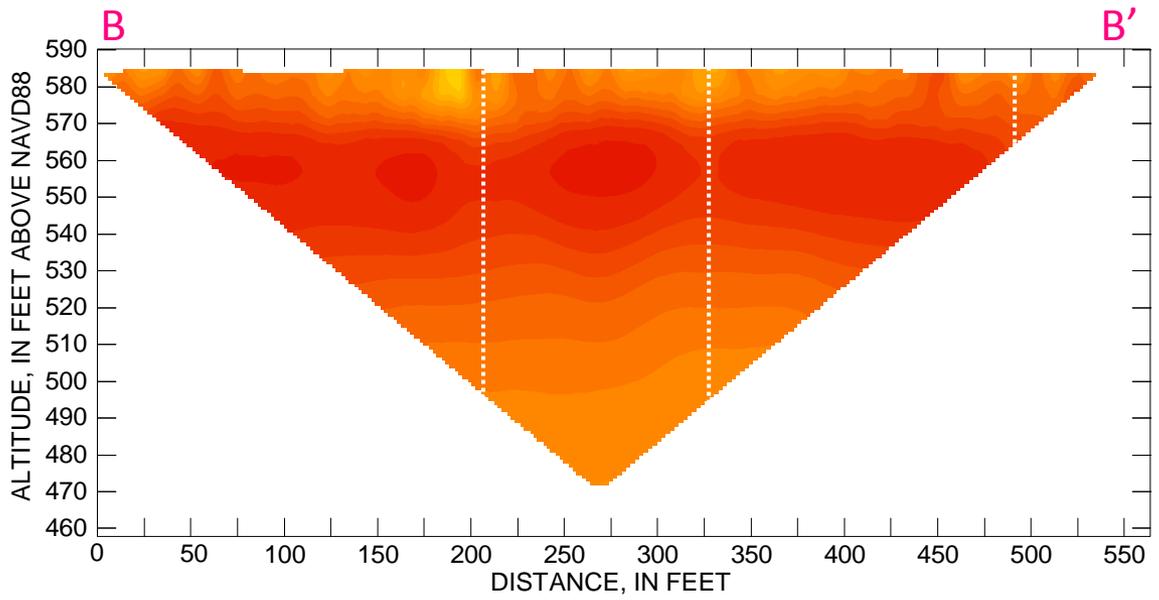
Site #5

Bedrock is met at surface.
 This is verified by the boring logs which show the bedrock altitude to be approximately 582 feet above NAVD88. There are some observable vertical features (white vertical lines on the profiles) which may represent fractures, but if they are fractures they would be insignificant in size.
