Middle Fork Vermilion River Above Oakwood, IL

Study Reach.--The channel reach under consideration is natural. A study reach, approximately 400 ft long, is selected upstream of the Kickapoo State Park Road bridge, as shown in the quadrangle map on the top left. The reach starts from 100 ft downstream of the Kickapoo State Park Road bridge and extends approximately 300 ft upstream. There are four surveyed cross sections (surveyed by the U.S. Geological Survey in May 2003) available for describing channel geometries in the study reach (see plots above). The channel alignment, approximate variations in channel width and bank conditions, and locations of the cross sections are shown in the aerial photo on the top right. Cross-sectional geometries vary gradually from upstream to downstream.

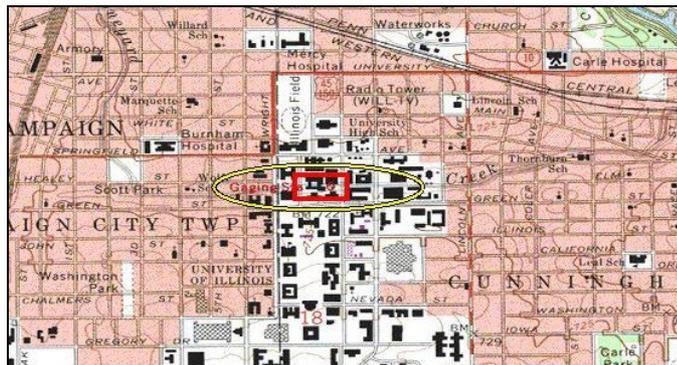
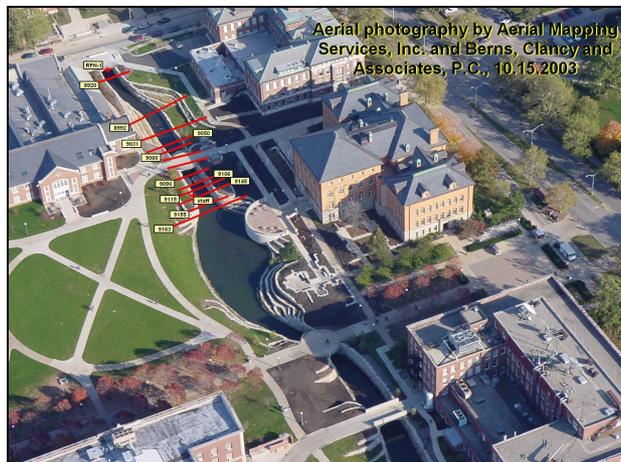
Study Reach.--The channel under consideration is constructed in an urban setting, as shown in the quadrangle map on the top left. The study reach, approximately 225 ft long, begins at a staff gage located on the left bank 45 ft upstream from the gage house and extends downstream to the upstream side of Matthews Street bridge. Eighteen surveyed cross sections (surveyed by Berns, Clancy, and Associates, in July 2000) are available for describing the geometries of the study reach. The channel alignment, approximate variations in channel width and bank conditions, and locations of cross sections are shown in the aerial photo on the top right.

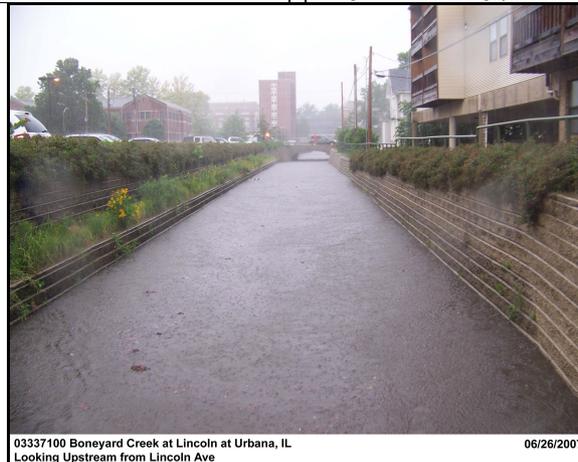
03337100 Boneyard Creek at Lincoln at Urbana, IL
Looking Upstream from Lincoln Ave
06/26/2007

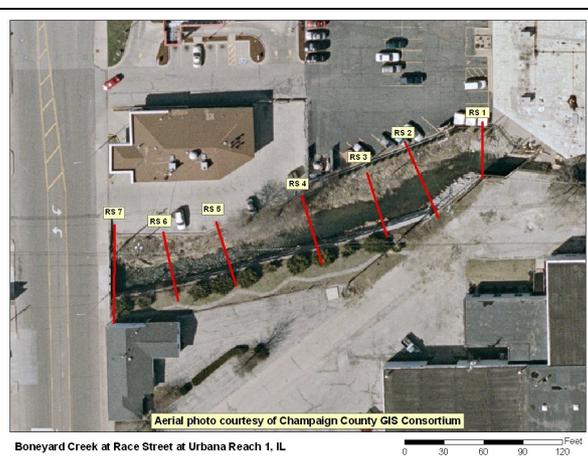
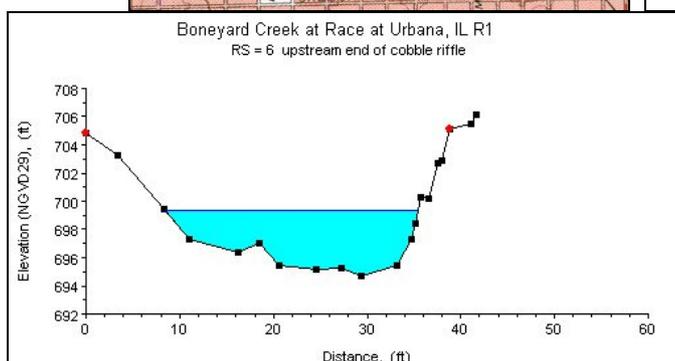
Study Reach.--The channel reach under consideration is constructed in an urban setting, as shown in the quadrangle map on the top left. The study reach, about 310 ft long, begins at the downstream side of Broadway Avenue and extends downstream to an abandoned bridge. Seven surveyed cross sections (surveyed by the U.S. Geological Survey in August 2004) are available for describing the channel geometries in the study reach. The channel alignment, approximate variations in channel width and bank conditions, and locations of cross sections are shown in the aerial photo on the top right. Cross-sectional plots at four river stations (RSs), as shown above, are selected to illustrate the variation in cross-sectional geometry.

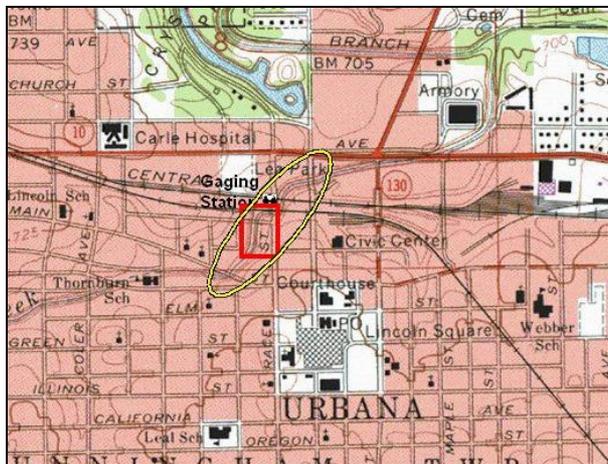
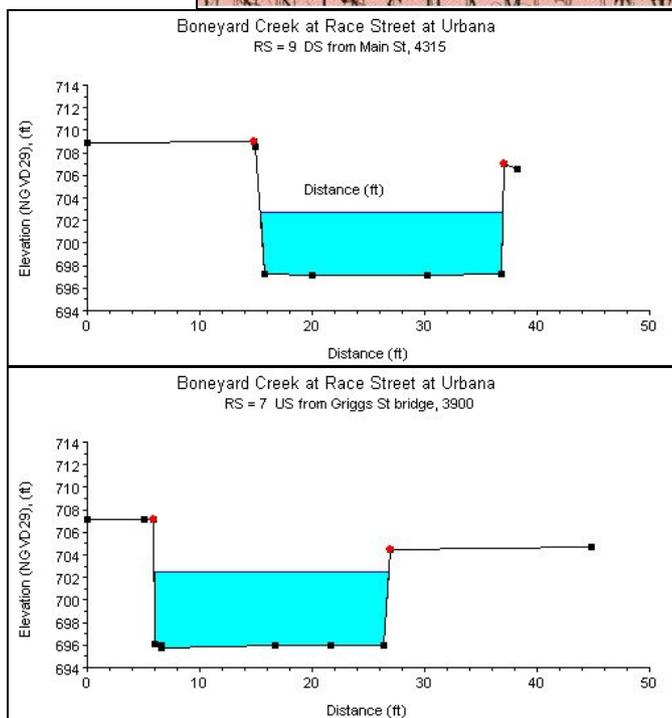
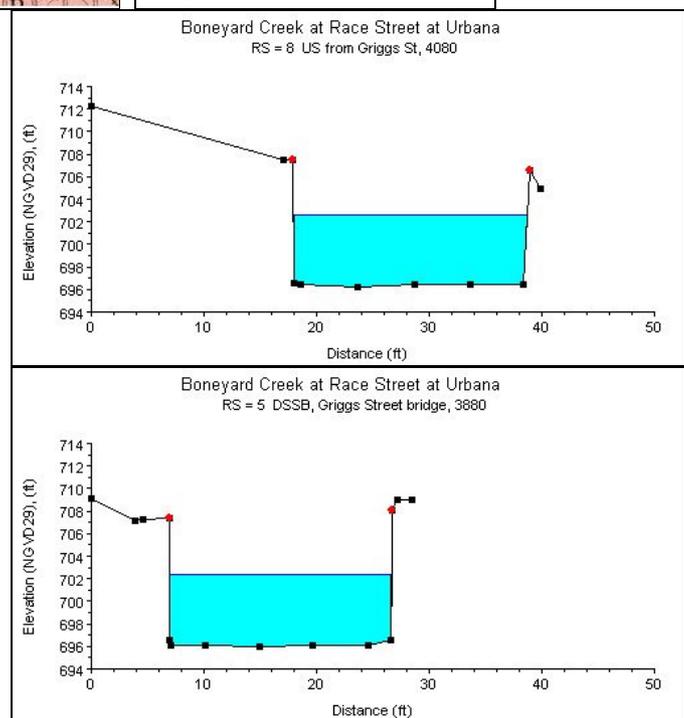
Study Reach.--The channel reach is constructed in an urban setting, as shown in quadrangle map on the top left. The study reach, approximately 855 ft long, is between Main Street and Race Street bridges. Ten cross sections (surveyed by Berns, Clancy, and Associates, in June 1997) are available for describing the channel geometries in the study reach. The channel alignment, approximate variations in channel width and bank conditions, and locations of cross sections are shown in the aerial photo on the top right. Because of the similarities in cross sectional geometries, cross sectional plots at river stations (RS) 8, 7, 5, and 4, as plotted above, are selected as representative cross sections.

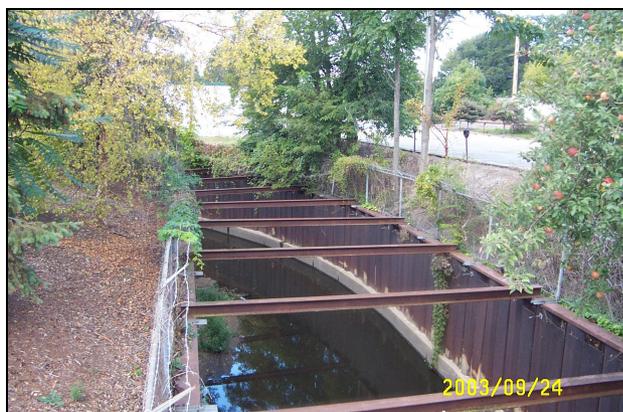
03337250 Boneyard Creek at Race Street at Urbana, IL Reach 2
Base conditions, looking upstream from Race St bridge

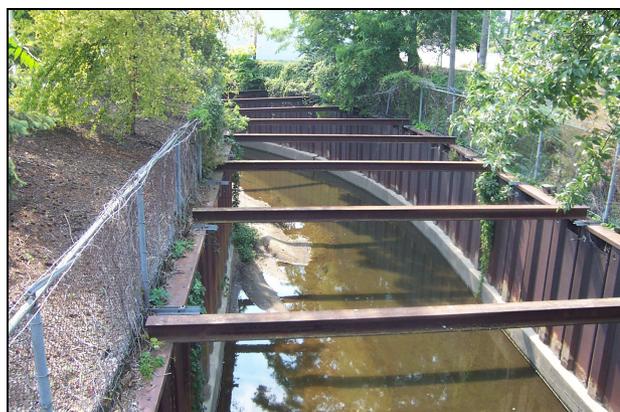
03337250 Boneyard Creek at Race Street at Urbana, IL Reach 2
From Race St, looking Upstream

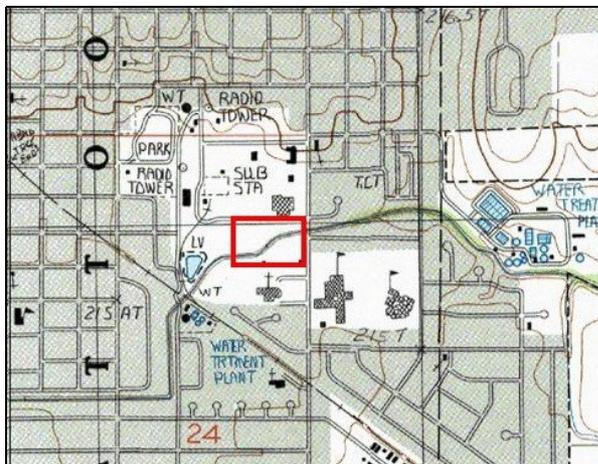
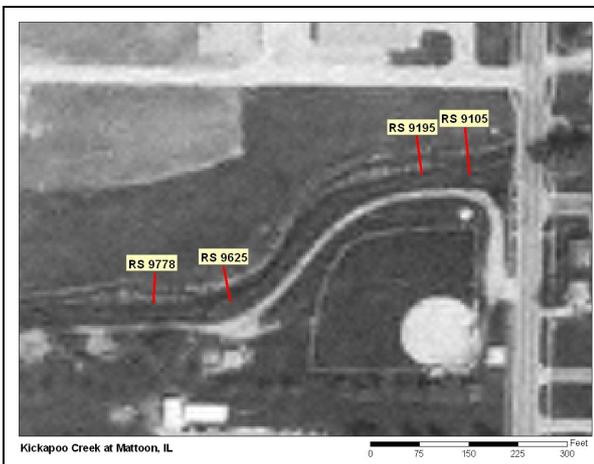
Study Reach.--The channel reach under consideration is a dredged ditch in an urban area. The study reach selected extends from the upstream side of the South 9th Street bridge to about 650 ft upstream from the bridge. The reach under consideration and the study reach are presented in the quadrangle map on the top left. Four surveyed cross sections (surveyed by the Illinois Department of Natural Resources, in February 2003) are available in the study reach (see plots above). The channel alignment, approximate channel width and bank conditions, and locations of the cross sections are shown in the aerial photo on the top right. Channel geometries are illustrated with cross-sectional plots at river stations (RS) 9625, 9195, and 9105.

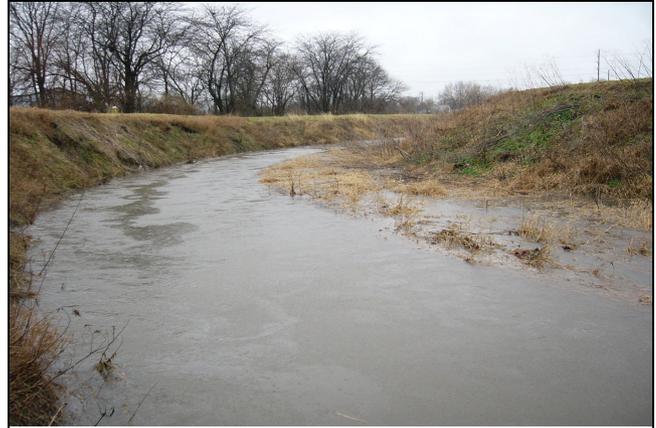
03343800 Kickapoo Creek at Mattoon, IL
Looking Upstream from RP3 01/05/05

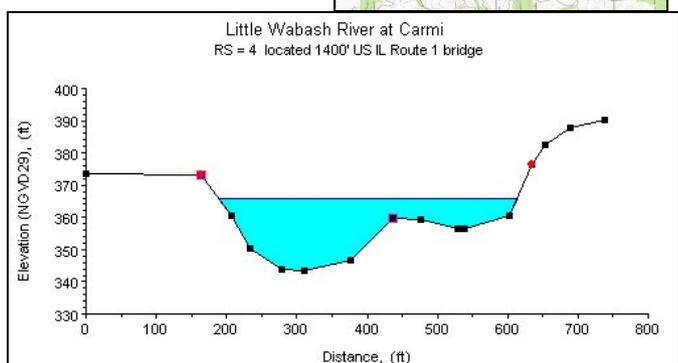
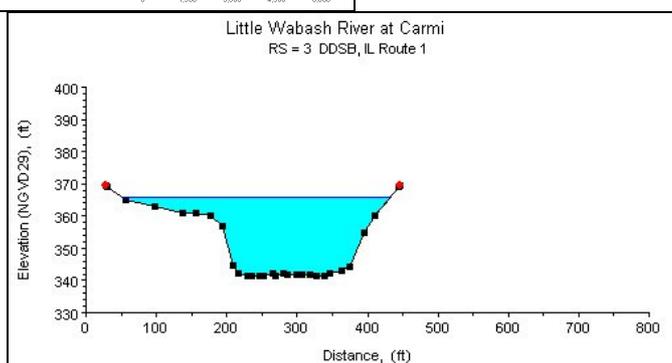
Study Reach.--The channel reach under consideration is natural and meandering. The study reach selected, approximately 2.9 miles long, extends from Main Street Bridge in Carmi to Possum Bridge, as shown in quadrangle map on the top left. Four surveyed cross sections (surveyed by the Illinois Department of Transportation (survey date unknown) and the U.S. Geological Survey in April 1993) are available at this site for evaluating the channel geometries (see plots above). The channel alignment, approximate variations in channel width and bank conditions, and locations of cross sections are shown in the aerial photo on the top right.

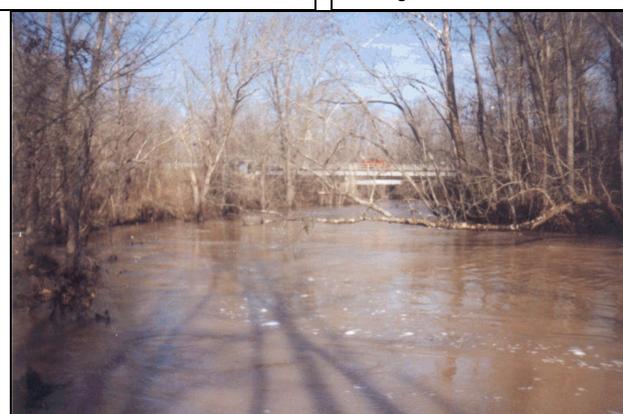
03612000 Cache River at Forman, IL
Looking Upstream

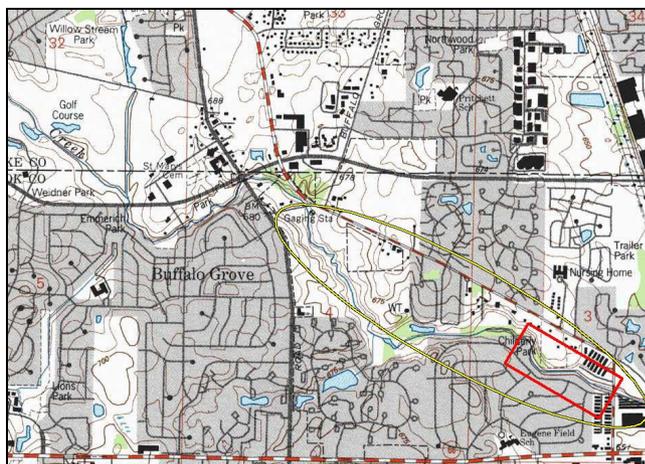
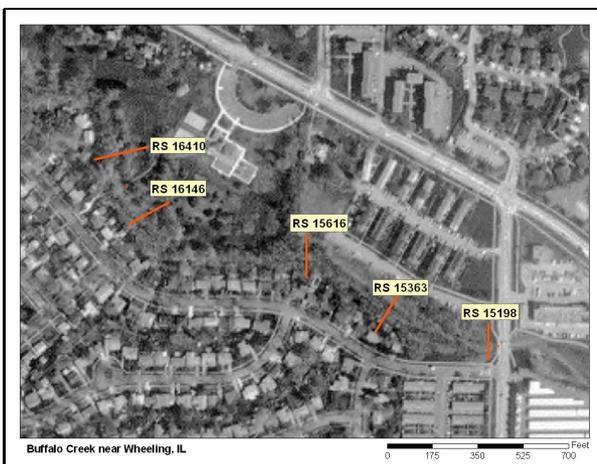
Study Reach.--The channel reach under consideration is meandering and dredged channel. The study reach selected, about 1950 ft long, is located between the Childerly Park pedestrian bridge and Elmhurst Road bridge, as shown in quadrangle map on the top left. Ten surveyed cross sections (surveyed by the Illinois Department of Natural Resources, in April and May 2003) are available for describing the channel geometries. The channel alignment, approximate variations in channel width and bank conditions, and locations of surveyed cross sections are shown in the aerial photo on the top right. Four representative cross sections at river station (RS) 16410, 16146, 15616, and 15363 are plotted above.

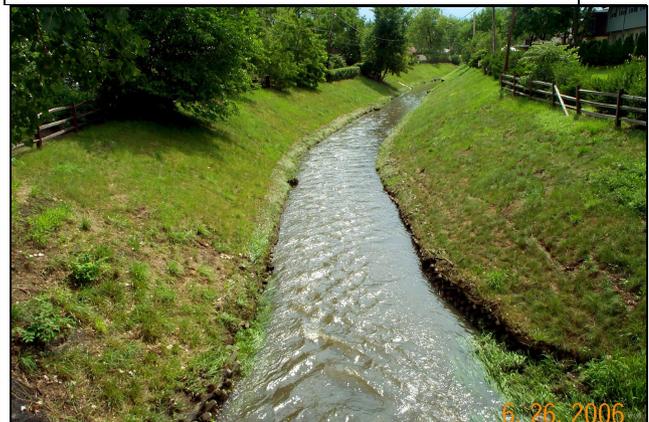
05529980 Weller Creek at Emerson St at Mt Prospect, IL (Reach 4)
Looking downstream 06/26/06

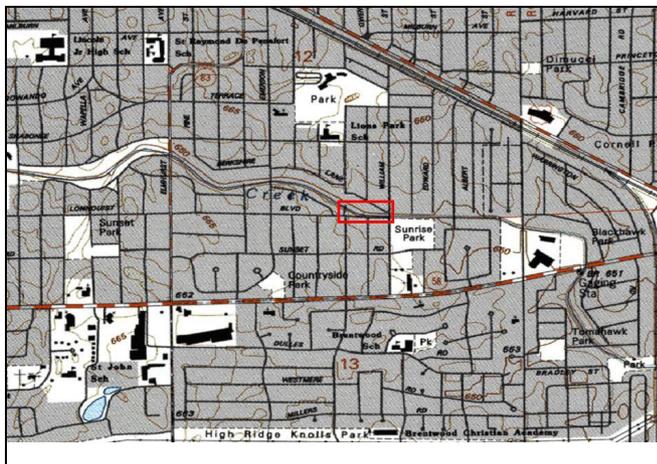
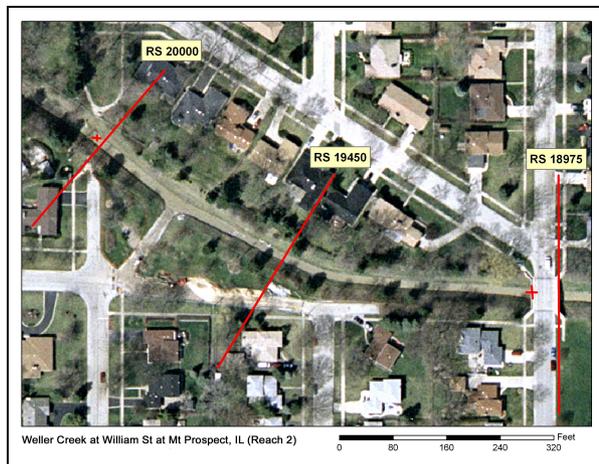
Study Reach.--The channel reach under consideration is a constructed channel in an urban setting, as shown on the quadrangle map at the top left. The study reach, about 730 ft long, is located from just upstream of the South School Street bridge to the South William Street bridge. Three surveyed cross sections (surveyed by the U.S. Corps of Engineers in May 2003) are available for describing the channel geometries in the study reach. The channel alignment, approximate variations in channel width and bank conditions, and locations of cross sections are shown in the aerial photo on the top right. Cross-sectional plots at four river stations (RSs), as shown above, are selected to illustrate the variation in cross-sectional geometry.

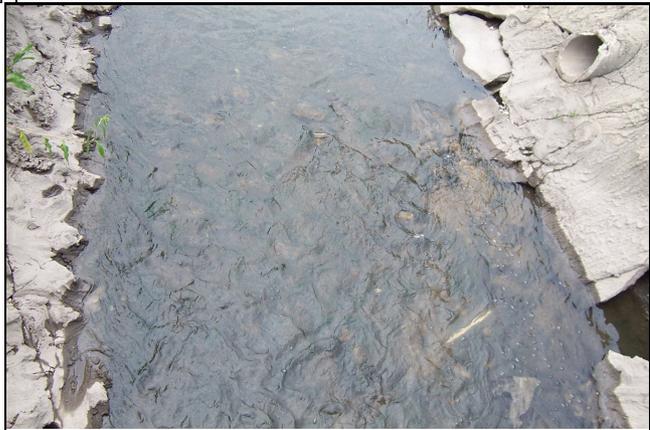
05530670 Silver Creek at Scott Ave at Franklin Park, IL (Reach 5)
Bed material, Louis St grouted riprap 06/03/03

Description of Channel.--This channel is artificial with grouted riprap banks and bed. The channel bed has cobbles on top of sand and is subject to algae growth, especially during warm periods. Channel cross sections are trapezoidal in shape with a top width of about 30 ft. The grouted concrete banks are moderately steep and have large weeds growing in through the cracks.

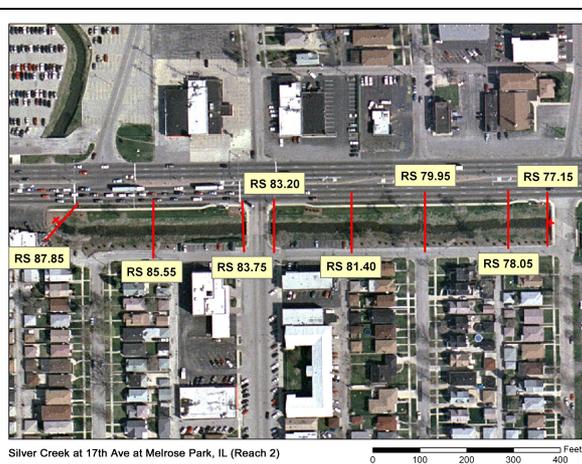
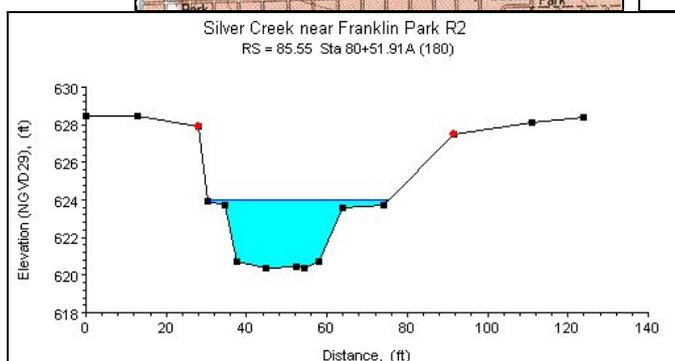
Study Reach.--The reach under consideration is a constructed straight channel in an urban area. The selected study reach, 1070 ft long, is located between downstream of 20th Avenue (Jewel Drive) bridge and upstream side of 17th Avenue bridge, as shown in the quadrangle map on the top left. Eight surveyed cross sections (surveyed by the Illinois Department of Natural Resources in 1995) are available for evaluating the channel geometries of the study reach. The alignment of the study reach, approximate variations in channel width and bank conditions, and locations of surveyed cross sections are shown in the aerial photo on the top right. The general channel shapes of the study reach are represented by four selected cross sections as plotted above.

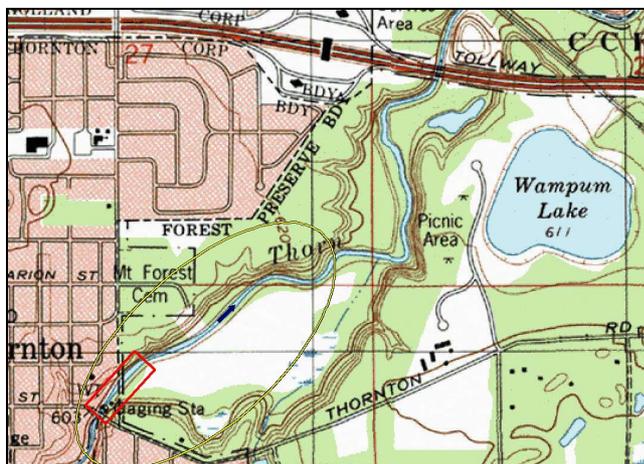
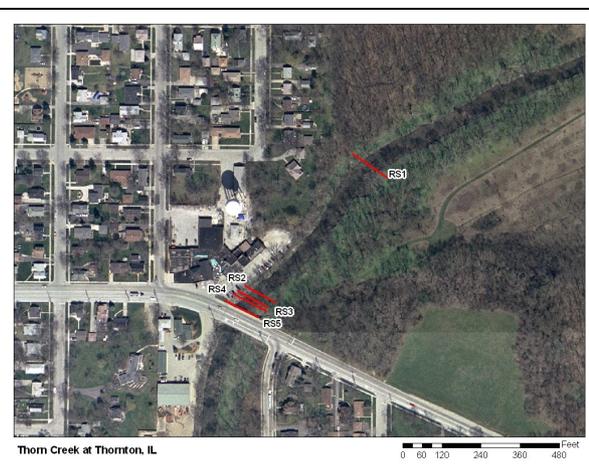
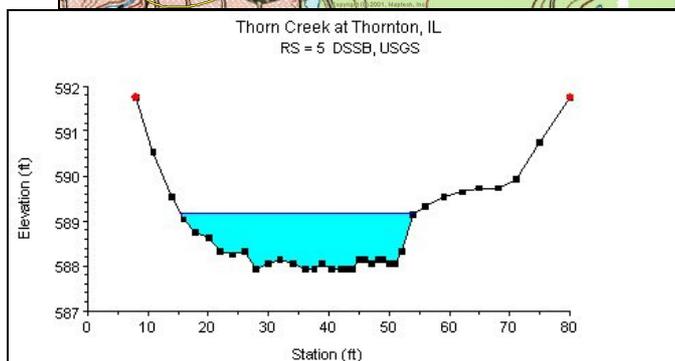
Study Reach.--The channel under consideration is meandering and natural in a forest preserve, as shown in the quadrangle map on the top left. The study reach selected extends from the USGS gage on Margaret Street bridge to 600 ft downstream from the gage. Three cross sections (surveyed by the U.S. Geological Survey in April 2001, and reconstructed from a measurement done in February 1999) are used for evaluating channel characteristics at this site. The alignment of the study reach, approximate variations in channel width and bank conditions, and locations of the surveyed cross sections are shown in the aerial photo on top-right. Cross-sectional geometries are shown in the cross section plots above.

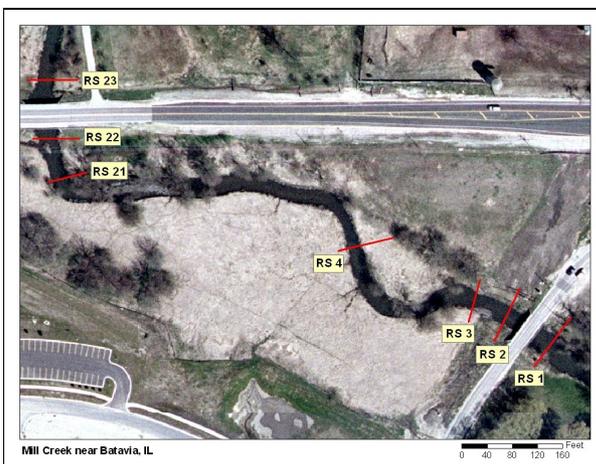
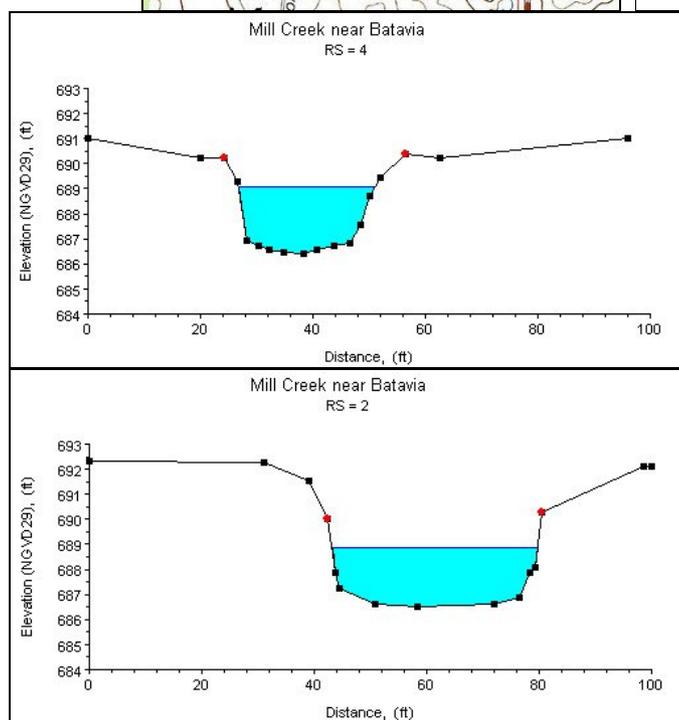
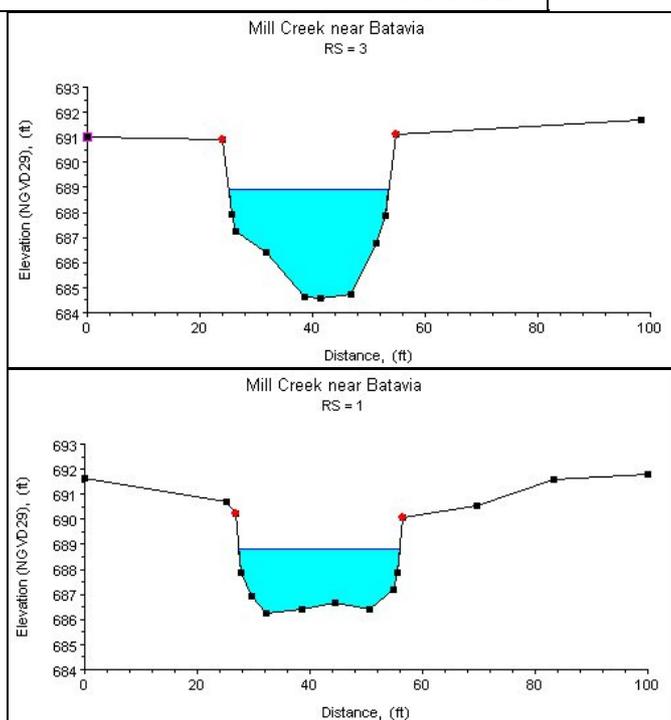
Study Reach.--The channel reach under consideration is a meandering, natural river, as shown in quadrangle map on the top left. Seven surveyed cross sections (surveyed by the Illinois Department of Natural Resources, in May 2003) are available in a reach from the Main Street bridge (upstream) to the Deer Path Road bridge (downstream). The study reach, approximately 400 ft long, was selected at the lower portion of this segment that starts from river station (RS) number RS1 upstream passing RS4, where bank vegetation is considered to be consistent in this lower reach. Bank conditions in the vicinity of Main Street were modified during the n-values study. The variations in channel alignment, width and bank conditions, as well as the locations of surveyed cross sections can be viewed in the aerial photo on the top right. Cross-sectional geometries, as described by the 4 downstream surveyed cross sections, are shown in the cross-sectional plot above.

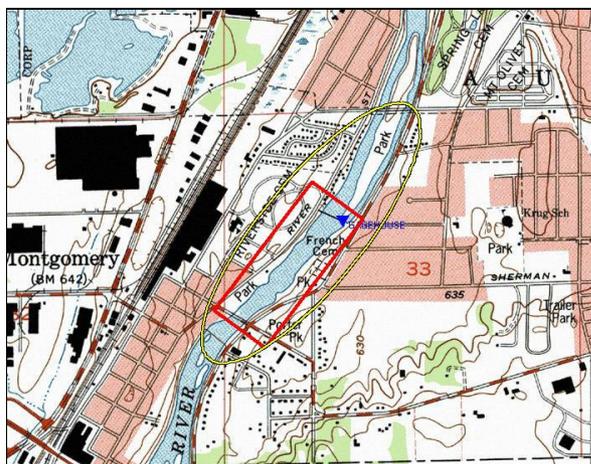
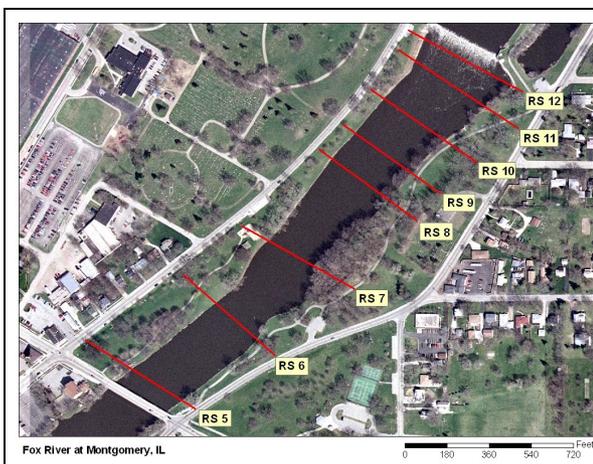
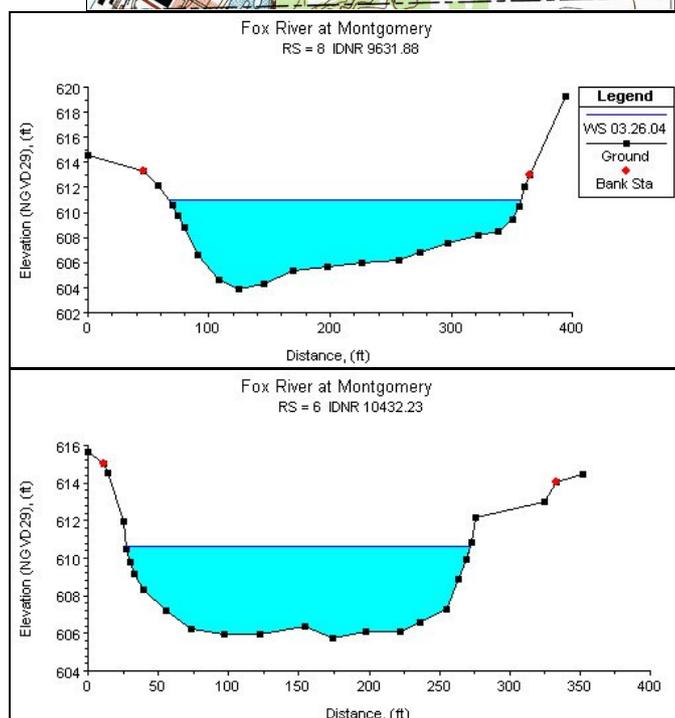
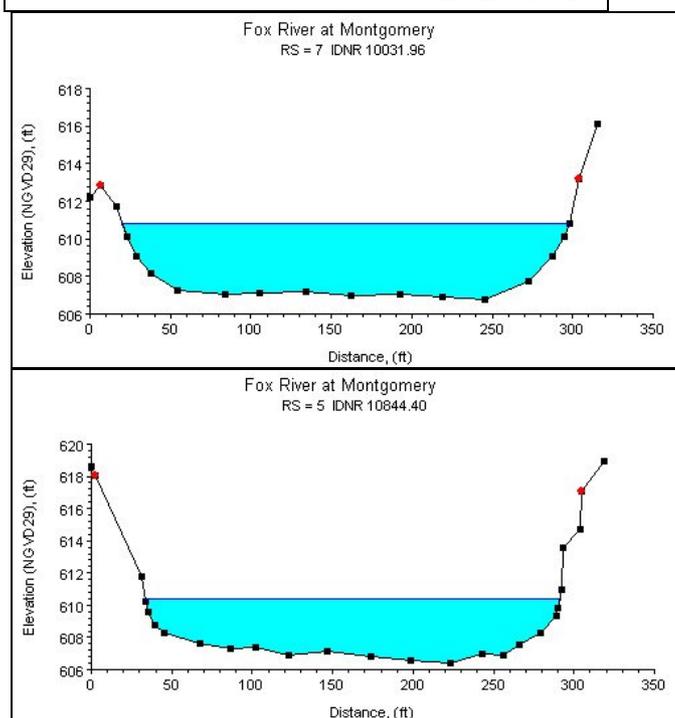
Study Reach.--The channel reach under consideration is wide and natural river. A study reach, approximately 2,110 ft long, is selected that begins about 100 ft downstream from the USGS gage house and extends to the upstream side of Mill Street bridge, as shown in quadrangle map on the top left. Eight surveyed cross sections (surveyed by Illinois Department of Natural Resources, in September 2003) are available for describing the channel geometries of the study reach. The channel alignment, approximate variations in channel width and bank conditions, and locations of cross sections are shown in the aerial photo on the top right. Four cross sections at river station (RS) 8, 7, 6, and 5 (see plots above) are considered representative for general cross sectional-shapes in the study reach.

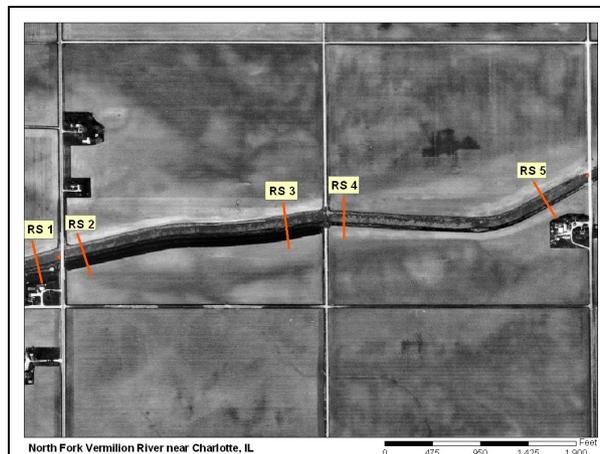
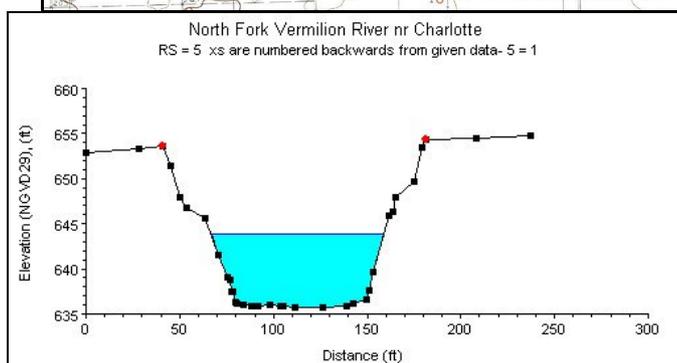
Study Reach.--The reach under consideration is dredged channel in agricultural fields with grass cover on both banks. The study reach, 5,324 ft long, is located from 200 ft downstream of Country Road 3400E bridge to 200 ft downstream of County Road 3300E bridge, as shown in quadrangle map on the top left. There are five surveyed cross sections (surveyed by the U.S. Geological Survey in January 2003) available for evaluating the characteristics of channel geometry in the study reach. The alignment of channel, approximate variations in channel width and bank conditions, and locations of surveyed cross sections are shown in the aerial photo on the top right. General shapes of

cross sections in the study reach are plotted above.

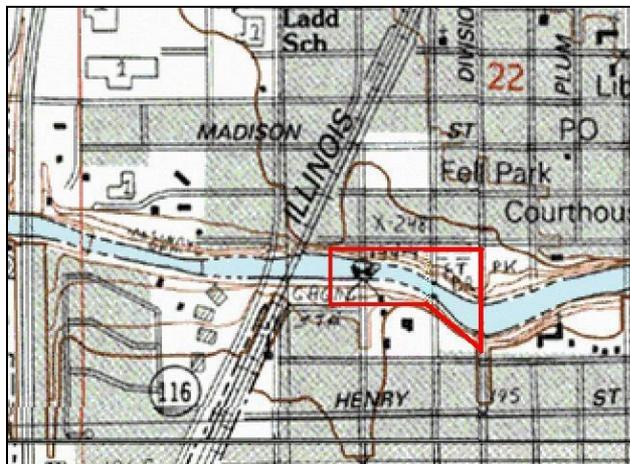
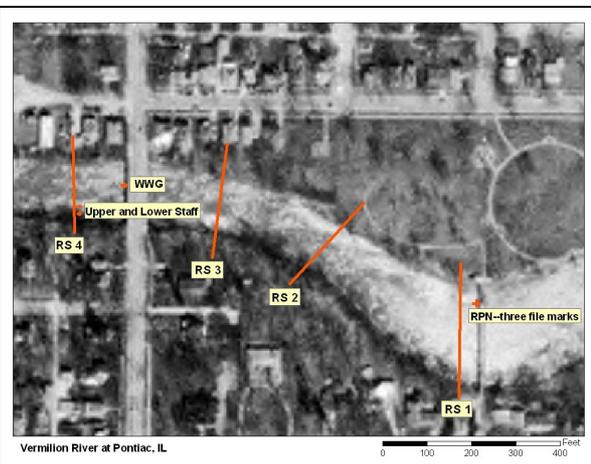
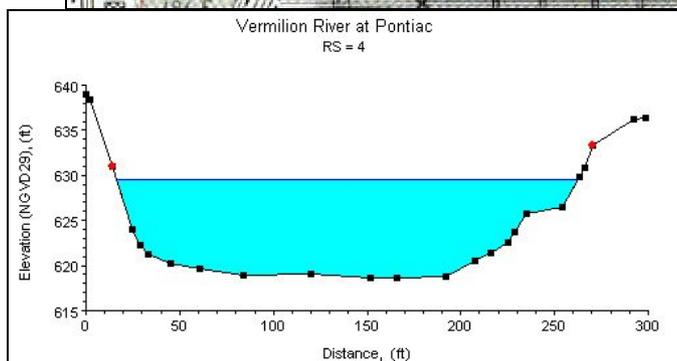
Study Reach.--The channel under consideration is natural in urban setting. The study reach, approximately 940 ft long, is located from the pedestrian footbridge in Humiston Riverside Park to 130 ft downstream of the gage on Vermillion Street bridge, as shown in quadrangle map on the top left. Four surveyed cross sections (surveyed by the U.S. Geological Survey in June 2003) are available for describing the channel characteristics of the study reach. The alignment of study reach, approximate variations in channel width and bank conditions, and locations of surveyed cross sections are shown in the aerial photo on the top right. Cross-sectional geometries, as described by four surveyed cross sections, vary gradually and continuously from upstream to downstream (see plots above).

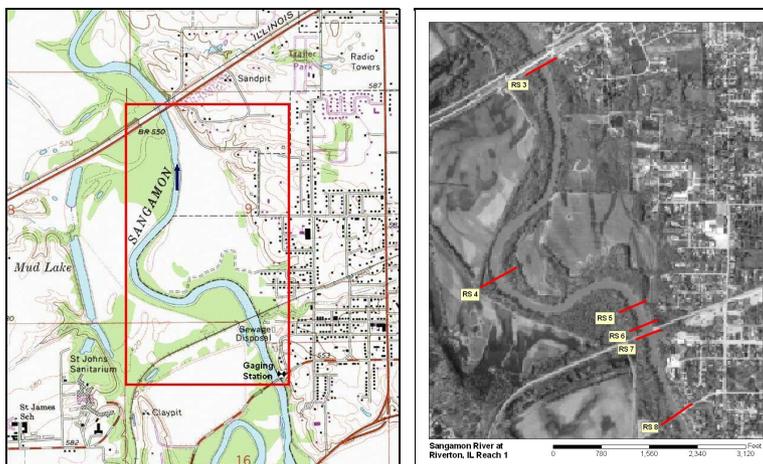
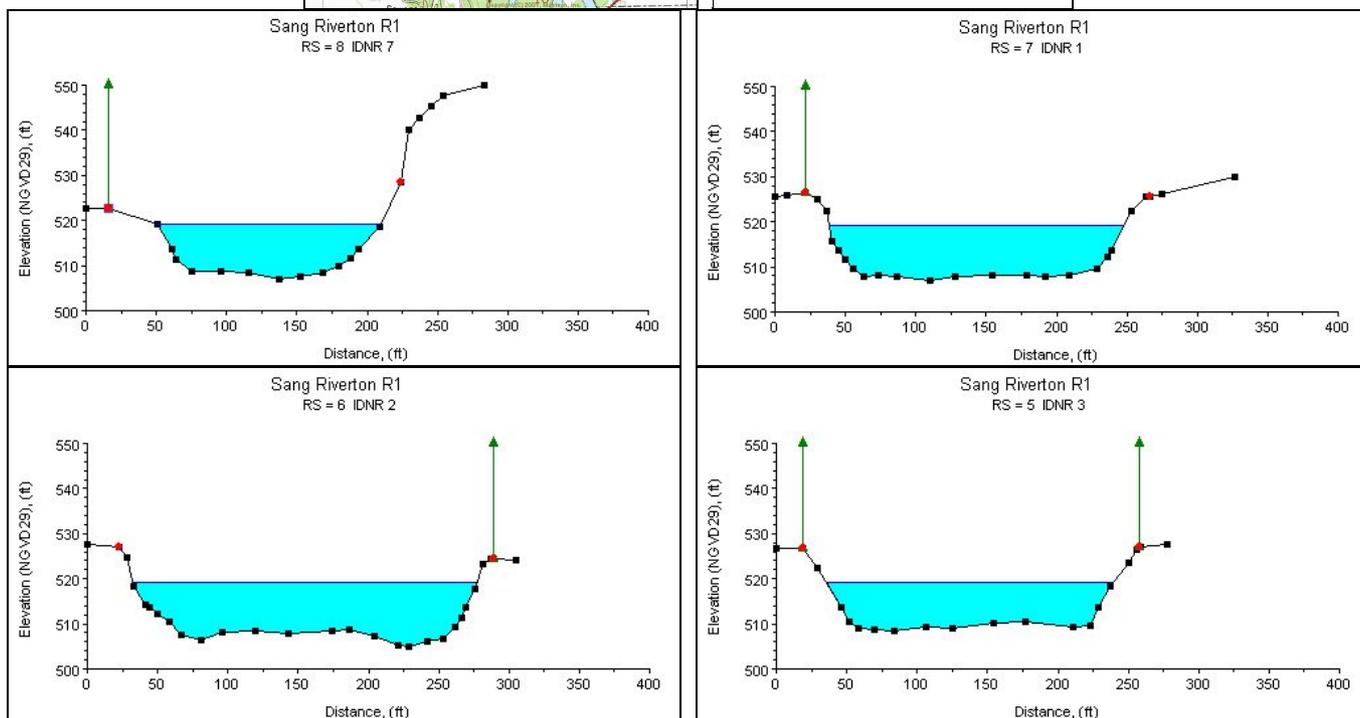
Study Reach.--The reach under consideration is the meandering, natural river. A study reach, approximately 8600 ft long, extends from the abandoned Old River Road bridge to the upstream side of State Highway 54 bridge, as shown in the quadrangle map on the top left. Six surveyed cross sections (surveyed by the Illinois Department of Natural Resources, in December 2003) are available for evaluating the channel geometries in the study reach. The channel alignment, approximate variations in channel width and bank conditions, and locations of surveyed cross sections are shown in the aerial photo on the top right. Cross-sectional geometries vary gradually from upstream to downstream (see plots above). The alignment of the study reach, approximate variations in channel width and bank conditions, and locations of the surveyed cross sections are shown in the aerial photo on the top right.

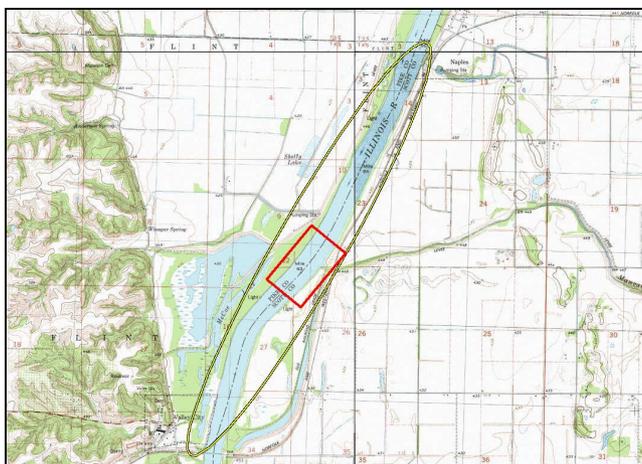
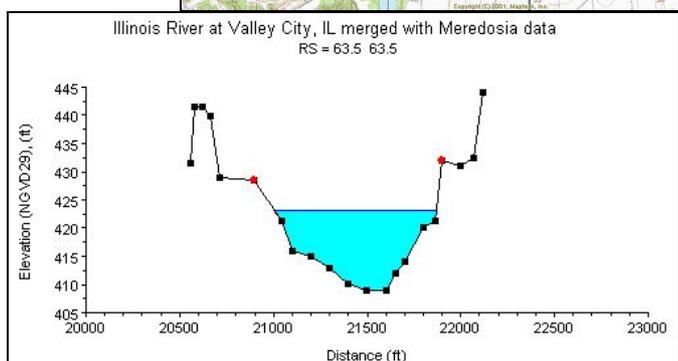
Study Reach.--The reach under consideration is a free-flowing navigation channel. The study reach, approximately 3,700 ft long, is located from the State Highway 104 bridge near Meredosia to the County Road 10 bridge near Valley City, as shown in the quadrangle map shown in the top left. There are 24 surveyed cross sections (surveyed by the U.S. Army Corps of Engineers, in August 1998) available for describing the channel geometry, four of them are in the study reach. The channel alignment, approximate variations in channel width and bank conditions, and locations of the four cross sections are shown in the aerial photo on the top right. The general shapes of cross sections in the study reach are plotted above.

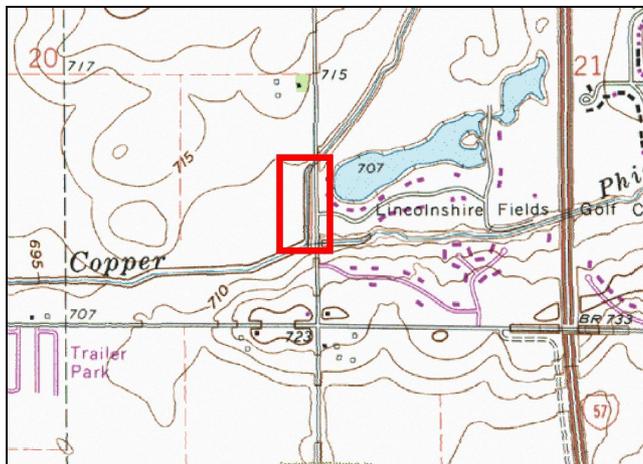
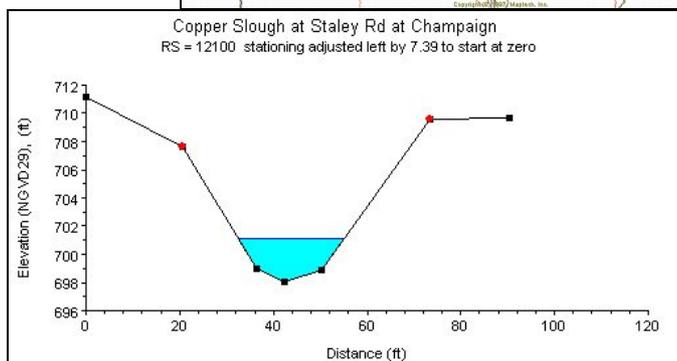
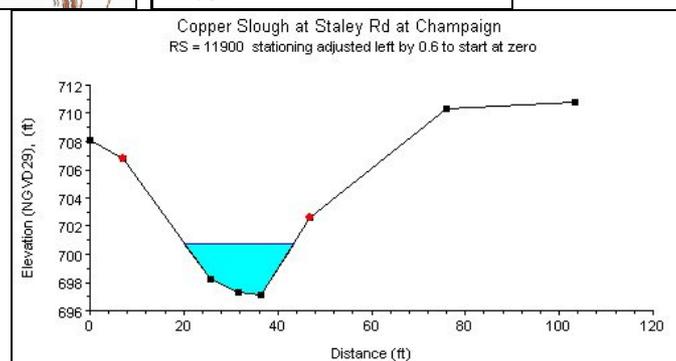
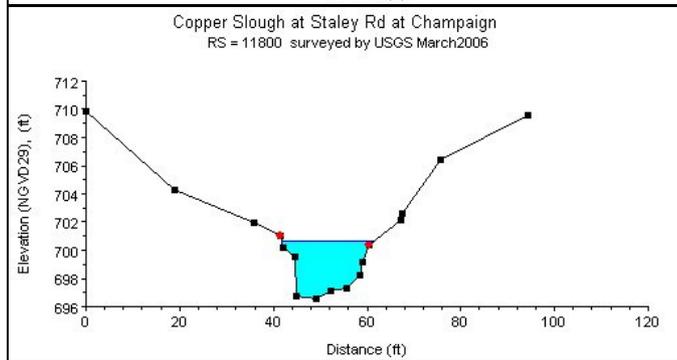
Study Reach.--The channel reach under consideration is a constructed channel in an urban setting, as shown on the quadrangle map at the top left. The study reach, about 750 ft. long, is located just downstream of the Staley Road bridge and upstream of the confluence with Phinney Branch. Four cross sections (surveyed by Clark-Dietz, Inc. in January 2005) are available for describing the channel geometries in the study reach. The channel alignment, approximate variations in channel width and bank conditions, and locations of cross sections are shown in the aerial photo on the top right. Because of the similarities in cross sectional geometries, cross sectional plots are river stations

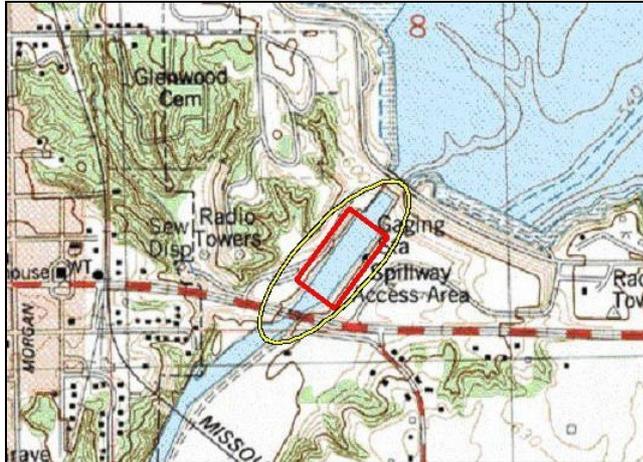
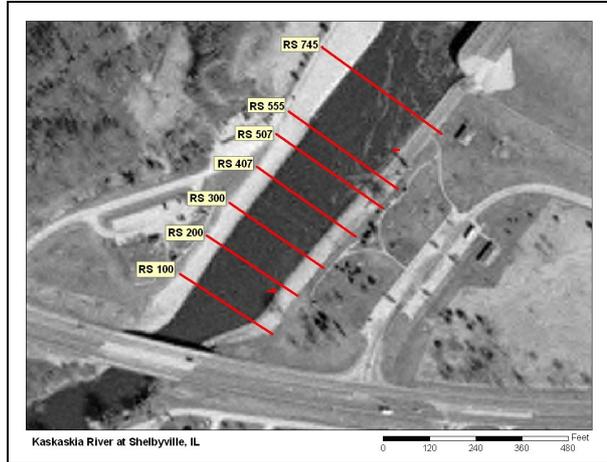
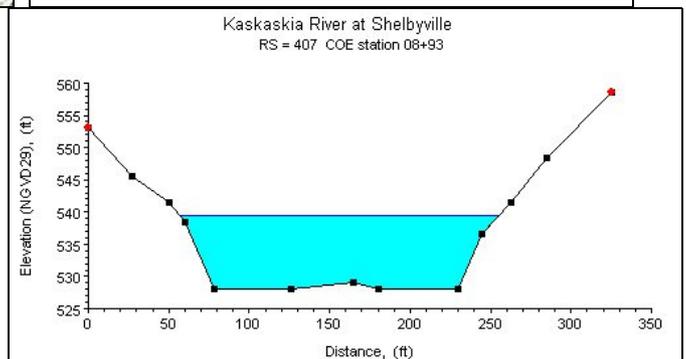
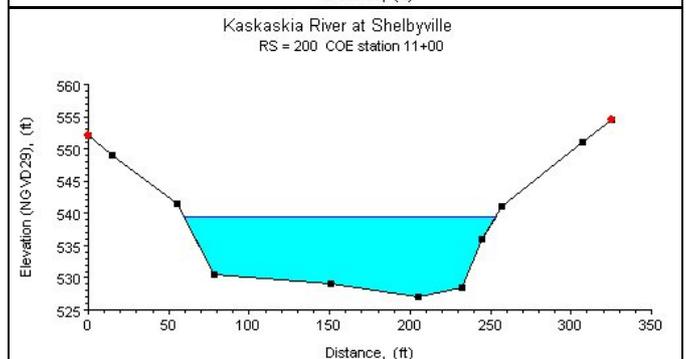
Study Reach.--The channel reach under consideration is constructed with riprap on both bank. The study reach, approximately 600 ft long, extends from upstream of the gage house to the upstream side of the State Highway 16 Bridge, as shown in the quadrangle map on the top left. Seven surveyed cross sections are available to describe the channel geometries. The channel alignment, approximate variations in channel width and bank conditions, and locations of surveyed cross sections are shown in the aerial photo on the top right. Cross-sectional geometries vary gradually and continuously from upstream to downstream. Seven surveyed cross sections (surveyed by the U.S. Army Corps of Engineers 1980) are available to describe channel geometry. The general shapes of cross sections in the study reach are illustrated with four selected cross section, (see plots above).

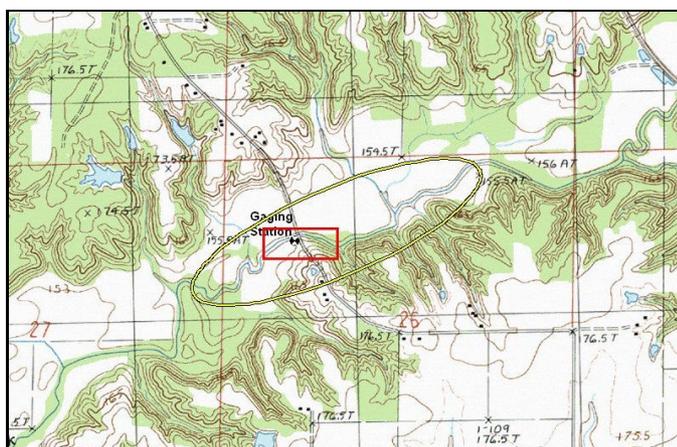
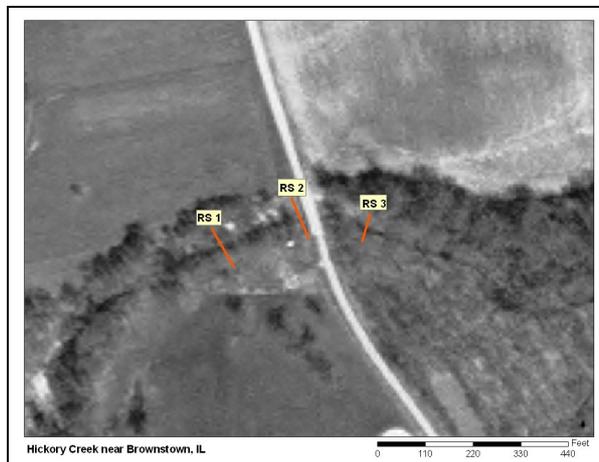
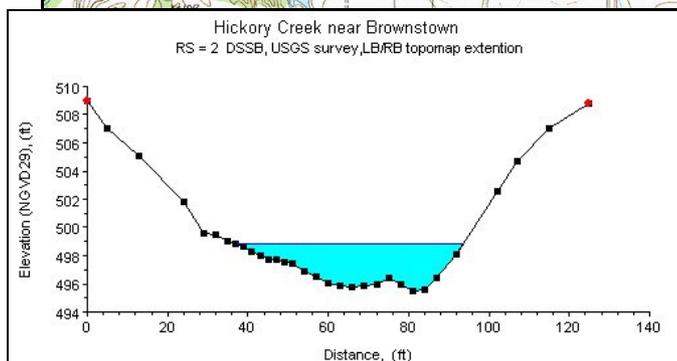
Study Reach.--The channel under consideration is natural and meandering in a rural area. The study reach, 300 ft long, is slightly off center of the county bridge, as shown in the quadrangle map on the top left. There are three cross sections (surveyed by the U.S. Geological Survey in March 2000) available for describing geometric characteristics in the study reach (see plots above). The channel alignment, approximate channel width and bank conditions, and locations of channel cross sections are presented in the aerial photo on the top right.

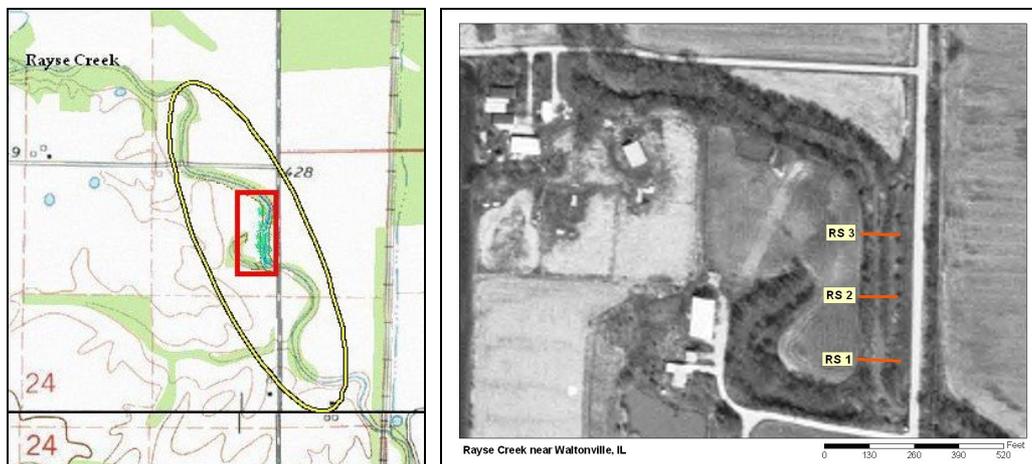
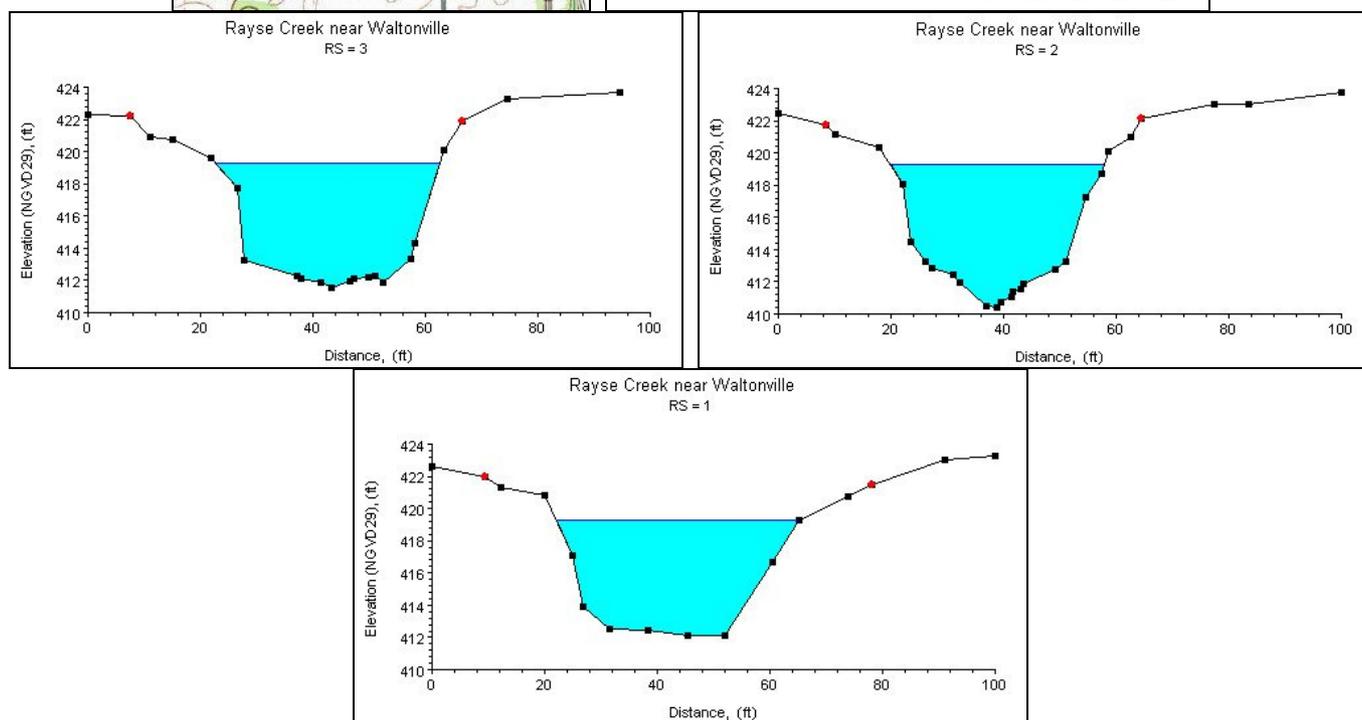
Study Reach.--The channel under consideration is a meandering reach of a natural channel, as shown in the quadrangle map on the top left. The study reach is 310 ft long and extends about 400 ft upstream from the bridge on County Road 600E. Three surveyed cross sections (surveyed by the U.S. Geological in April of 2003) are available for characterizing the channel geometry in the study reach (see plots above). The alignment of the study reach, approximate variations in channel width and bank conditions, and locations of the surveyed cross sections are shown in the aerial photo on the top right.
