Middle Fork Vermilion River Above Oakwood, IL

Study Reach.--The channel reach under consideration is natural. A study reach, approximately 400 ft long, is selected upstream of the Kickapoo State Park Road bridge, as shown in the quadrangle map on the top left. The reach starts from 100 ft downstream of the Kickapoo State Park Road bridge and extends approximately 300 ft upstream. There are four surveyed cross sections (surveyed by the U.S. Geological Survey in May 2003) available for describing channel geometries in the study reach (see plots above). The channel alignment, approximate variations in channel width and bank conditions, and locations of the cross sections are shown in the aerial photo on the top right. Cross-sectional geometries vary gradually from upstream to downstream.

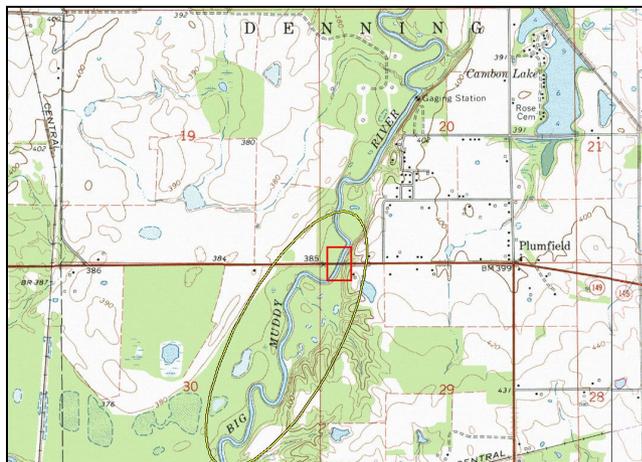
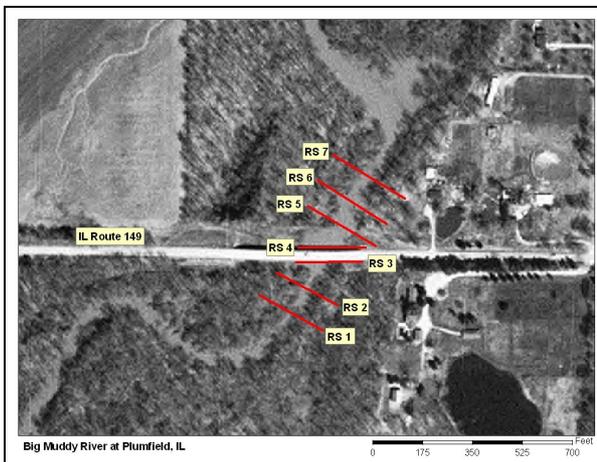
Study Reach.--The reach under consideration has a series of bends, as shown in the quadrangle map on the top left. The study reach selected, approximately 535 ft long, is centered on the bridge on State Highway 149. There are seven surveyed cross sections (surveyed by the Illinois Department of Transportation, in December 1997) available for evaluating the channel geometry in the study reach. The alignment of study reach, approximate variations in channel width and bank conditions, and locations of surveyed cross sections are shown in the aerial photo on the top right. Cross-sectional geometries vary gradually and continuously from upstream to downstream. The general shapes of cross sections in the study reach are represented with cross sections at river station (RS) 2, 3, 4, and 5 (see plots above).

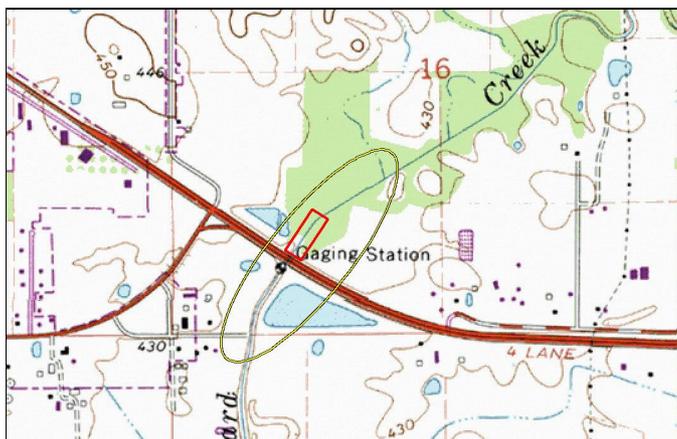
Study Reach.--The channel reach under consideration is dredged in an urban setting. A study reach, approximately 600 ft long, is selected that extends upstream from the State Route 13 bridge as shown on the quadrangle map on the top left. Three surveyed cross sections (surveyed by the Illinois Department of Natural Resources in June 2005) are available for describing the channel geometries of the study reach (see plots above). The channel alignment, approximate variations in channel width and bank conditions, and locations of cross sections are shown in the aerial photo on the top right.

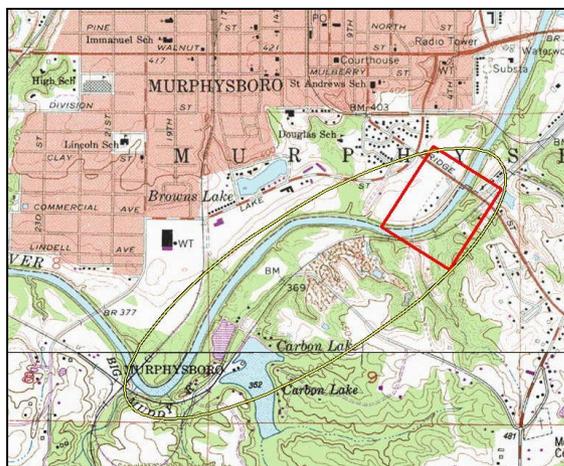
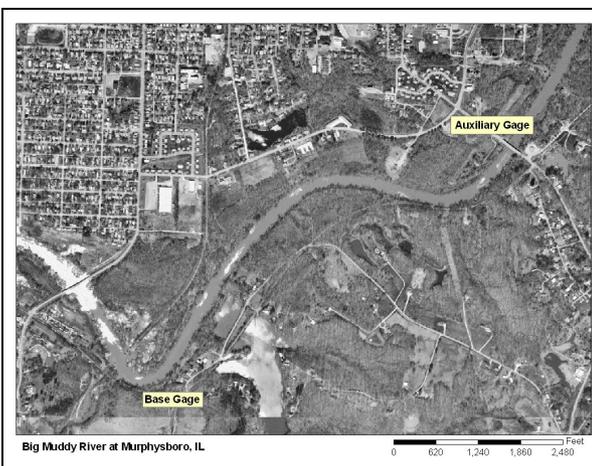
Study Reach.--The reach under consideration is a wide, natural meandering channel. The study reach, 8900 ft long, extends from the USGS auxiliary gage on Route 127 bridge to the USGS base gage, located just upstream of the South Twentieth Street bridge, as shown is the quadrangle map on the top left. The alignment of study reach, approximate variations in channel width and bank conditions, and locations of surveyed cross sections are shown in the aerial photo on the top right.
