Drainage Ditch at Devonshire Dr. at Champaign, IL

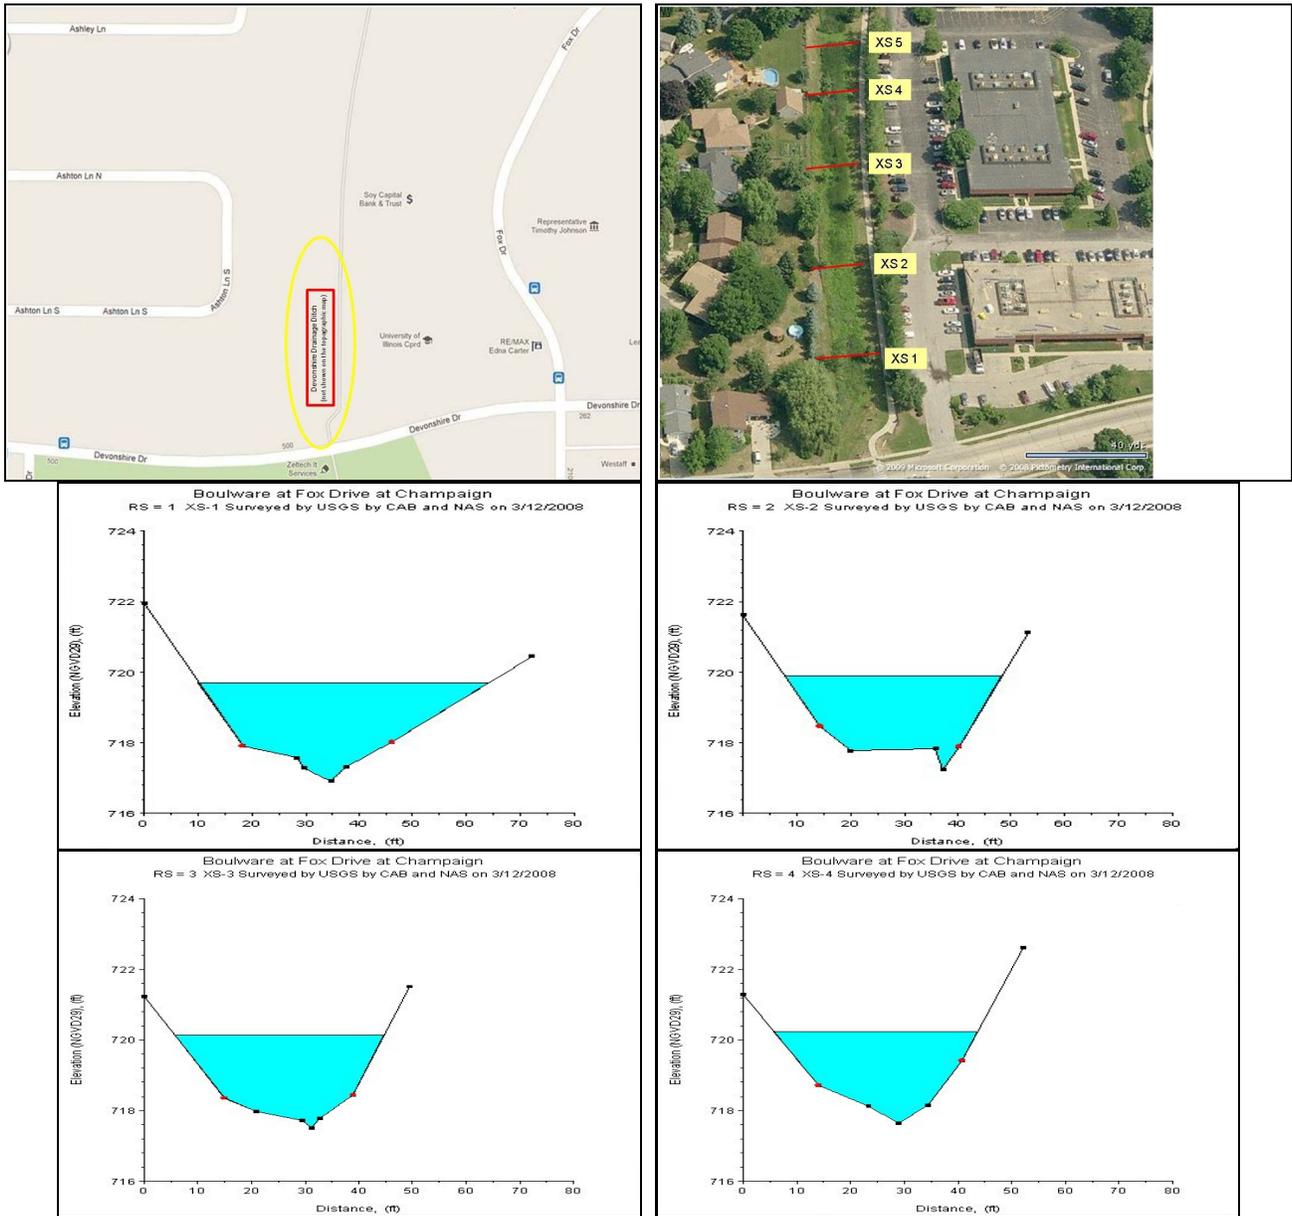
Study Reach.--The channel reach is a drainage ditch in an urban setting, as shown in quadrangle map on the top left. The study reach is approximately 800 ft long and is located upstream of the intersection with Devonshire Drive Road. Five surveyed cross sections (surveyed by the USGS-ILWSC in March 2008) are available for describing the geometry of the study reach. Cattails fill the channel seasonally. The channel alignment is relatively straight and cross sections were reworked to a trapezoidal shape. The channel alignment, approximate variations on channel width and bank conditions, and locations of the cross section are shown in the aerial photograph on the top right. Four cross sections are selected to illustrate the cross sectional and longitudinal variations of the geometry. It can be seen from the plots above that the cross sectional shape is essentially trapezoidal but erosion and deposition patterns are developing in the bed area.

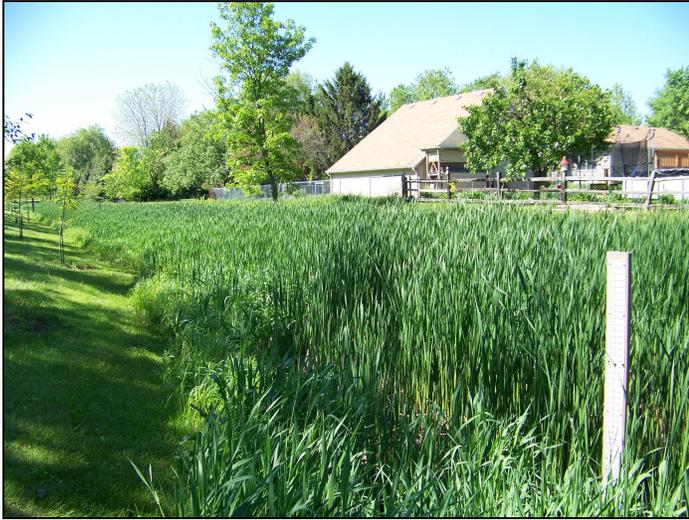
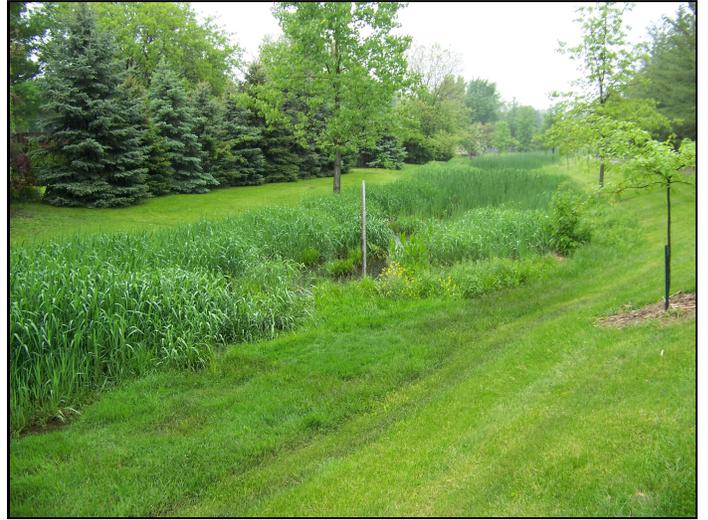
Description of the Channel. --The alignment of the study reach is straight. Its channel has been reworked to form a trapezoidal shape and that shape remained at the time of survey in March, 2008, except for the development of local erosion or deposition. The bottom width of the channel is approximately 26 ft. During growing seasons most of the streambed is covered with cattails except for the most downstream section, which is covered by weeds. The bank has a mild slope ($\sim 15^\circ$) and is covered with mowed grass with evenly spaced young trees (~ 5 inches in diameter). The top width of the channel is approximately 50 ft.
