# Embarras River Tributary at Champaign, IL

Embarras Tributary at Champaign, IL

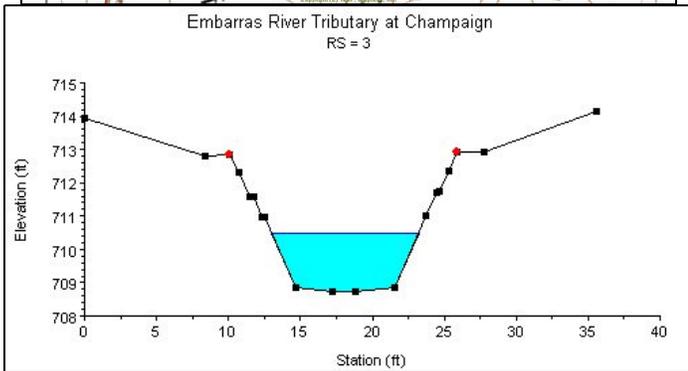
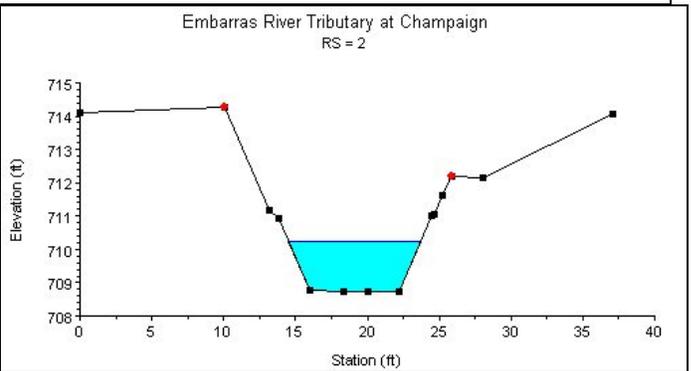
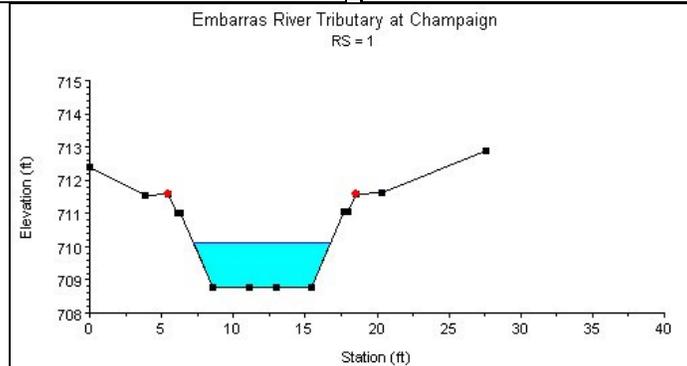
**Study Reach.**--The reach under consideration is a rectangular concrete drainage channel in an urban setting, as shown in quadrangle map on the top left. The study reach, about 200 ft long, is located south of Gerty St., to the west and parallel to Griffith Drive. Three cross sections (surveyed by USGS, in February 2006) are available for describing the channel geometries considered in the study, and locations of cross sections are shown in the aerial photo on the top right. Because of the similarities in cross sectional geometries, cross sectional plots at river stations (RS) 1, 2, and 3, as plotted above, are selected as representative cross sections.

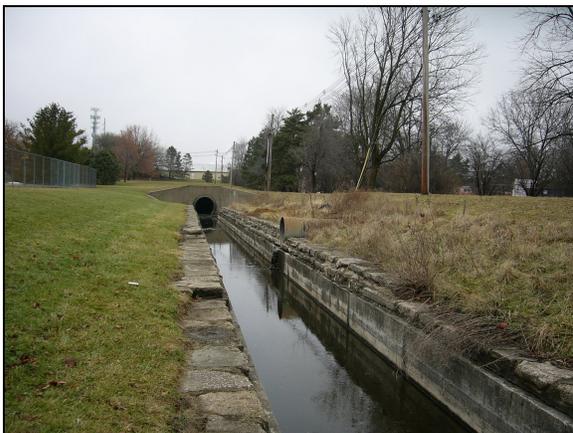
03343200 Embarras Tributary at Champaign, IL  
Looking upstream from downstream end 03/08/06

**Description of Channel.**--This channel is located downstream of a six foot diameter culvert pipe, which collects run-off from portions of the University of Illinois campus and Research Park. The study reach begins after a stilling basin, approximately 20 ft downstream of the pipe outlet. The stilling basin is concrete-padded, with a broad-crested weir at downstream end. There is a second culvert-pipe outfall on the left-side, approximately 110 ft downstream of the total channel length. The flow contributions from this pipe may necessitate moving the study reach upstream within the channel to exclude its effects. The bed material consists of depositional silt, sand, and muck with algal and light grass growth; the upstream end has some flag-stones layers, with each successive layer set-back a few inches from the one below. The study reach has a rectangular cross-sectional geometry. Bed and lower banks are concrete-lined with flag-stone layered on the upper banks of both sides. Occasional bed depositions consist of silt and fine sand and algal

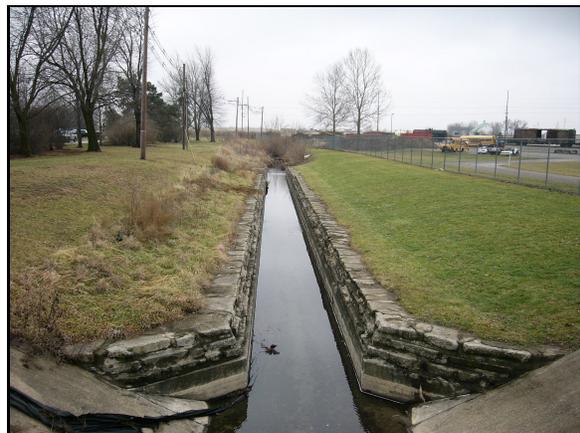
03343200 Embarras Tributary at Champaign, IL  
Looking downstream from upstream end 03/08/06

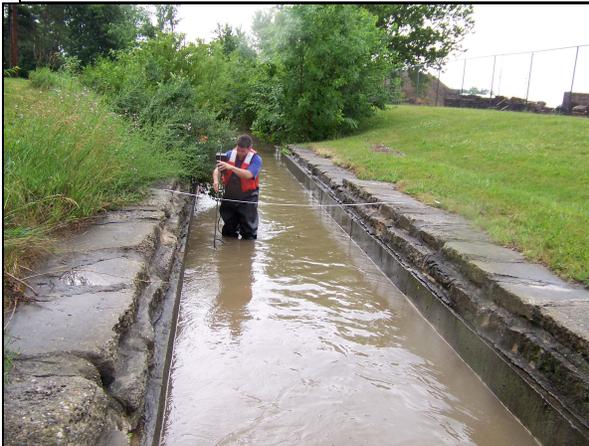
03343200 Embarras Tributary at Champaign, IL  
Looking Downstream 06/26/2007

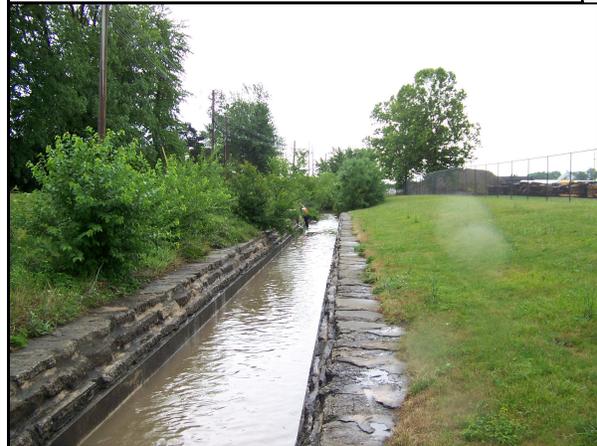
03343200 Embarras Tributary at Champaign, IL  
Looking Downstream 06/26/2007

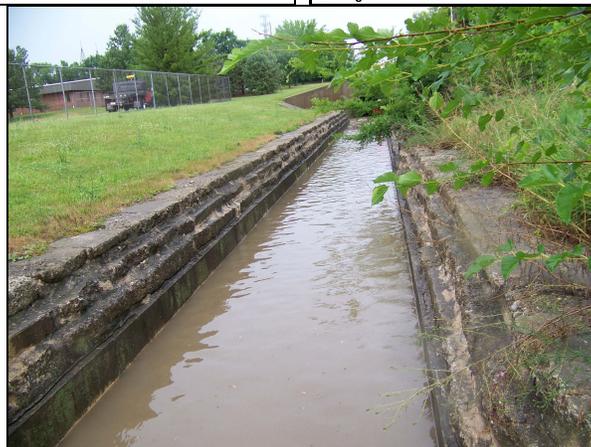
03343200 Embarras Tributary at Champaign, IL  
Looking Upstream 06/26/2007
