Blackberry Creek near Yorkville, IL

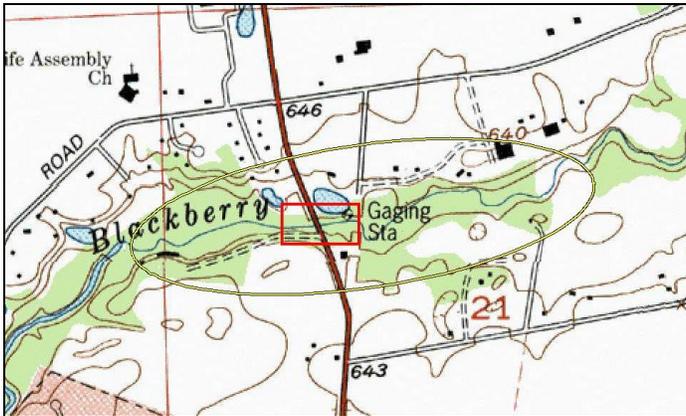
Study Reach.--The channel reach is a relatively straight and natural channel in a wooded area, as shown in quadrangle map on the top left. The study reach, approximately 1,400 ft long, extends from the USGS gage, located about 300 ft upstream from the Route 47 bridge, to about 1270 ft downstream of the Route 47 bridge. Four surveyed cross sections (surveyed by the U.S. Geological Survey, Illinois Department of Natural Resources, and Smith Engineering in 2001 and the Illinois Department of Transportation, in April 2003) are available for describing geometries of the study reach. The channel alignment, approximate variations in channel width and bank conditions, and locations of the cross sections are shown in the aerial photograph on the top right. Cross-sectional geometries, as described in four cross sections (see plots above), vary continuously from upstream to downstream.

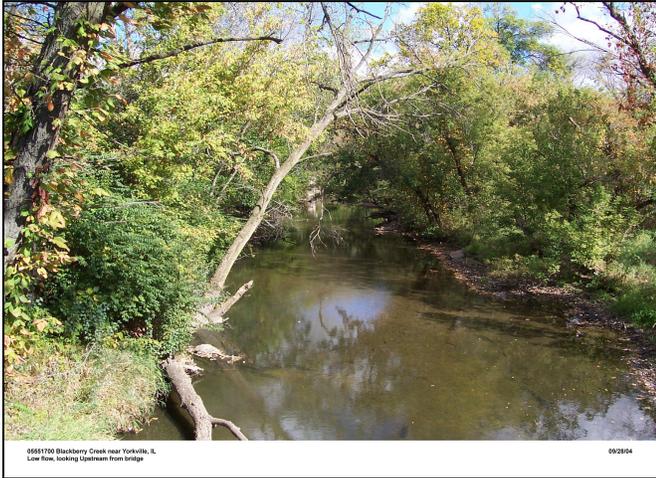
09/28/04

0661700 Blackberry Creek near Yorkville, IL
Low flow, looking upstream from bridge

Description of Channel.--This channel is natural with trapezoidal cross sections in a fairly straight reach. The bed materials consist of shifting sand and gravel. The bottom width of the channel varies from approximately 20 to 30 ft. Bank materials consist of bare earth with exposed tree roots. Dense underbrush and medium trees (from 6 to 12 inches in diameter) are found on top of the bank and on the floodplains. The bank heights are about 10 ft at the upstream end and gradually drop to about 3 ft at the downstream end. The left bank is gradually sloped. The right bank of the channel, downstream from the gage, is fairly steep. The top width of the channel is approximately 70 ft. The channel banks begin to overflow at a stage of about 6.5 ft. Large debris jams are common in the channel.

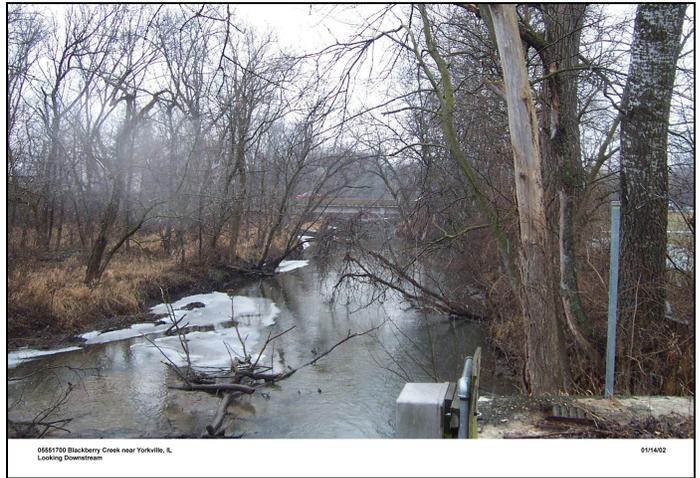
01/14/02

0661700 Blackberry Creek near Yorkville, IL
Looking Downstream
