# Sangamon River at Riverton Reach 1, IL

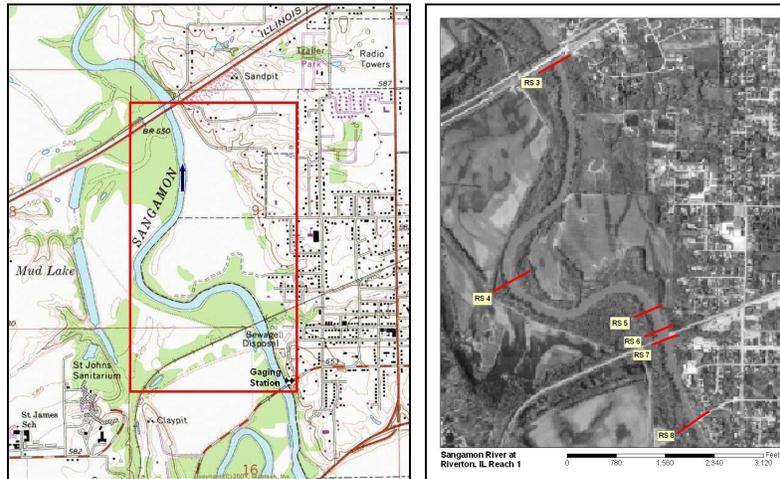
**Study Reach.**--The reach under consideration is the meandering, natural river. A study reach, approximately 8600 ft long, extends from the abandoned Old River Road bridge to the upstream side of State Highway 54 bridge, as shown in the quadrangle map on the top left. Six surveyed cross sections (surveyed by the Illinois Department of Natural Resources, in December 2003) are available for evaluating the channel geometries in the study reach. The channel alignment, approximate variations in channel width and bank conditions, and locations of surveyed cross sections are shown in the aerial photo on the top right. Cross-sectional geometries vary gradually from upstream to downstream (see plots above). The alignment of the study reach, approximate variations in channel width and bank conditions, and locations of the surveyed cross sections are shown in the aerial photo on the top right.

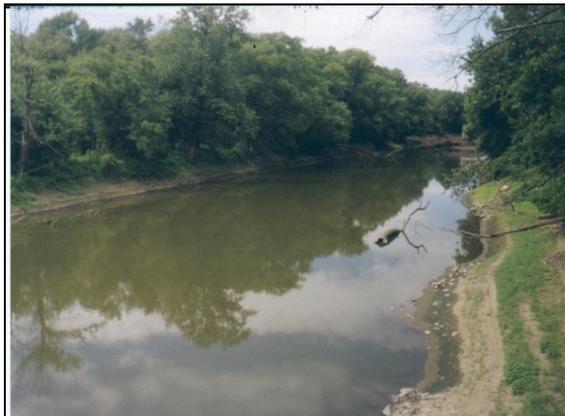
05576500 Sangamon River at Riverton, IL Reach 1  
Looking Downstream from gage house

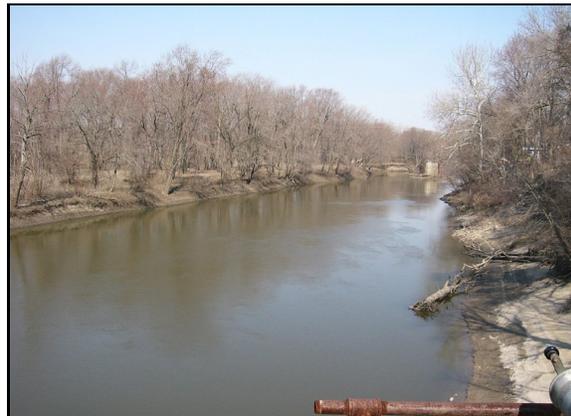
03/23/04

05576500 Sangamon River at Riverton, IL Reach 1  
Looking Downstream from WWG2

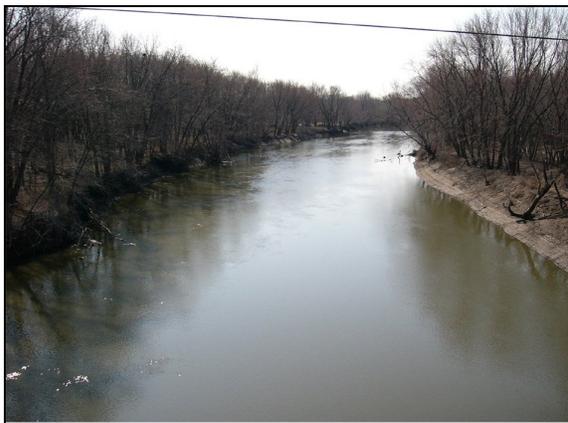
03/23/04

05576500 Sangamon River at Riverton, IL Reach 1  
Looking Upstream from Rte 54 bridge

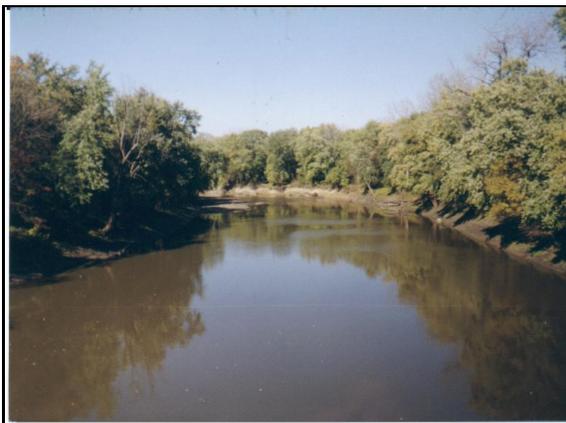
05576500 Sangamon River at Riverton, IL Reach 1  
Looking Downstream towards old bridge pier site

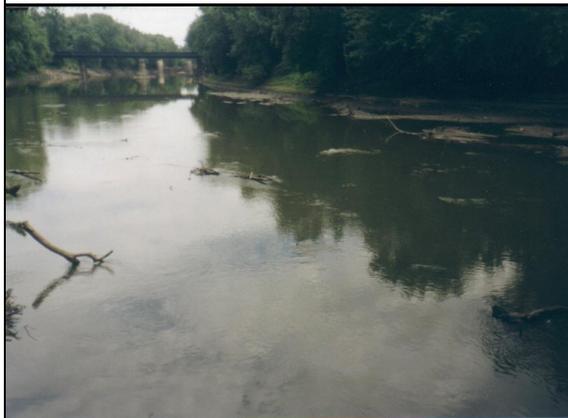
05576500 Sangamon River at Riverton, IL Reach 1  
Looking Upstream toward railroad trestle

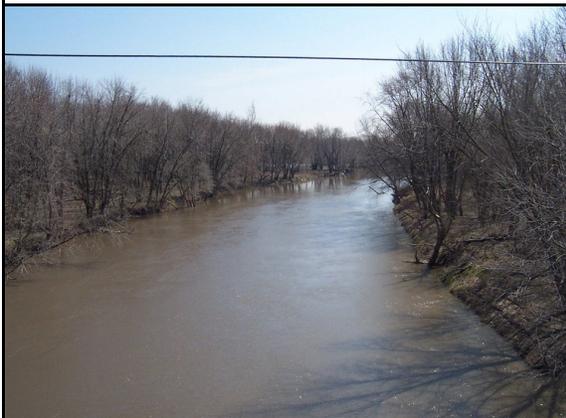
03/27/02

05576500 Sangamon River at Riverton, IL Reach 1  
Looking Upstream from Rte 54 bridge
