Sugar Creek near Bloomington, IL

Study Reach.--The channel reach under consideration is the artificially straightened river, as shown in the quadrangle map on the top left. The study reach selected, approximately 450 ft long, is a segment upstream of the I74 bridge extending from the USGS gage house at upstream to upstream of I74 bridge at the downstream end. Three surveyed cross sections (surveyed by the U.S. Geological Survey in September 2004) are available to define channel geometries at this site (see plots above). The alignment of the study reach, approximate variations in channel width and bank conditions, and locations of the surveyed cross sections are shown in the aerial photo on the top right.

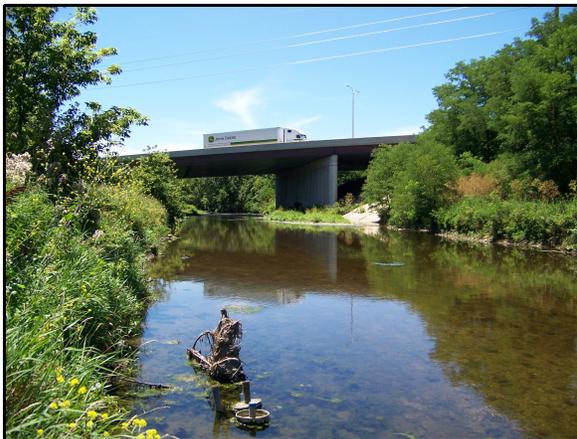
05580950 Sugar Creek near Bloomington, IL
7/10/2007
Low flow, looking downstream

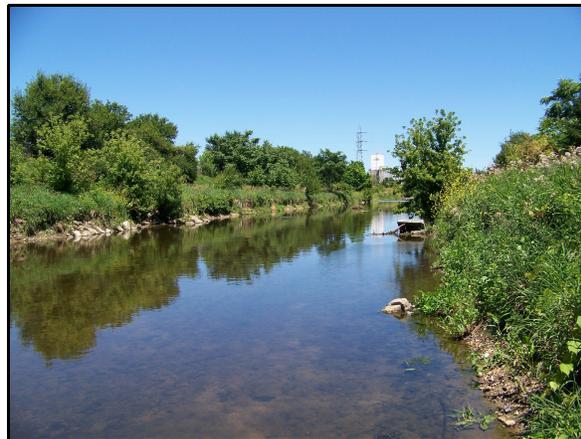
05580950 Sugar Creek near Bloomington, IL
7/10/2007
Low flow, looking upstream

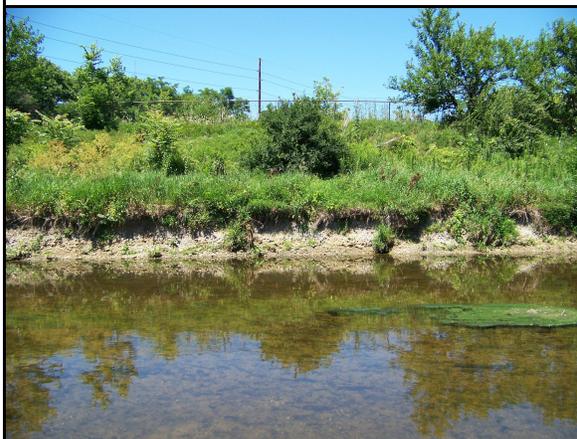
05580950 Sugar Creek near Bloomington, IL
7/11/2007
Low flow, looking at right bank

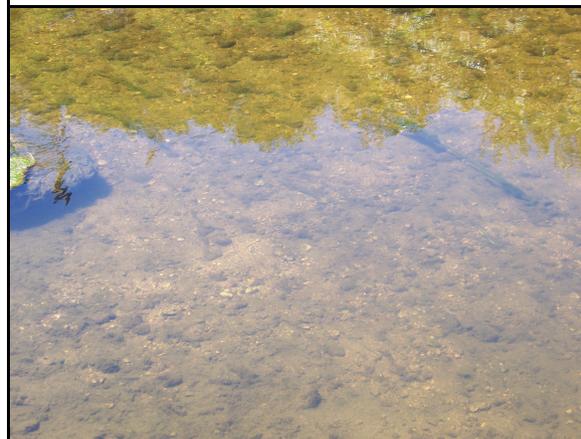
05580950 Sugar Creek near Bloomington, IL
7/10/2007
Low flow, looking at bed material

Description of Channel.--The study reach represents a channelized, straightened river in a suburban environment. The streambed material is sand and gravel with scattered small cobbles. Tall grasses and sparse small brush line both banks. Appreciable amounts of algae grow in the channel during summer months. The channel has moderately steep-sloping banks about 6 ft high. The top width varies from 70 ft to 90 ft. The channel bed has a flat bottom about 65 ft wide. The cross-sectional shape is trapezoidal. The channel is straight.

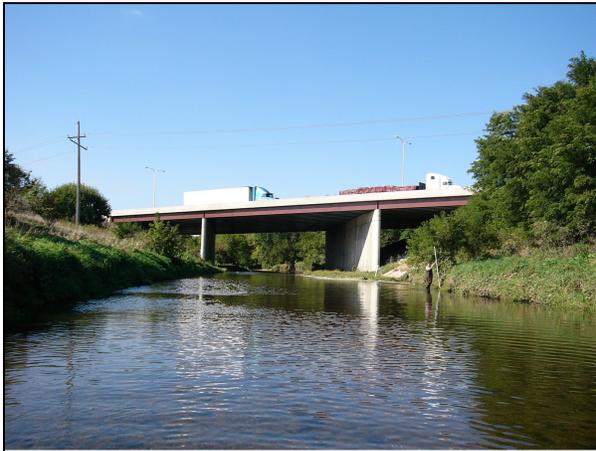
05580950 Sugar Creek near Bloomington, IL
Looking Downstream from gage

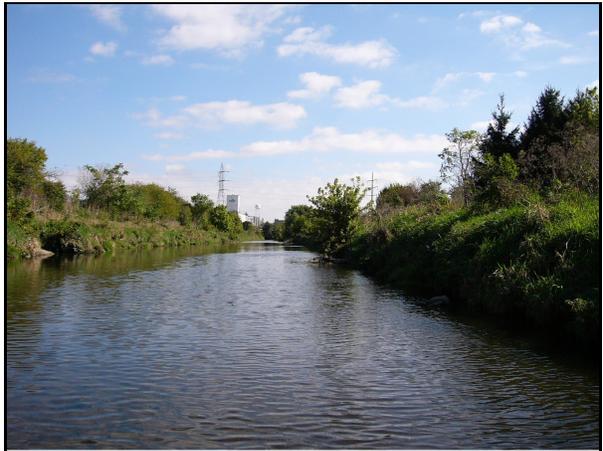
05580950 Sugar Creek near Bloomington, IL
Looking Upstream from gage

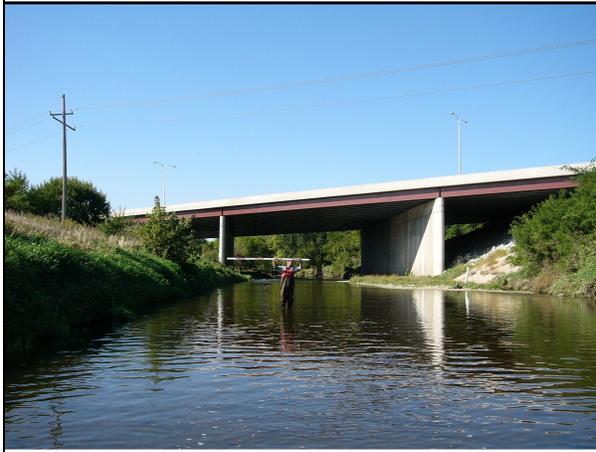
07/10/03

05580950 Sugar Creek near Bloomington, IL
Looking Downstream, stage visualization

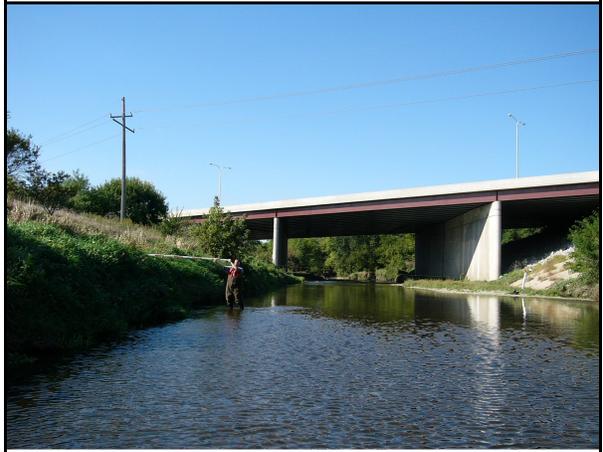
07/10/03

05580950 Sugar Creek near Bloomington, IL
Looking Downstream, stage visualization

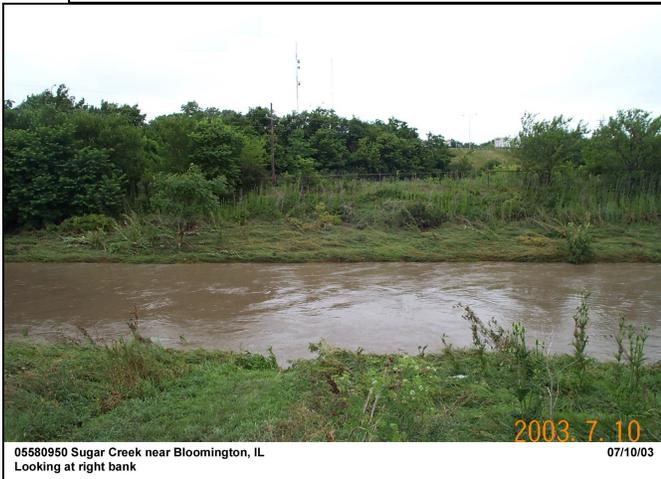
07/10/03

05580950 Sugar Creek near Bloomington, IL
Looking at right bank

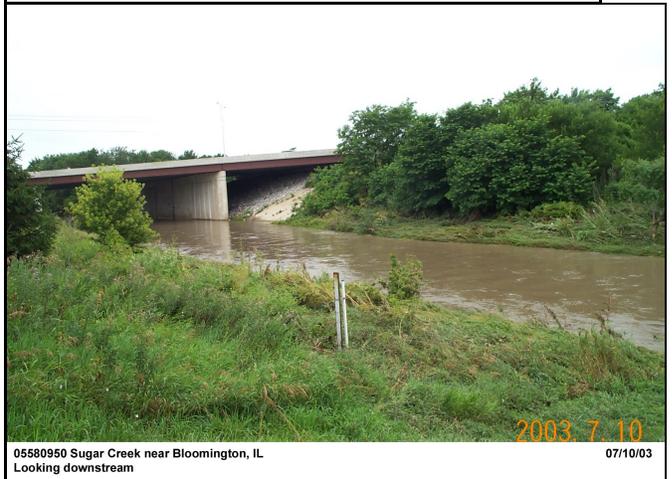
07/10/03

05580950 Sugar Creek near Bloomington, IL
Looking downstream
