Rayse Creek near Waltonville, IL

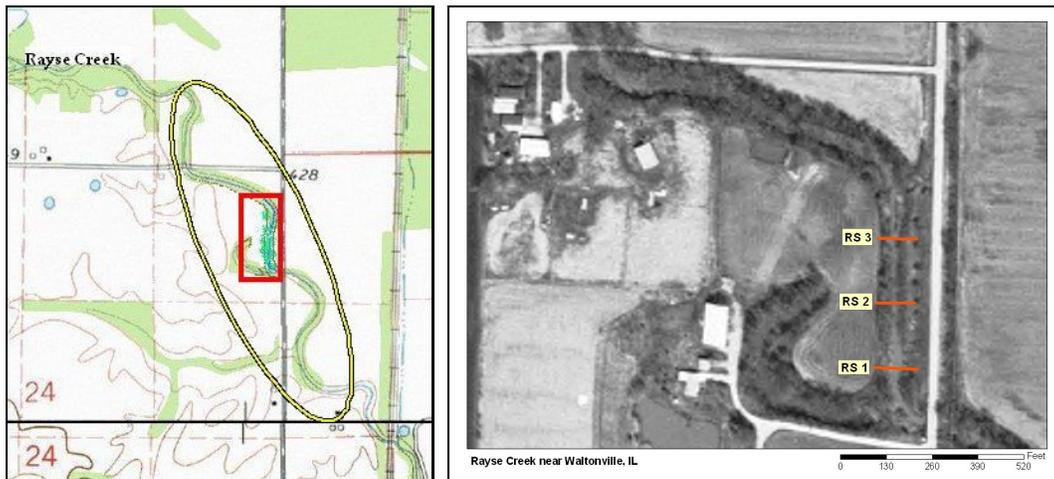
Study Reach.--The channel under consideration is a meandering reach of a natural channel, as shown in the quadrangle map on the top left. The study reach is 310 ft long and extends about 400 ft upstream from the bridge on County Road 600E. Three surveyed cross sections (surveyed by the U.S. Geological in April of 2003) are available for characterizing the channel geometry in the study reach (see plots above). The alignment of the study reach, approximate variations in channel width and bank conditions, and locations of the surveyed cross sections are shown in the aerial photo on the top right.

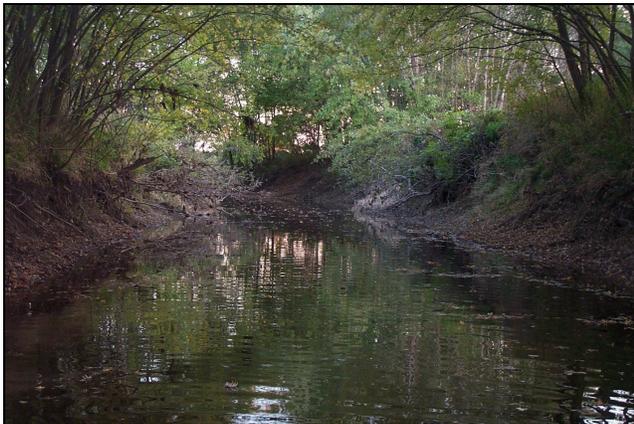
05595730 Rayse Creek near Waltonville, IL
Looking Downstream from the first staff gage

Description of Channel.--The channel is a straightened reach of a natural channel. Streambed consists of silt, clay, and gravel mixtures. The streambed is subject to growth of aquatic vegetation during the spring through fall months. Bank material consists of bare earth with tree roots. Cross sections are generally in trapezoidal shape with encroachment occurring at the center of the channel. Bottom width is approximately 25 ft; banks are about 10 ft high and have a top width of about 60 ft. Both banks are fairly steep. Canopy cover overhangs the channel. Channel is subject to log and debris jams throughout the year.

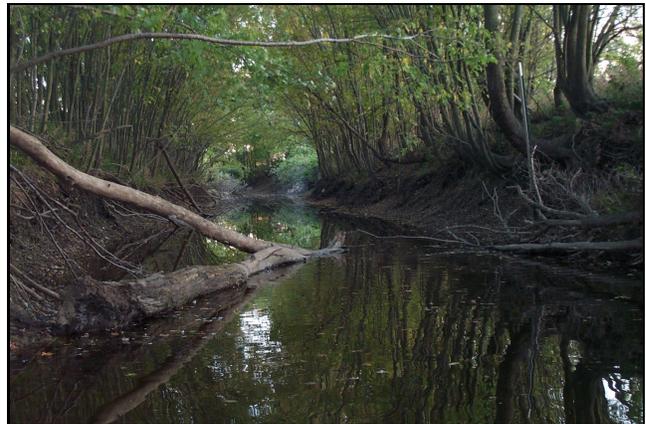
05595730 Rayse Creek near Waltonville, IL
Looking Downstream from second staff gage

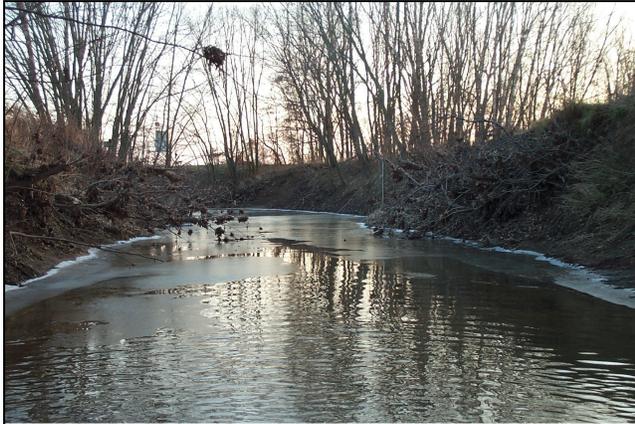
05595730 Rayse Creek near Waltonville, IL
Looking Downstream from Upstream of first staff gage

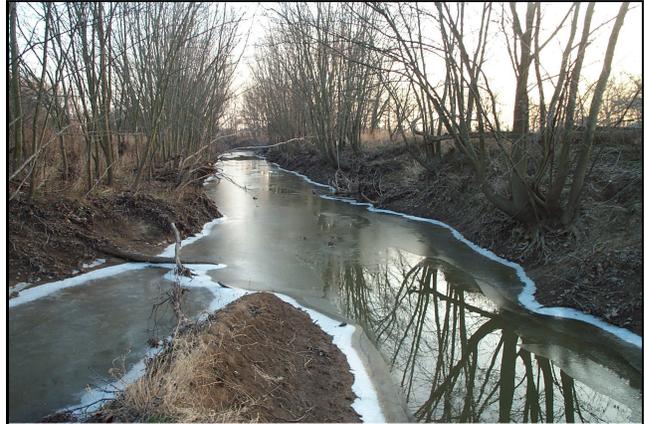
05595730 Rayse Creek near Waltonville, IL
Looking Downstream from Upstream of second staff gage

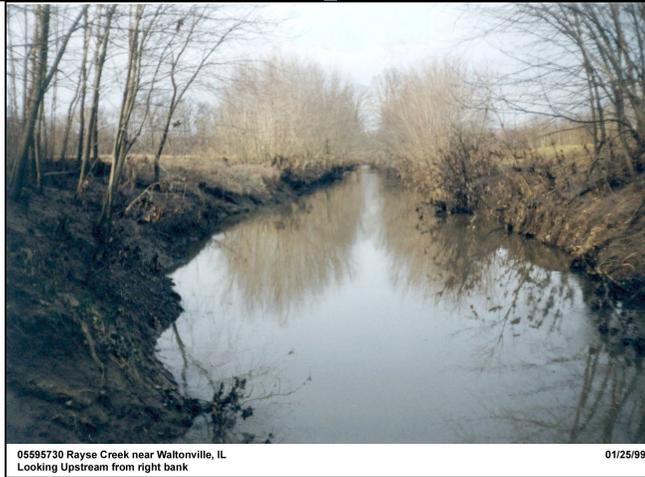
01/25/99

05595730 Rayse Creek near Waltonville, IL
Looking Upstream from right bank
