Crab Orchard Creek near Marion, IL Reach 1

Study Reach.--The channel reach under consideration is a natural channel regulated in urban settings. The study reach, approximately 620 ft long, is a channelized portion of the stream located from the downstream side of the State Route 13 bridge to just above a drainage ditch leading out of the lake (approximately 800 ft downstream), as shown in the quadrangle map on the top left. Three surveyed channel cross sections (surveyed by the Illinois Department of Natural Resources in June 2005) are available for describing the channel geometries (see plots above). The alignment of the study reach, approximate variations in channel width and bank conditions, and locations of the three cross sections are shown in the aerial photo on the top right.

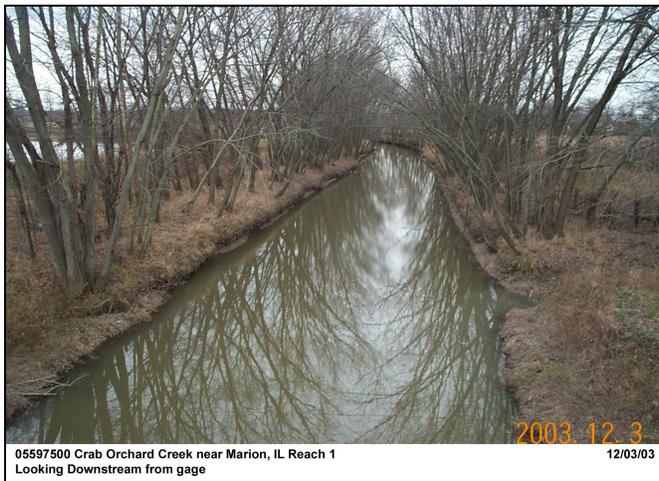
05597500 Crab Orchard Creek near Marion, IL Reach 1
Looking Downstream from gage

Description of Channel.--This channel is a dredged and straightened, located in an urban setting. The bed is composed of clay-sand-fine gravel mixtures. The channel is subject to heavy vegetation as well as scour and fill, and can be cluttered with logjams, debris jams, and beaver dams. The channel shape can be described as rectangular and the channel alignment is straight. Both banks are low, full of brush, and will overflow at about 11 ft. The bank face is covered with exposed tree roots and clay-sand mixtures. The left bank is a levee, which separates the creek from a borrow-pit lake. The right flood plain is grassy pasture.

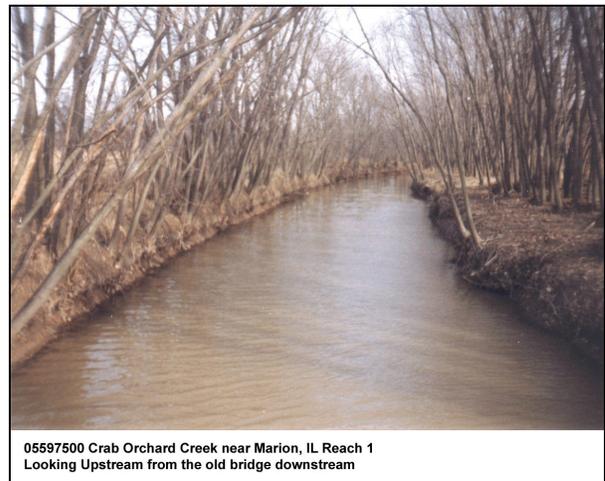
05597500 Crab Orchard Creek near Marion, IL Reach 1
Looking Upstream from the old bridge downstream
