# Determination of Roughness Coefficients for Streams in West-Central Florida

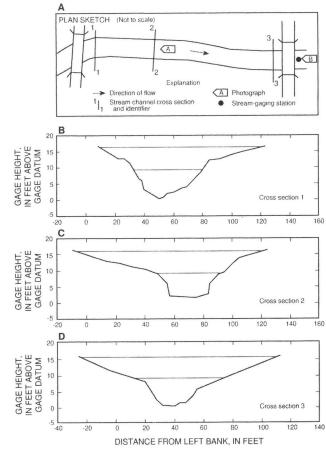
Figure 10. Payne Creek near Bowling Green. (A) plan sketch, (B) cross section 1, (C) cross section 2, and (D) cross section 3.

Date of observation	Average depth (ft)	Average surface width (ft)	Discharge (ft <sup>3</sup> /s)	Average cross section area (ft <sup>2</sup> )	Hydraulic radius (ft)	Mean velocity (ft/s)	Slope	Coefficient of roughness n
Sept. 10, 1988	---	---	1500.0	899.0	6.60	1.680	0.001030	0.104
Aug. 15, 1992	---	---	915.0	550.0	5.60	1.680	0.000810	0.081
Aug. 12, 1992	---	---	852.0	497.0	5.55	1.730	0.000700	0.071
Aug. 11, 1992	---	---	728.0	712.0	5.35	1.780	0.000670	0.064
Aug. 09, 1992	---	---	674.0	380.0	5.23	1.790	0.000710	0.065
June 30, 1992	---	---	607.0	336.0	4.99	1.820	0.000640	0.058
Sept. 05, 1992	---	---	539.0	298.0	4.77	1.820	0.000640	0.056
June 29, 1992	---	---	524.0	289.0	4.72	1.820	0.000630	0.055
Sept. 15,	---	---	491.0	272.0	4.63	1.810	0.000660	0.056

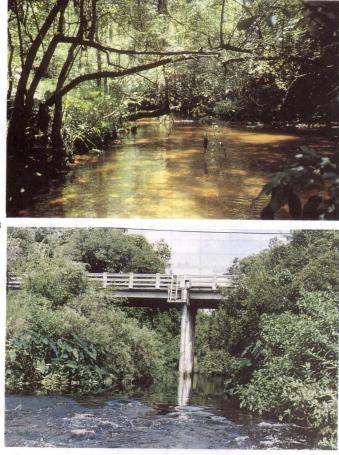
Figure 12. Payne Creek near Bowling Green. Photographs of channel looking (A) upstream from cross section 2 and (B) looking upstream from cross section 3.

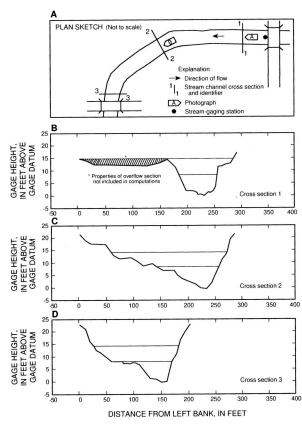
Figure 13. Peace River at Zolfo Springs. (A) plan sketch, (B) cross section 1, (C) cross section 2, (D) cross section 3.

Date of observation	Average depth (ft)	Average surface width (ft)	Discharge (ft <sup>3</sup> /s)	Average cross section area (ft <sup>2</sup> )	Hydraulic radius (ft)	Mean velocity (ft/s)	Slope	Coefficient of roughness n
Aug. 12, 1992	---	---	3010.0	1310.0	7.12	2.390	0.000170	0.032
Sept. 05, 1992	---	---	2300.0	1100.0	6.26	2.170	0.000160	0.031
Aug. 31, 1992	---	---	1860.0	947.0	5.84	2.020	0.000140	0.029
June 30, 1992	---	---	1810.0	925.0	5.77	2.010	0.000130	0.029
Oct. 05, 1992	---	---	1760.0	904.0	5.71	2.000	0.000130	0.029
Sept. 17, 1992	---	---	1120.0	644.0	5.48	1.770	0.000100	0.029
Sept. 30, 1992	---	---	865.0	523.0	4.94	1.680	0.000080	0.026
Oct. 13, 1992	---	---	837.0	504.0	4.88	1.680	0.000090	0.029
Feb. 04, 1993	---	---	790.0	477.0	4.73	1.680	0.000110	0.030

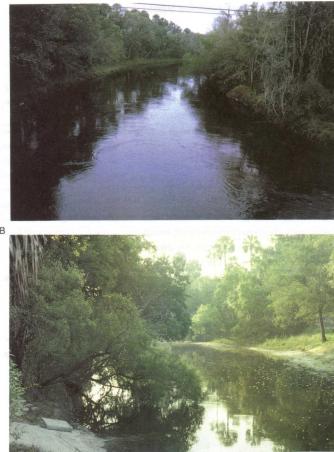
Figure 15. Peace River at Zolfo Springs. Photographs of channel looking (A) downstream from above cross section 1 and (B) looking downstream from above cross section 2.

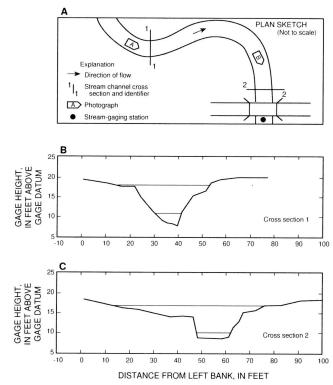
Figure 16. Horse Creek near Myakka Head. (A) plan sketch, (B) cross section 1, and (C) cross section 2.

Date of observation	Average depth (ft)	Average surface width (ft)	Discharge (ft <sup>3</sup> /s)	Average cross section area (ft <sup>2</sup> )	Hydraulic radius (ft)	Mean velocity (ft/s)	Slope	Coefficient of roughness n
Sept. 02, 1994	---	---	529.0	232.0	3.43	2.400	0.001600	0.060
Apr. 01, 1993	---	---	495.0	208.0	3.36	2.500	0.001470	0.054
Aug. 11, 1992	---	---	488.0	203.0	3.35	2.500	0.001600	0.056
Mar. 13, 1993	---	---	211.0	73.3	3.00	2.890	0.001630	0.044
Sept. 17, 1992	---	---	69.0	31.1	1.84	2.240	0.001500	0.039
Oct. 13, 1992	---	---	37.0	22.9	1.49	1.600	0.002270	0.058
Feb. 04, 1993	---	---	22.0	18.3	1.28	1.200	0.002410	0.071

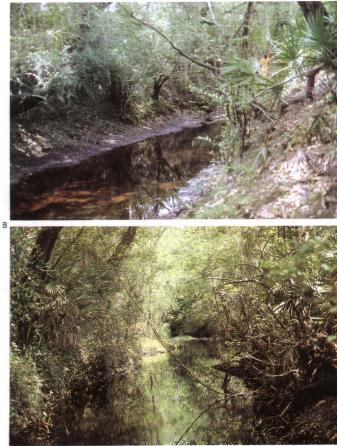
Figure 18. Horse Creek near Myakka Head. Photographs of channel looking (A) downstream from above cross section 1 and (B) looking downstream from above cross section 2.

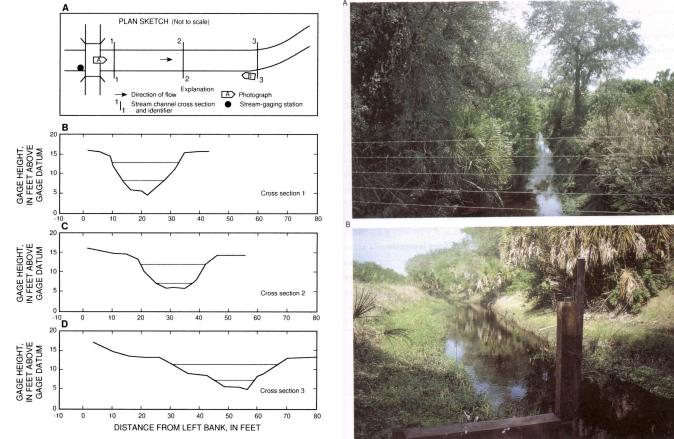
Figure 19. South Creek near Varno. (A) plan sketch, (B) cross section 1, (C) cross section 2, and (D) cross section 3.

Date of observation	Average depth (ft)	Average surface width (ft)	Discharge (ft <sup>3</sup> /s)	Average cross section area (ft <sup>2</sup> )	Hydraulic radius (ft)	Mean velocity (ft/s)	Slope	Coefficient of roughness <i>n</i>
Apr. 02, 1993	---	---	166.0	114.0	3.58	1.470	0.000380	0.047
Apr. 05, 1993	---	---	130.0	93.1	3.18	1.410	0.000360	0.043
Mar. 13, 1993	---	---	94.0	72.2	2.74	1.300	0.000330	0.040
Jan. 16, 1993	---	---	59.0	50.3	2.26	1.240	0.000410	0.043
Oct. 05, 1992	---	---	55.0	48.6	2.23	1.130	0.000380	0.043
Jan. 26, 1993	---	---	50.0	46.0	2.18	1.090	0.000410	0.045
Feb. 27, 1993	---	---	20.0	29.7	1.72	0.660	0.000360	0.059
Oct. 14, 1992	---	---	13.0	26.4	1.59	0.500	0.000520	0.090

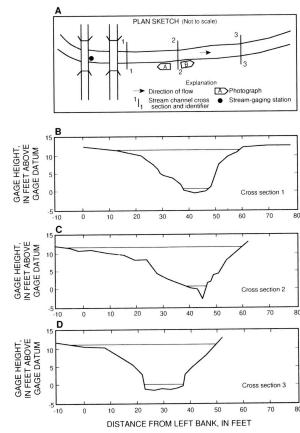
Figure 22. Walker Creek near Sarasota. (A) plan sketch, (B) cross section 1, (C) cross section 2, and (D) cross section 3.

Date of observation	Average depth (ft)	Average surface width (ft)	Discharge (ft <sup>3</sup> /s)	Average cross section area (ft <sup>2</sup> )	Hydraulic radius (ft)	Mean velocity (ft/s)	Slope	Coefficient of roughness n
June 25, 1992	---	---	971.0	316.0	4.49	3.090	0.000950	0.042
July 23, 1992	---	---	438.0	166.0	4.14	2.570	0.000930	0.045
Aug. 07, 1992	---	---	398.0	157.0	4.40	2.290	0.000800	0.044
Apr. 01, 1993	---	---	312.0	131.0	3.79	2.400	0.000970	0.048
Apr. 01, 1993	---	---	278.0	121.0	3.63	2.320	0.000950	0.047
Jan. 15, 1993	---	---	242.0	107.0	3.40	2.290	0.000930	0.045
Jan. 15, 1993	---	---	217.0	103.0	3.33	2.140	0.001000	0.049
Jan. 14, 1993	---	---	141.0	73.8	2.74	1.940	0.001050	0.048
Sept. 27, 1994	---	---	19.0	25.0	1.53	0.800	0.001480	0.094
Feb. 29, 1992	---	---	13.0	26.7	1.60	0.530	0.001920	0.155
Oct. 14, 1992	---	---	9.4	20.1	1.33	0.540	0.001510	0.121
Mar. 12, 1993	---	---	4.8	17.8	1.22	0.320	0.001480	0.194

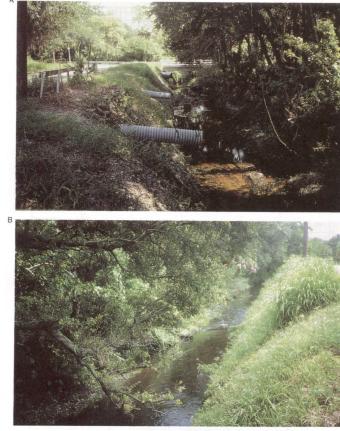
Figure 24. Walker Creek near Sarasota. Photographs of channel looking (A) upstream from cross section 2 and (B) looking downstream from cross section 2.

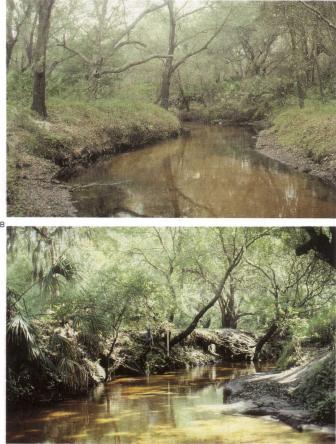
Figure 27. Bullfrog Creek near Wimauma. Photographs of channel looking (A) downstream from above cross section 1, (B) looking downstream from cross section 3, and (C) looking upstream from cross section 5—Continued.

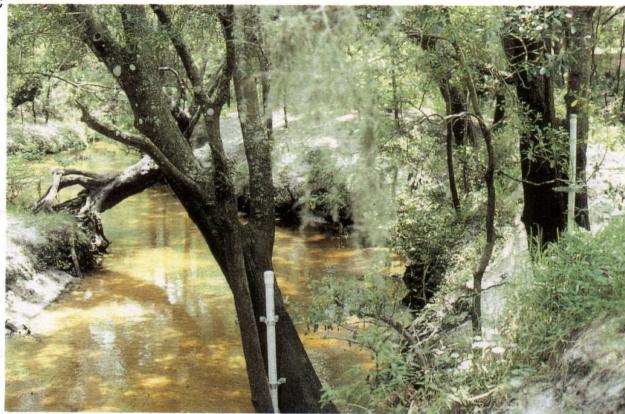
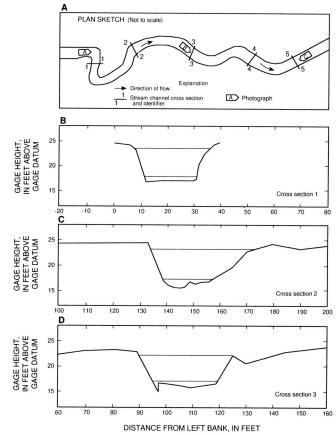
Figure 28. Bullfrog Creek near Wimauma. (A) plan sketch, (B) cross section 1, (C) cross section 2, (D) cross section 3, (E) cross section 4, and (F) cross section 5.

Date of observation	Average depth (ft)	Average surface width (ft)	Discharge (ft <sup>3</sup> /s)	Average cross section area (ft <sup>2</sup> )	Hydraulic radius (ft)	Mean velocity (ft/s)	Slope	Coefficient of roughness n
Mar. 13, 1993	---	---	356.0	211.0	4.00	1.820	0.000740	0.059
Apr. 16, 1993	---	---	264.0	163.0	3.79	1.710	0.000720	0.062
June 08, 1992	---	---	216.0	131.0	3.28	1.730	0.000820	0.058
Apr. 25, 1992	---	---	142.0	90.8	2.72	1.610	0.000630	0.055
Jan. 09, 1993	---	---	141.0	95.1	2.79	1.530	0.000800	0.057

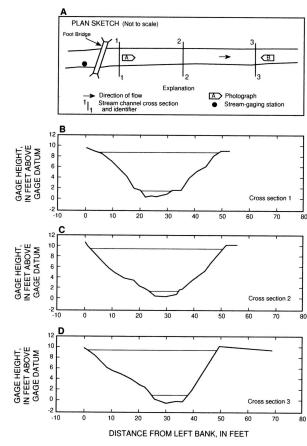
Figure 28. Delaney Creek near Tampa. (A) plan sketch, (B) cross section 1, (C) cross section 2, and (D) cross section 3.

Date of observation	Average depth (ft)	Average surface width (ft)	Discharge (ft <sup>3</sup> /s)	Average cross section area (ft <sup>2</sup> )	Hydraulic radius (ft)	Mean velocity (ft/s)	Slope	Coefficient of roughness <i>n</i>
June 28, 1992	---	---	496.0	224.0	4.56	2.220	0.000570	0.045
Sept. 06, 1993	---	---	222.0	113.0	3.09	1.970	0.000300	0.028
Sept. 04, 1992	---	---	119.0	67.0	2.40	1.790	0.000290	0.024
Sept. 28, 1994	---	---	80.0	42.0	1.90	1.940	0.001000	0.035
Sept. 27, 1994	---	---	76.0	39.8	1.84	1.940	0.000900	0.032
Oct. 03, 1992	---	---	37.0	22.9	1.29	1.670	0.000910	0.029
Aug. 17, 1993	---	---	31.0	21.5	1.24	1.520	0.000950	0.031
Oct. 06, 1992	---	---	20.0	15.7	1.00	1.390	0.001050	0.032
Sept. 16, 1992	---	---	11.0	12.2	0.84	1.000	0.000870	0.035

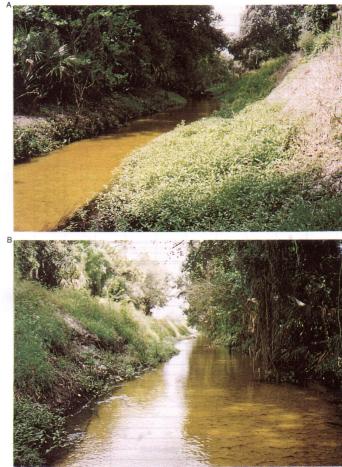
Figure 29. Delaney Creek near Tampa. Photographs of channel looking (A) downstream from cross section 1 and (B) looking upstream from cross section 3.

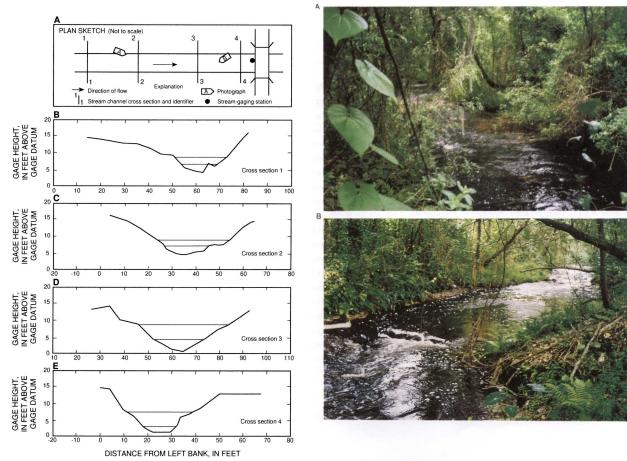
Figure 31. Baker Creek at McIntosh Road near Antioch. (A) plan sketch, (B) cross section 1, (C) cross section 2, (D) cross section 3, and (E) cross section 4.

Date of observation	Average depth (ft)	Average surface width (ft)	Discharge (ft <sup>3</sup> /s)	Average cross section area (ft <sup>2</sup> )	Hydraulic radius (ft)	Mean velocity (ft/s)	Slope	Coefficient of roughness <i>n</i>
Aug. 30, 1994	---	---	310.0	108.0	3.10	3.120	0.002230	0.051
Oct. 03, 1992	---	---	151.0	57.9	2.34	3.020	0.003240	0.058
Aug. 27, 1993	---	---	128.0	49.3	2.13	2.880	0.004760	0.066
Sept. 06, 1993	---	---	81.0	40.6	1.88	2.140	0.004270	0.095
Aug. 28, 1993	---	---	78.0	37.3	1.78	2.230	0.004150	0.088
Sept. 07, 1993	---	---	51.0	30.0	1.54	1.790	0.004240	0.108

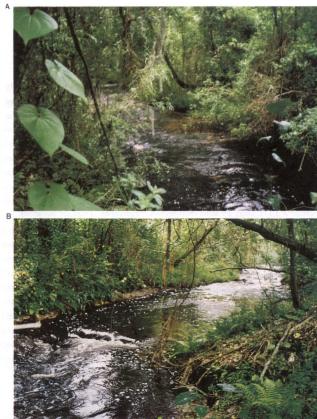
Figure 32. Baker Creek at McIntosh Road near Antioch. Photographs of channel looking (A) downstream from cross section 2 and (B) looking upstream from cross section 4.

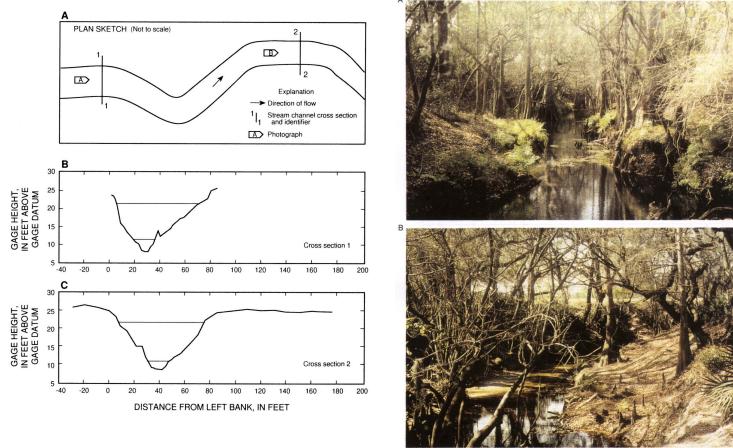
Figure 34. Anclote River near Elfers. (A) plan sketch, (B) cross section 1, and (C) cross section 2.

Date of observation	Average depth (ft)	Average surface width (ft)	Discharge (ft <sup>3</sup> /s)	Average cross section area (ft <sup>2</sup> )	Hydraulic radius (ft)	Mean velocity (ft/s)	Slope	Coefficient of roughness <i>n</i>
Oct. 05, 1992	---	---	782.0	458.0	6.23	1.710	0.000520	0.066
Sept. 10, 1992	---	---	274.0	194.0	3.85	1.420	0.000720	0.068
Sept. 06, 1992	---	---	209.0	153.0	3.32	1.380	0.000880	0.070
Sept. 01, 1992	---	---	173.0	128.0	3.16	1.360	0.000680	0.060
Sept. 10, 1993	---	---	152.0	118.0	3.02	1.310	0.000840	0.069
Sept. 15, 1992	---	---	107.0	94.8	2.64	1.160	0.001240	0.086
Mar. 15, 1993	---	---	100.0	89.2	2.54	1.140	0.000740	0.066
Apr. 17, 1993	---	---	76.0	72.0	2.31	1.080	0.000780	0.067
Apr. 16, 1993	---	---	67.0	63.3	2.22	1.070	0.000660	0.060
Apr. 01, 1993	---	---	54.0	61.4	2.19	0.900	0.000720	0.075

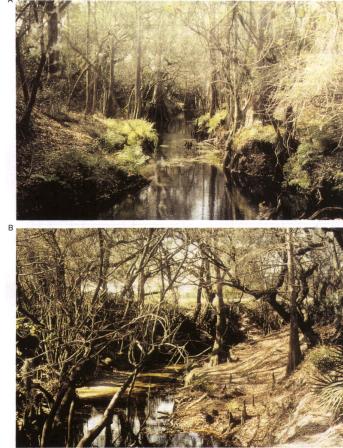
Figure 36. Anclote River near Elfers. Photographs of channel looking (A) downstream from cross section 1 and (B) looking downstream from cross section 2.

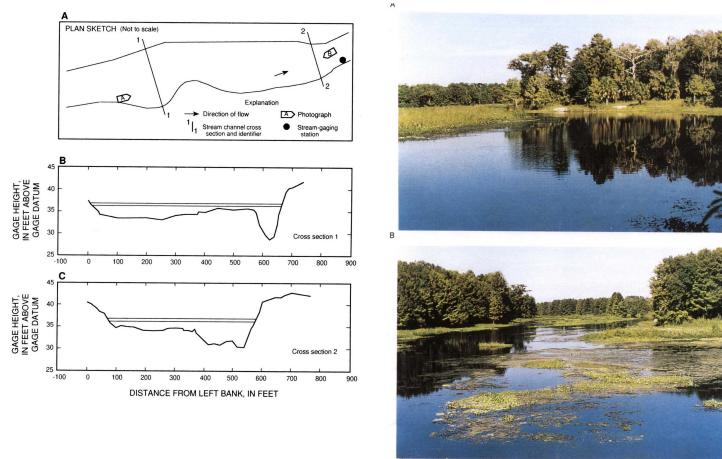
Figure 37. Withlacoochee River at Wysong Dam at Carlson. (A) plan sketch, (B) cross section 1, and (C) cross section 2.

Date of observation	Average depth (ft)	Average surface width (ft)	Discharge (ft <sup>3</sup> /s)	Average cross section area (ft <sup>2</sup> )	Hydraulic radius (ft)	Mean velocity (ft/s)	Slope	Coefficient of roughness <i>n</i>
Oct. 15, 1992	---	---	352.0	1890.0	3.22	0.190	0.000050	0.117
Sept. 28, 1993	---	---	332.0	1970.0	3.34	0.170	0.000070	0.157
Oct. 08, 1992	---	---	321.0	1830.0	3.12	0.180	0.000060	0.139
Mar. 17, 1993	---	---	313.0	1980.0	3.36	0.160	0.000050	0.148
Feb. 02, 1993	---	---	284.0	1720.0	2.96	0.170	0.000050	0.125

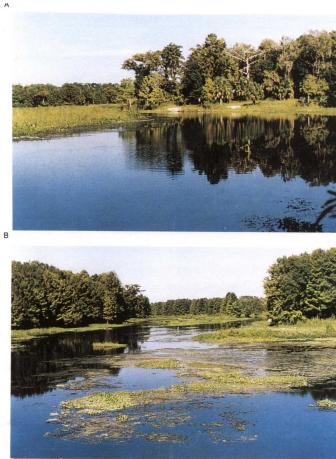
Figure 39. Withlacoochee River at Wysong Dam at Carlson. Photographs of channel looking (A) downstream from cross section 1 and (B) looking upstream from cross section 2.
