Middle Fork Vermilion River Above Oakwood, IL

Study Reach.--The channel reach is natural. The study reach is approximately 400 ft long and is adjacent to the Kickapoo State Park Road bridge, as shown in the quadrangle map on the top left. The reach starts from 100 ft downstream of the Kickapoo State Park Road bridge and extends approximately 300 ft upstream. There are four surveyed cross sections (surveyed by the U.S. Geological Survey in May 2003) available for describing channel geometries in the study reach (see plots above). The channel alignment, approximate variations in channel width and bank conditions, and locations of the cross sections are shown in the aerial photograph on the top right. Cross-sectional geometries vary gradually from upstream to downstream.

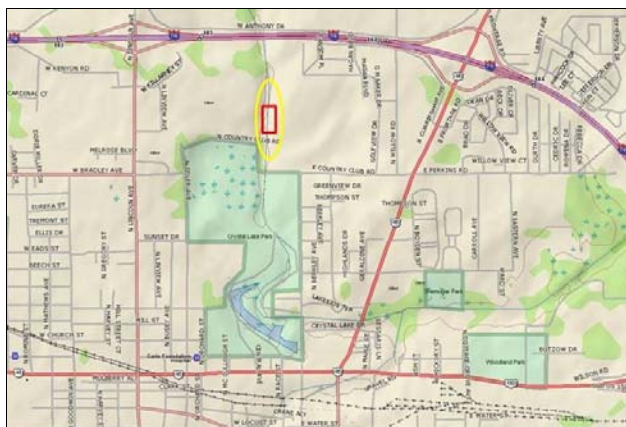
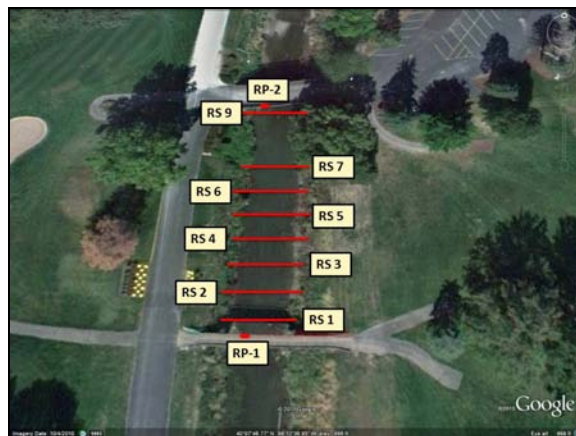
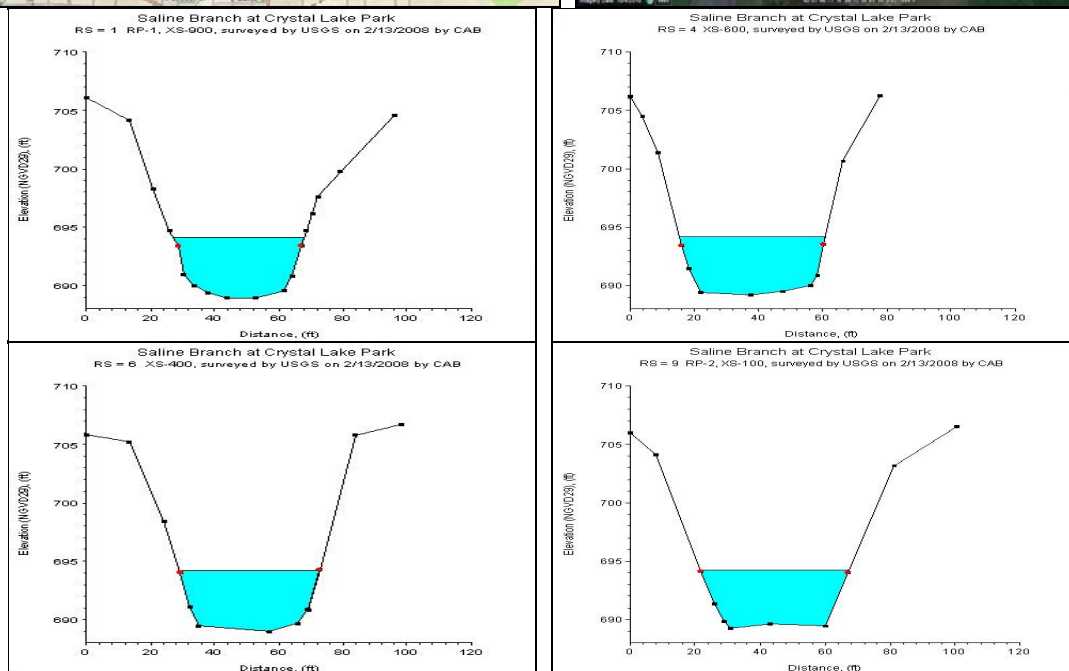
Saline Branch near Crystal Lake Park at Urbana, IL

Study Reach.--The channel reach is straight, channelized, and located in a suburb setting, as shown in quadrangle map on the top left. The study reach is 171 ft long, running between a vehicle bridge upstream and a pedestrian bridge downstream on the property of the Urbana Country Club. The USGS surveyed eight cross sections in March, 2008, between the two bridges. The channel alignment, approximate variations of channel width and bank conditions, and location of the cross section are shown in the aerial photograph on the top right. Cross sectional geometry represented by four selected cross sections are shown in plots above.

Description of Channel.--The channel is a straightened reach of a natural channel. The streambed consists of silt, sand and gravel mixtures and is subject to the growth of aquatic vegetation during the spring, summer and fall months. The width of the streambed is approximately 30 ft. Bank materials consist of bare earth below the normal depth line, with shrubs and turf grass above. The bank slope is fairly steep, approximately 35 ° to 40°. Cross sectional geometry is trapezoidal in shape. Average top width of the cross sections is approximately 70 ft.

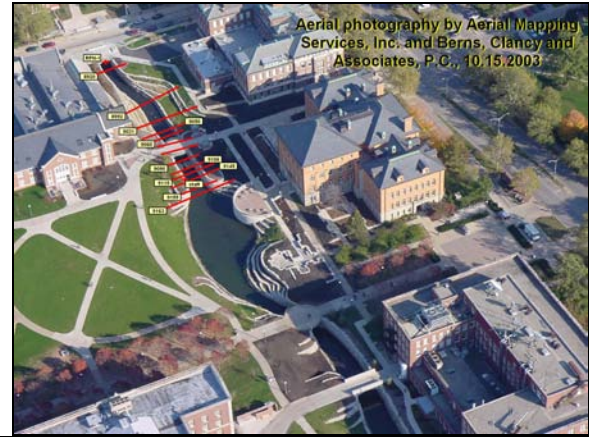
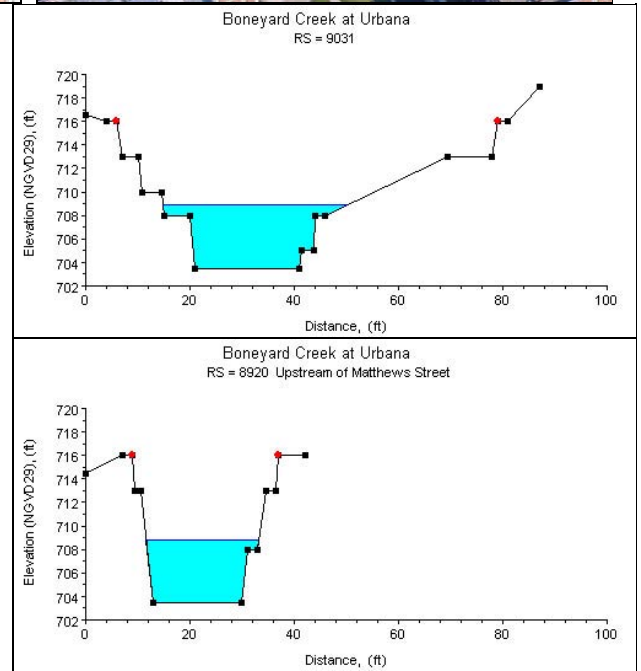
Boneyard Creek at Urbana, IL

Study Reach.--The channel reach is constructed in an urban setting, as shown in the quadrangle map on the top left. The study reach, approximately 225 ft long, begins at a staff gage located on the left bank 45 ft upstream from the gage house and extends downstream to the upstream side of the Matthews Street bridge. Eighteen surveyed cross sections (surveyed by Berns, Clancy, and Associates, in July 2000) are available for describing the geometries of the study reach. The channel alignment, approximate variations in channel width and bank conditions, and locations of cross sections are shown in the aerial photograph on the top right.

Description of the Channel.--This channel is constructed, straight, and varies gradually. The streambed consists of precast concrete revetment pavers with randomly placed 12 to 15 inch rounded river boulders extending 6 to 8 inches above the surface of the pavers. The pavers are gravel filled. Low flow is constricted by a prefabricated Parshall Flume with a 2-ft opening, located in the reach on the upstream side of the Kings Highway bridge. The elevation of the crest of the flume is 703.69 ft. The flume becomes submerged at a stage of about 10.74 ft. Dense seasonal growth of aquatic plants and algae occurs on the channel bottom. Urban debris, such as bicycles and assorted garbage, accumulates and dissipates during events. Banks are constructed from layers of limestone stones. The bank surface is jagged and irregular. The banks range from 13 to 19 ft high and the bottom width ranges from about 18 to 20 ft. The upstream end of the reach is a rectangular channel from near the gage to the downstream side of the Kings Highway bridge. Downstream of the bridge, the channel is a steep-sided trapezoid with terraced banks until Matthews Street. The top width of the channel varies from 20 ft in the upstream rectangular section to 90 ft at the widest point in the trapezoidal section downstream. Cross-sectional geometries vary gradually and continuously from upstream to downstream.

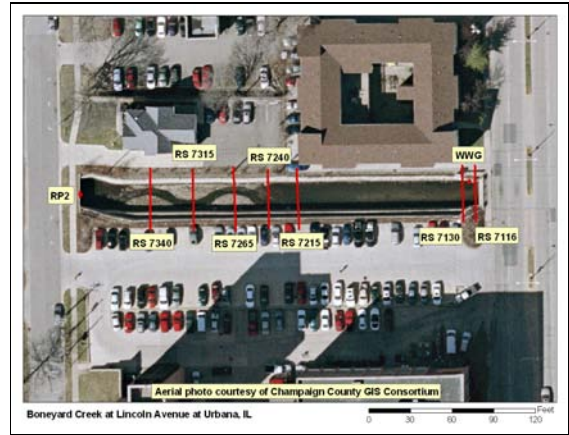
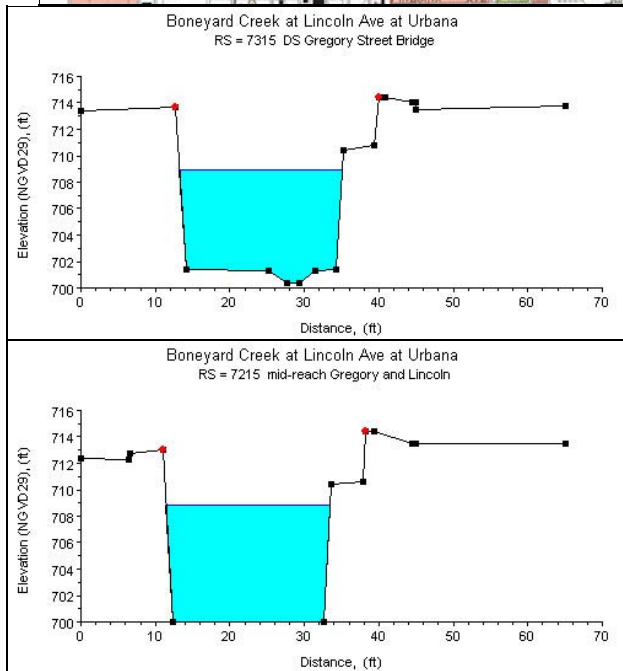
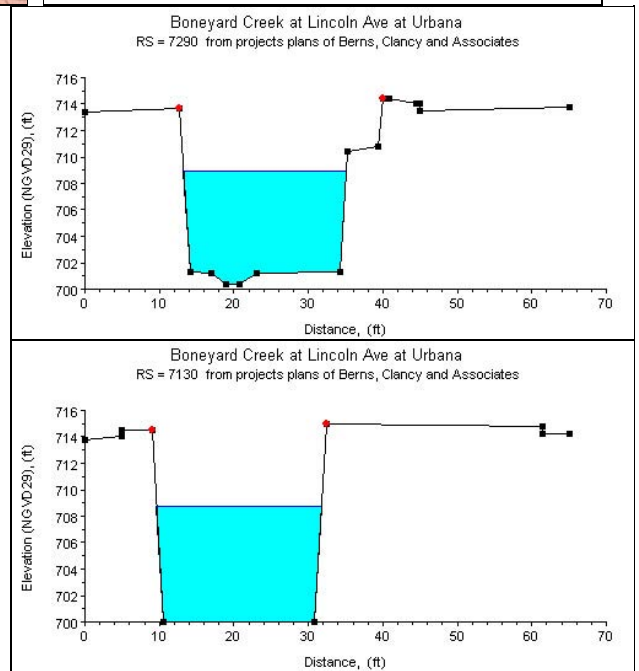
Boneyard Creek at Lincoln Avenue at Urbana, IL

Study Reach.--The channel reach is constructed in an urban setting, as shown in the quadrangle map on the top left. The study reach, approximately 300 ft long, is located from the downstream side of the Gregory Street bridge to the upstream side of the Lincoln Avenue bridge. Nine surveyed cross sections (surveyed by Berns, Clancy, and Associates, in July 2000) are available for describing the channel geometries in the study reach (see plots above). The channel alignment, approximate variations in channel width and bank conditions, and locations of cross sections are shown in the aerial photograph on the top right.

Description of Channel.--This channel is constructed with cross sections, rectangular in shape, in a uniform straight reach. The bed material consists of precast concrete revetment pavers with medium gravel infill.

Medium and coarse gravel accumulates and migrates along the channel bed. A low-flow meander was constructed in a 60-ft long section starting at the downstream side of the Gregory Street bridge at the upstream end of the reach. Aquatic weeds and thick algae grow in the channel bed during the warm months and in low-flow conditions. The bottom width of the channel is about 20 ft. The banks are constructed from modular concrete block retaining walls with one terrace on the right bank and the left bank nearly vertical. The banks are approximately 14 ft high and have a top width of about 22 ft.

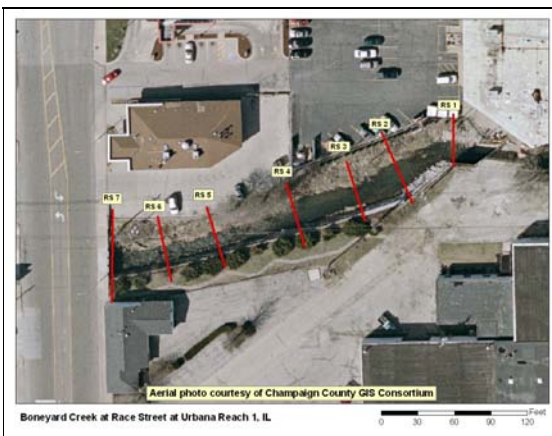
Boneyard Creek at Race Street at Urbana, IL Reach 1

Study Reach.--The channel reach is constructed in an urban setting, as shown in the quadrangle map on the top left. The study reach, about 310 ft long, begins at the downstream side of Broadway Avenue and extends downstream to an abandoned bridge. Seven surveyed cross sections (surveyed by the U.S. Geological Survey in August 2004) are available for describing the channel geometries in the study reach. The channel alignment, approximate variations in channel width and bank conditions, and locations of cross sections are shown in the aerial photograph on the top right. Cross-sectional plots at four river stations (RSs), as shown above, are selected to illustrate the variation in cross-sectional geometry.

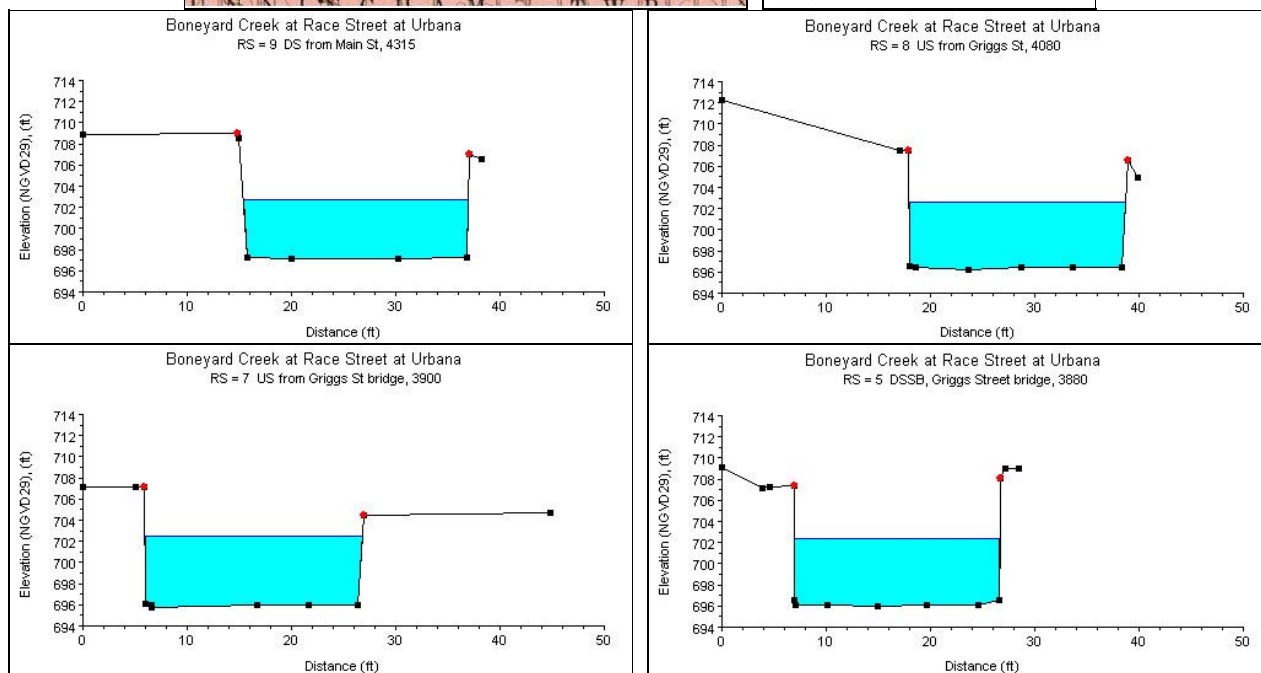
Boneyard Creek at Race Street at Urbana, IL Reach 2

Study Reach.--The channel reach is constructed in an urban setting, as shown in the quadrangle map on the top left. The study reach, approximately 855 ft long, is between the Main and Race Street bridges. Ten cross sections (surveyed by Berns, Clancy, and Associates, in June 1997) are available for describing the channel geometries in the study reach. The channel alignment, approximate variations in channel width and bank conditions, and locations of cross sections are shown in the aerial photograph on the top right. Because of the similarities in cross sectional geometries, cross sectional plots at river stations (RS) 8, 7, 5, and 4, as plotted above, are selected as representative cross sections.

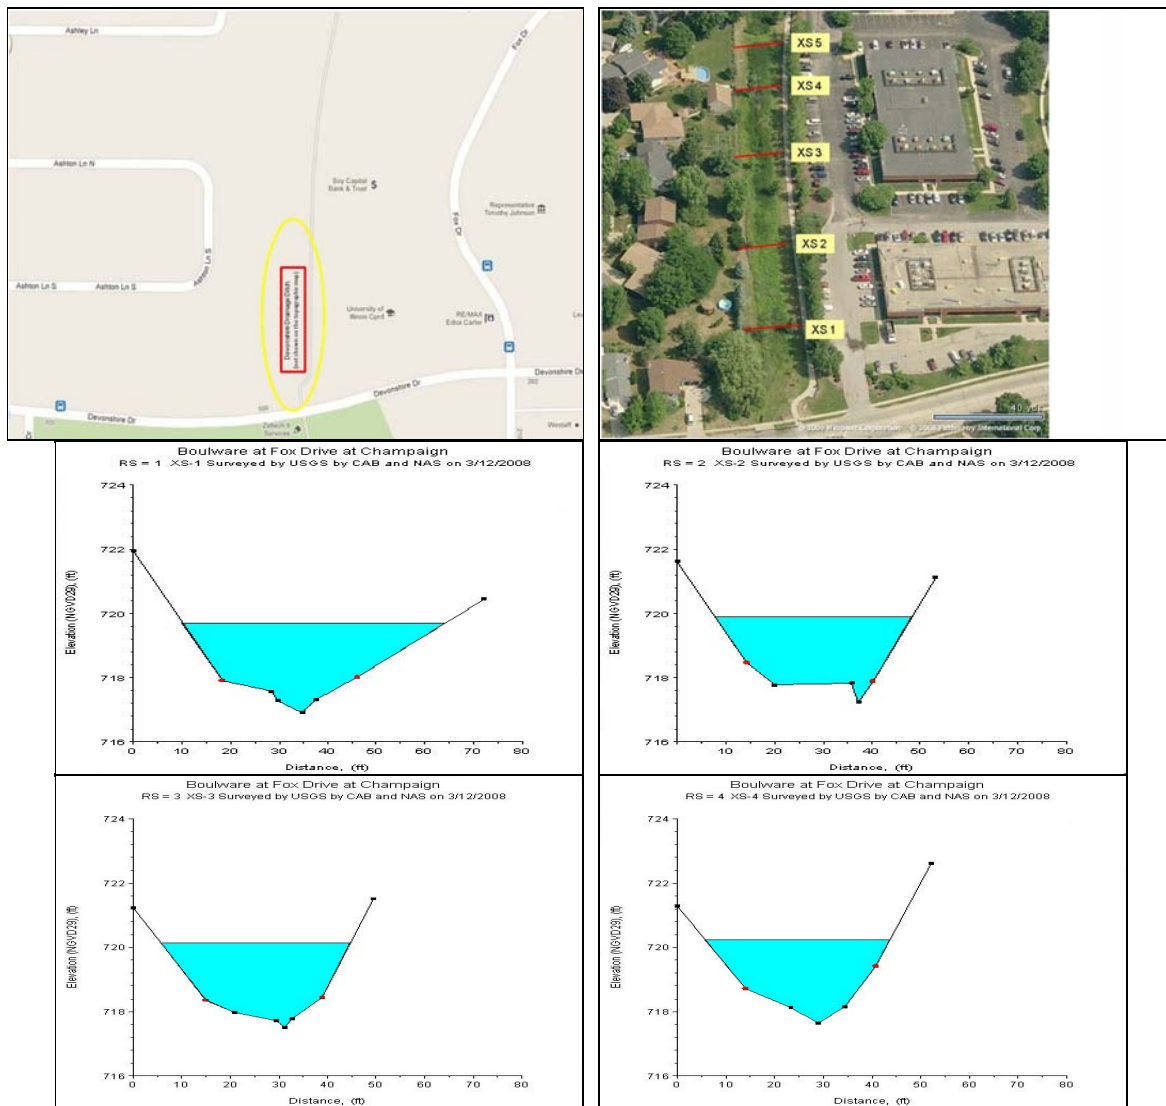
Drainage Ditch at Devonshire Dr. at Champaign, IL

Study Reach.--The channel reach is a drainage ditch in an urban setting, as shown in quadrangle map on the top left. The study reach is approximately 800 ft long and is located upstream of the intersection with Devonshire Drive Road. Five surveyed cross sections (surveyed by the USGS-ILWSC in March 2008) are available for describing the geometry of the study reach. Cattails fill the channel seasonally. The channel alignment is relatively straight and cross sections were reworked to a trapezoidal shape. The channel alignment, approximate variations on channel width and bank conditions, and locations of the cross section are shown in the aerial photograph on the top right. Four cross sections are selected to illustrate the cross sectional and longitudinal variations of the geometry. It can be seen from the plots above that the cross sectional shape is essentially trapezoidal but erosion and deposition patterns are developing in the bed area.

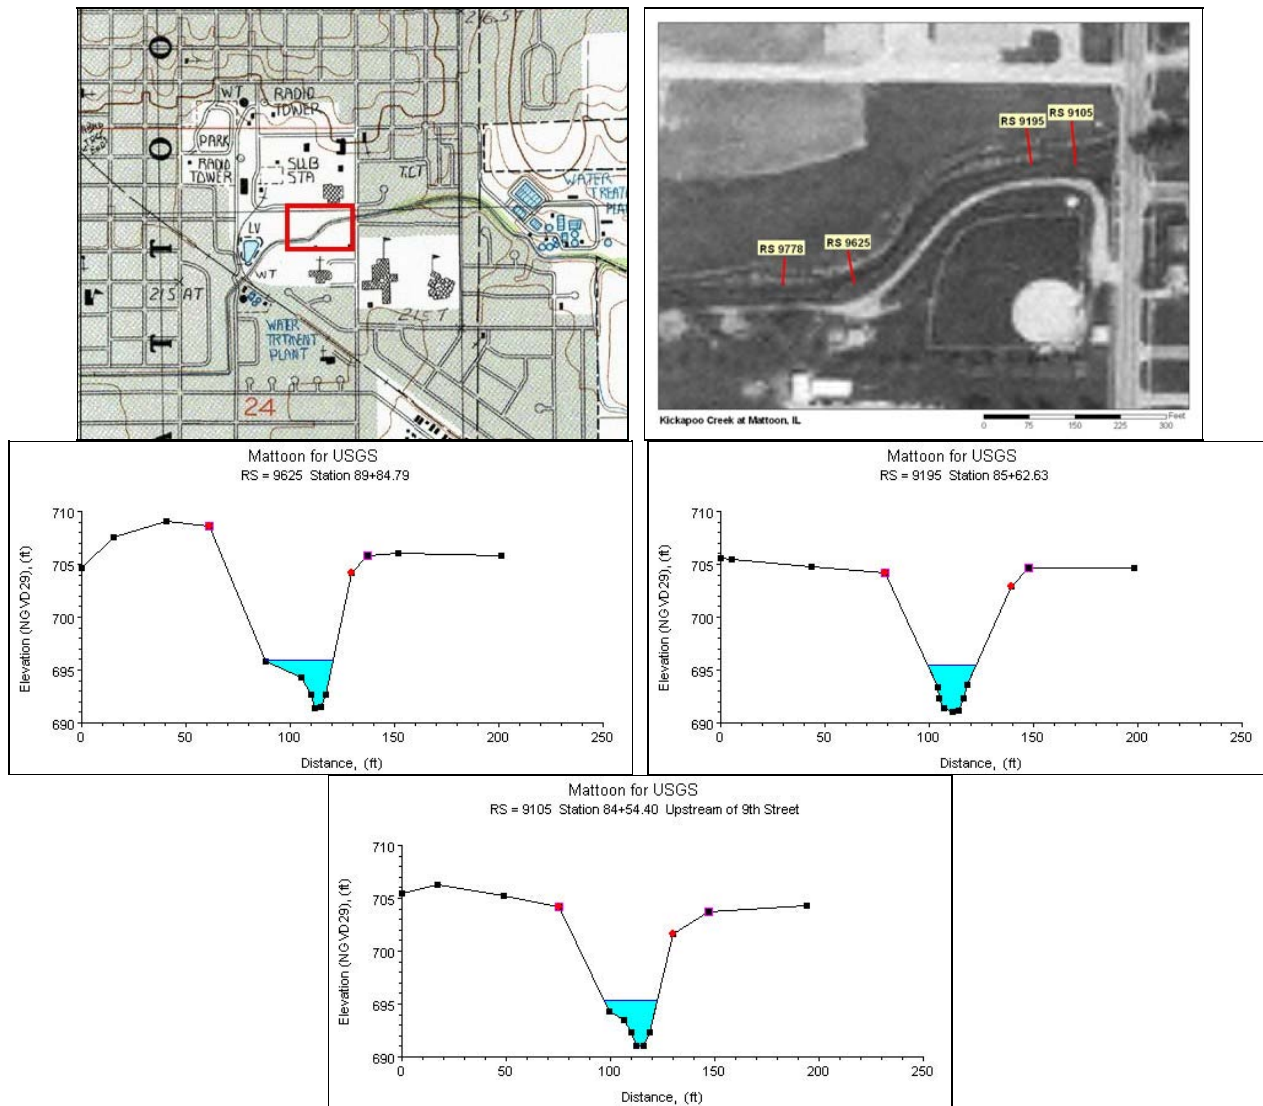
Kickapoo Creek at Mattoon, IL

Study Reach.--The channel reach is a dredged ditch in an urban area. The study reach extends from the upstream side of the South 9th Street bridge to about 650 ft upstream of the bridge. The channel reach and the study reach are presented in the quadrangle map on the top left. Four surveyed cross sections (surveyed by the Illinois Department of Natural Resources, in February 2003) are available in the study reach (see plots above). The channel alignment, approximate channel width and bank conditions, and locations of the cross sections are shown in the aerial photograph on the top right. Channel geometries are illustrated with cross-sectional plots at river stations (RS) 9625, 9195, and 9105.

Description of Channel.--This channel is constructed grass with trapezoidal cross sections. Overall, the study reach covers a meandering reach of the channel. Portions of the bank have collapsed and the waste has been deposited as berms at the toe of the bank. With berms formed at different locations, a small meandering channel is shaped within the bottom to convey base flow during dry seasons. The streambed consists of sands (medium to coarse sizes) in the center and loose silt/clay at submerged border areas at both banks. Above the main channel, the banks and bed are covered with dense tall grasses. The top width of the excavated channel is around 40 ft and bottom width from around 15 to 20 ft. Banks are around 15 ft high.

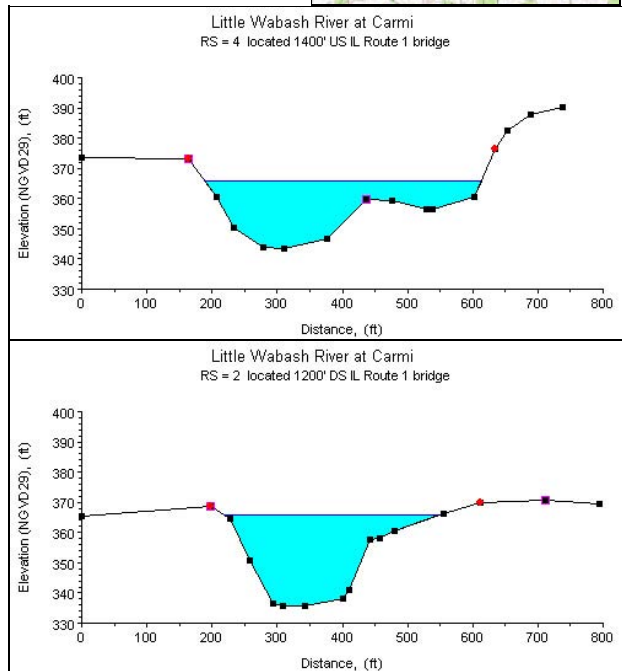
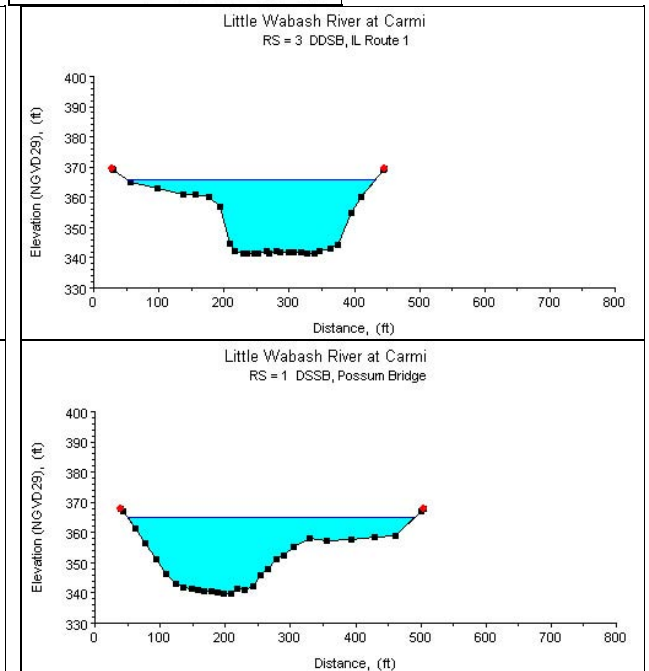
Little Wabash River at Carmi, IL

Study Reach.--The channel reach is natural and meandering. The study reach, approximately 2.9 miles long, extends from the Main Street Bridge in Carmi to Possum Bridge, as shown in the quadrangle map on the top left. Four surveyed cross sections (surveyed by the Illinois Department of Transportation (survey date unknown) and the U.S. Geological Survey in April 1993) are available at this site for evaluating the channel geometries (see plots above). The channel alignment, approximate variations in channel width and bank conditions, and locations of cross sections are shown in the aerial photograph on the top right.

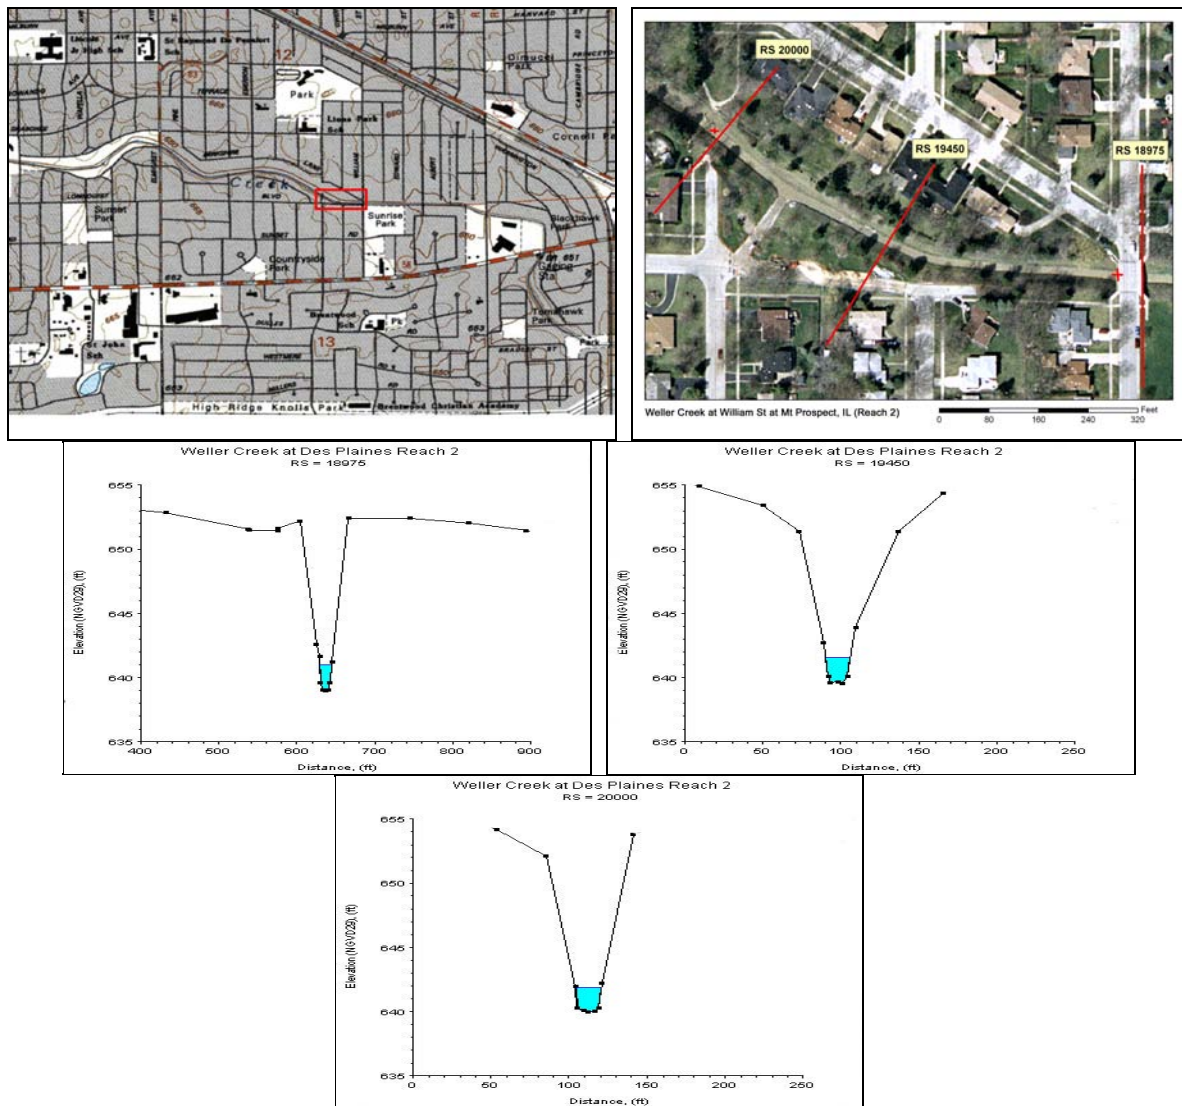
Weller Creek at William St at Mt Prospect, IL (Reach 2)

Study Reach.--The channel reach is a constructed channel in an urban setting, as shown on the quadrangle map at the top left. The study reach, about 730 ft long, is located from just upstream of the South School Street bridge to the South William Street bridge. Three surveyed cross sections (surveyed by the U.S. Corps of Engineers in May 2003) are available for describing the channel geometries in the study reach. The channel alignment, approximate variations in channel width and bank conditions, and locations of cross sections are shown in the aerial photograph on the top right. Cross-sectional plots at three river stations (RSs), as shown above, are selected to illustrate the variation in cross-sectional geometry.

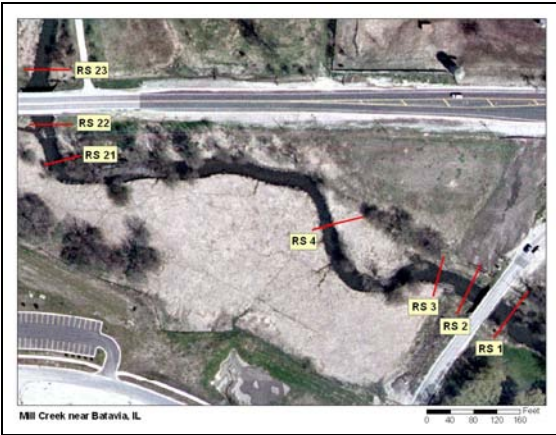
Mill Creek near Batavia, IL

Study Reach.--The channel reach is a meandering, natural river, as shown in the quadrangle map on the top left. Seven surveyed cross sections (surveyed by the Illinois Department of Natural Resources, in May 2003) are available in a reach from the Main Street bridge (upstream) to the Deer Path Road bridge (downstream). The study reach, approximately 400 ft long, was selected as the lower portion of this segment that starts from river station(RS) RS1 upstream and passing through RS4, where bank vegetation is considered to be consistent in the lower reach. Bank conditions in the vicinity of Main Street were modified during the n-values study. The variations in channel alignment, width and bank conditions, as well as the locations of surveyed cross sections can be viewed in the aerial photograph on the top right. Cross-sectional geometries, as described by the four downstream surveyed cross sections, are shown in the cross-sectional plots above.

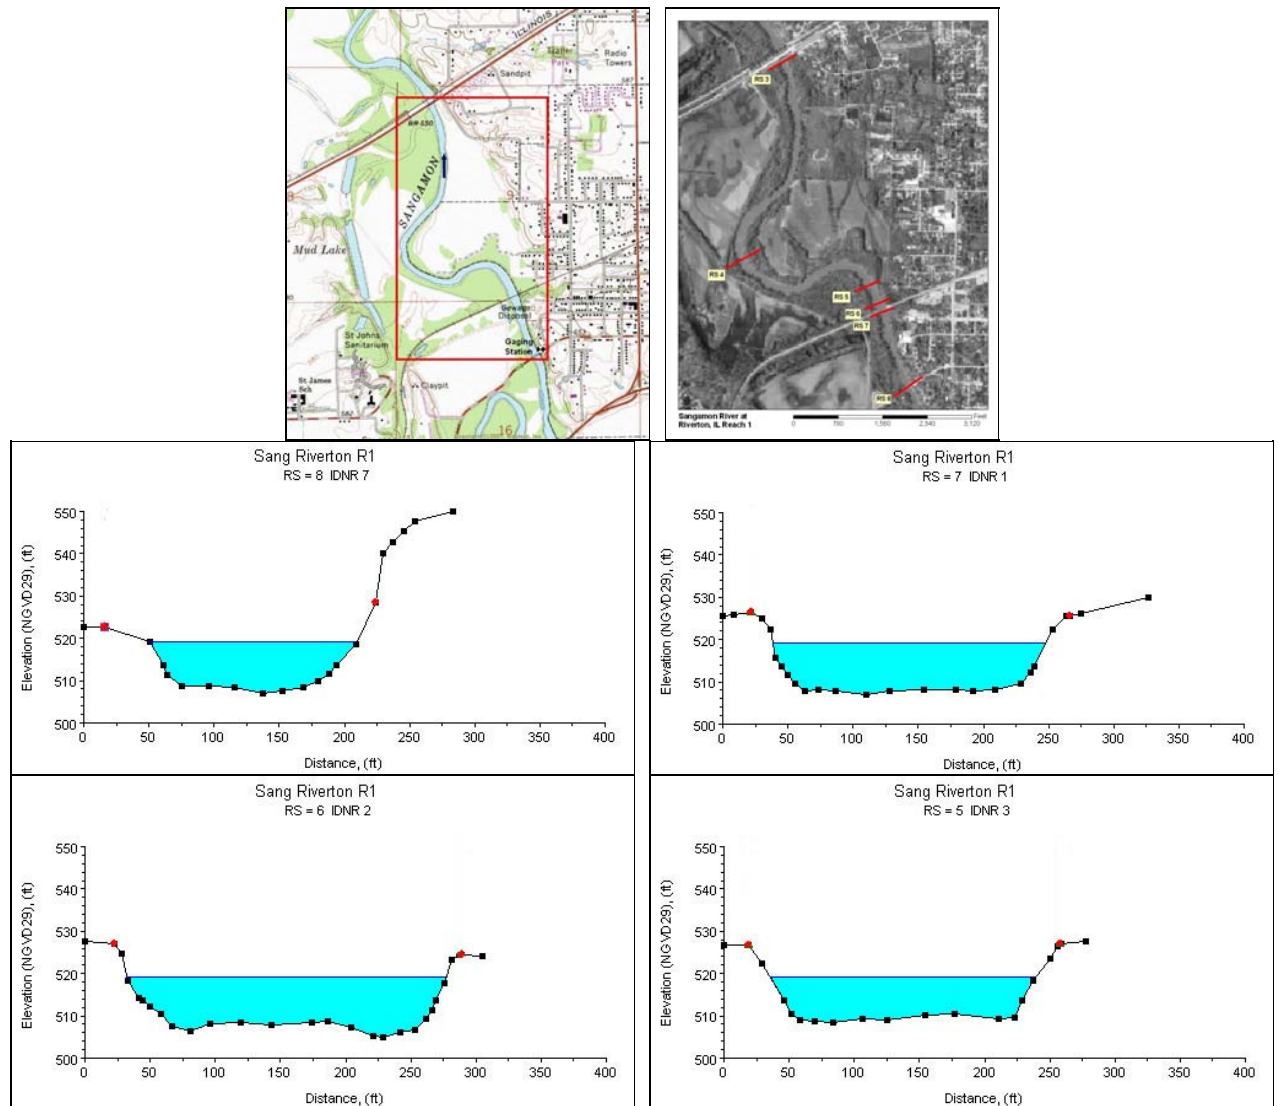
Sangamon River at Riverton Reach 1, IL

Study Reach.--The channel reach is a meandering, natural river. The study reach is approximately 8,600 ft long and extends from the abandoned Old River Road bridge to the upstream side of the State Highway 54 bridge, as shown in the quadrangle map on the top left. Six surveyed cross sections (surveyed by the Illinois Department of Natural Resources, in December 2003) are available for evaluating the channel geometries in the study reach. The channel alignment, approximate variations in channel width and bank conditions, and locations of surveyed cross sections are shown in the aerial photograph on the top right. Cross-sectional geometries vary gradually from upstream to downstream (see plots above). The alignment of the study reach, approximate variations in channel width and bank conditions, and locations of the surveyed cross sections are shown in the aerial photograph on the top right.

Description of Channel.--This channel is natural and meandering. Bed material consists of sand and gravel. The banks are bare earth, shales, clay and sand. The cross sectional shape is generally trapezoidal except for the upstream meandering reach. The channel widens in the downstream direction. In the downstream straight reach, bottom width is about 150 ft and top width is about 200 ft, with a bank height around 15 ft. Sandbars were observed on the relatively flat streambed.
