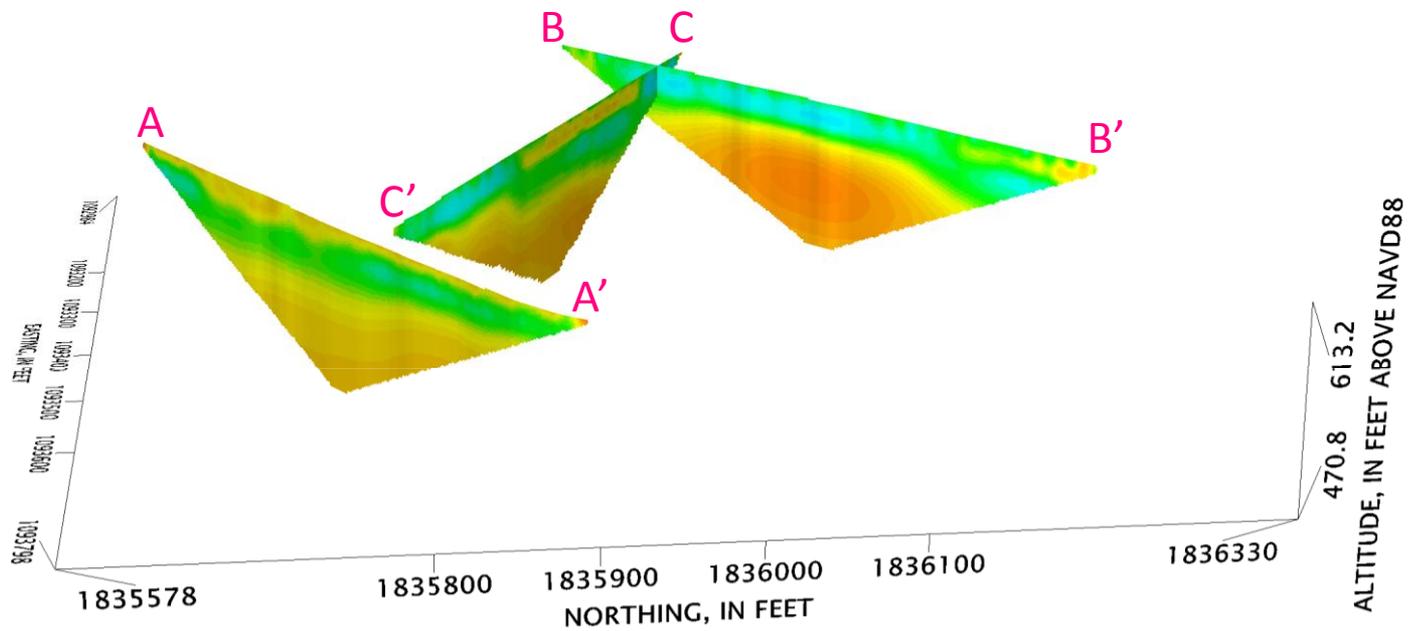
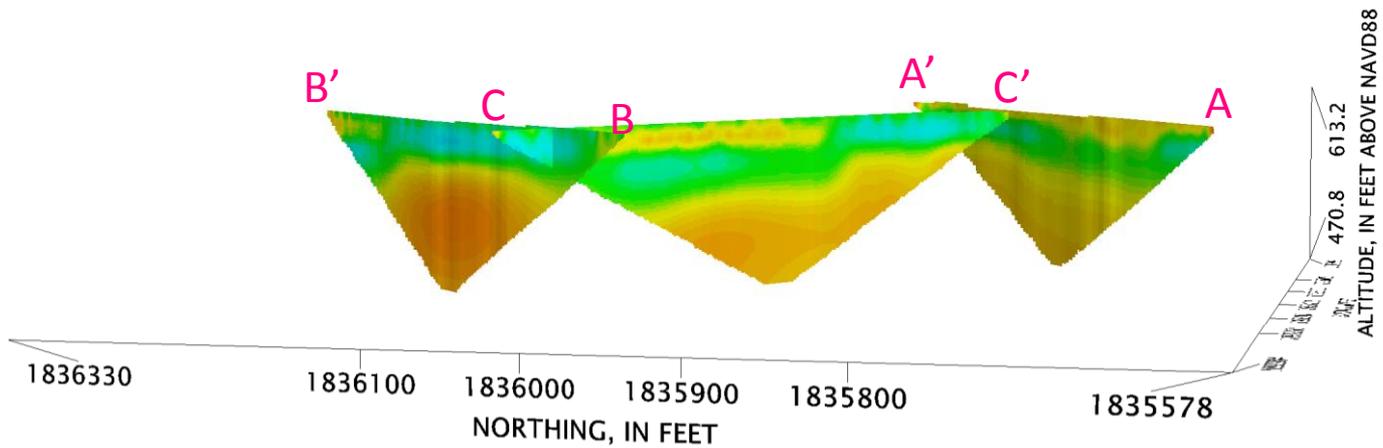
Site #1

Bedrock is consistent across the site.
 No apparent horizontal or vertical anomalous features exist.

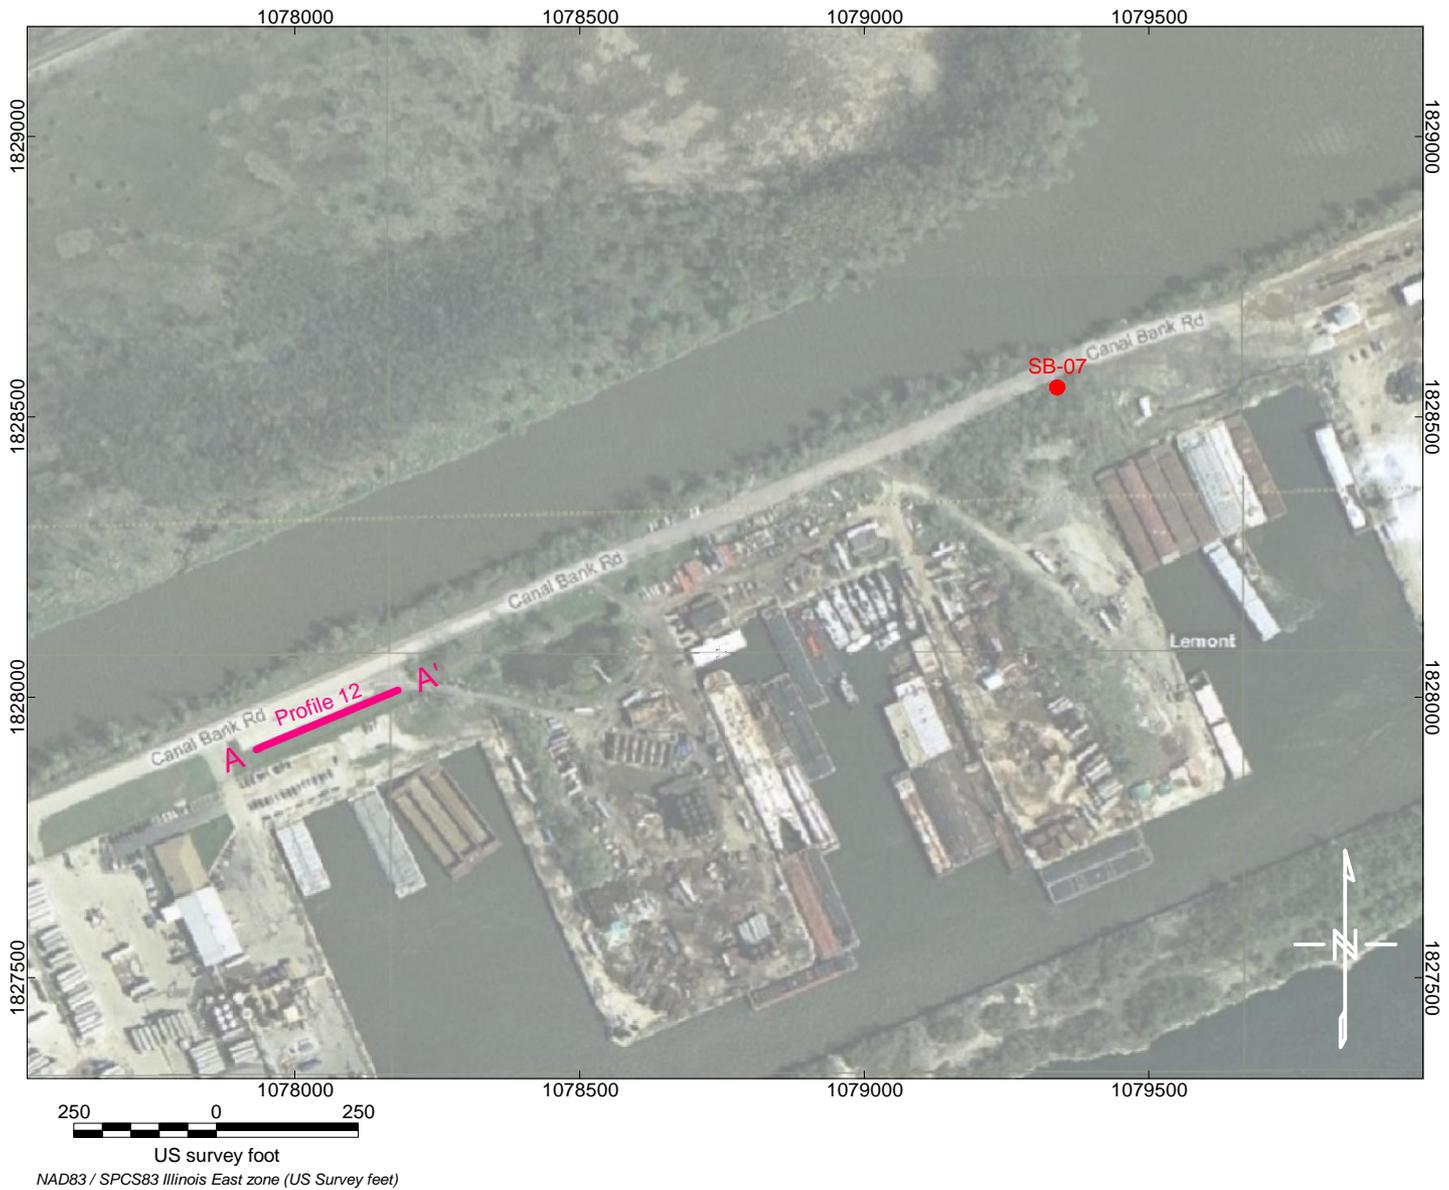
Site #2

Bedrock is most likely absent at this site. SB-08 which is right next to the two profiles showed fill from surface to a depth of 30 feet and never hit bedrock. DC profiles appear to show that the fill continues down to more than 100 feet. There is a possibility that the near surface low resistive clays and silts are drowning out the highly resistive bedrock which may explain the small resistivity increase at an altitude of about 520 feet above NAVD88.

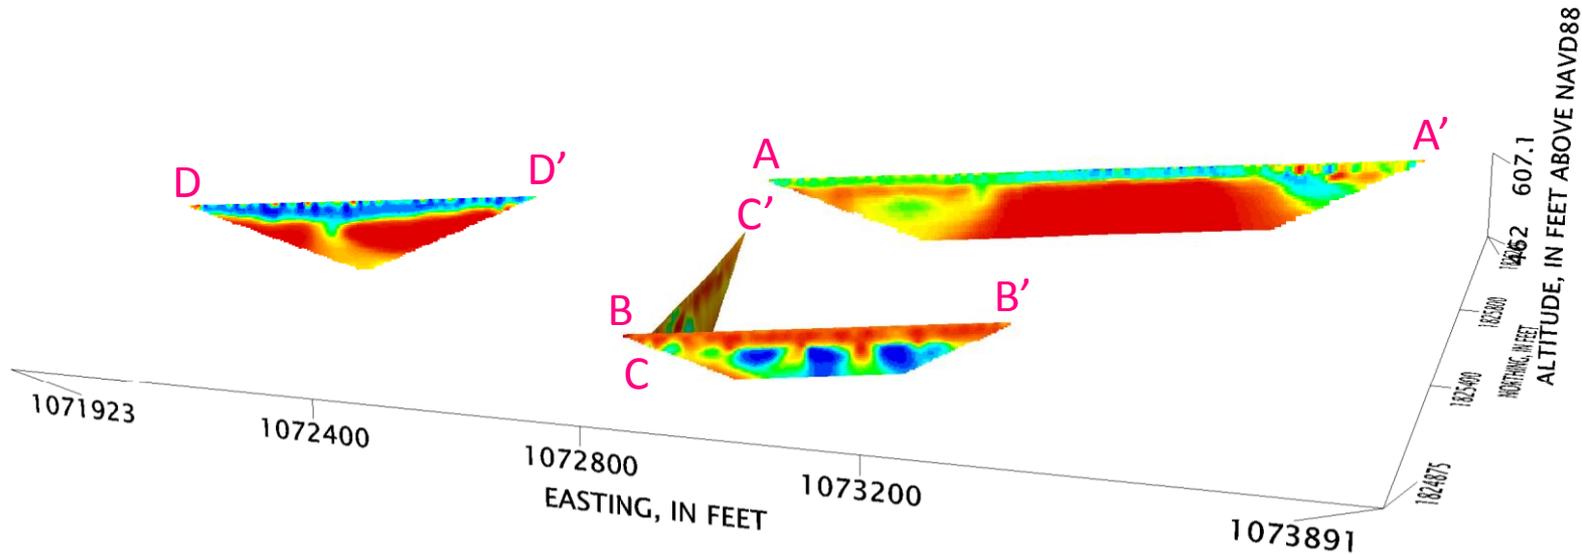
Profile 10 (C-C')

There is a horizontal anomalous feature found across the total length of the profile with the feature being more prominent (less resistive and more blue and green in color) near the beginning of the profile and becoming less prominent (more resistive and more yellow and orange in color) towards the end of the profile. This could represent a fracture or fracture zone that decreases in size toward the end of the profile (or further north on the site). There is also a vertical anomalous feature found at about 85 feet from the beginning of the profile.

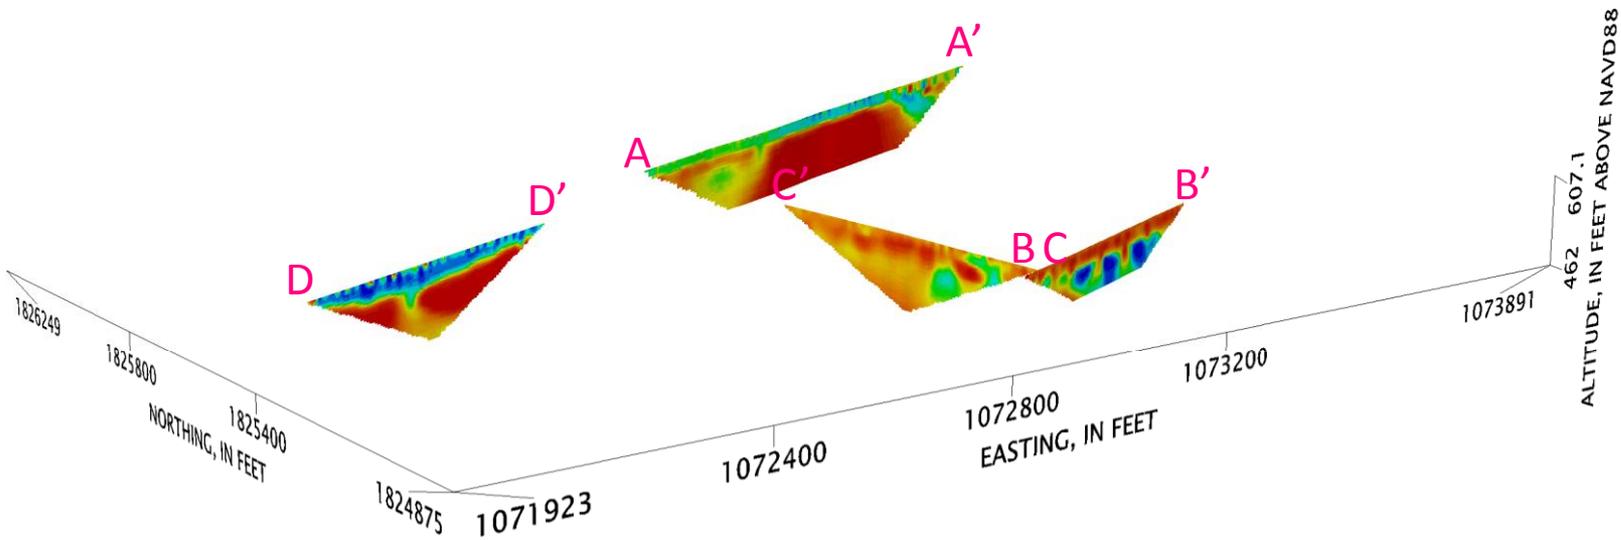
Profile 11 (D-D')

There is a vertical anomalous feature found at approximately 220 feet from the beginning of the profile. This feature could be representative of a vertical fracture found at the site, but the profile was collected near (within 5 feet) from a chain linked fence which could skew the results. But similar to Profile 8, this feature cannot be ignored due to the other anomalous features found on nearby profiles.

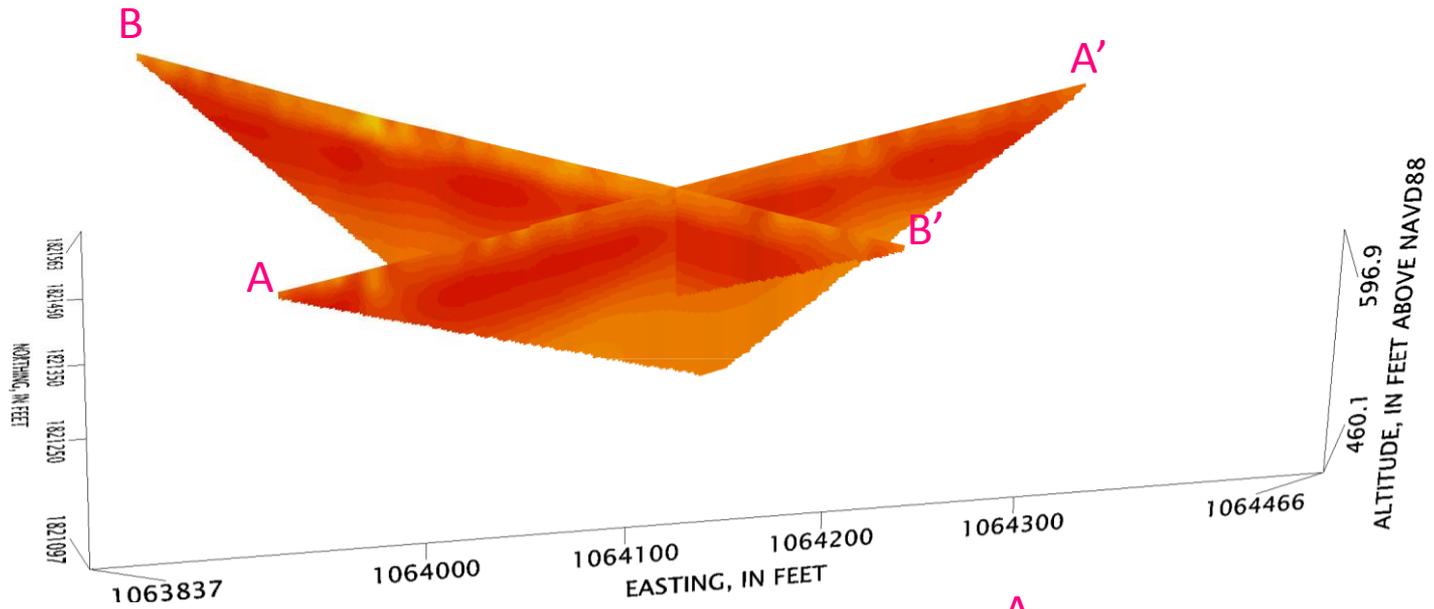
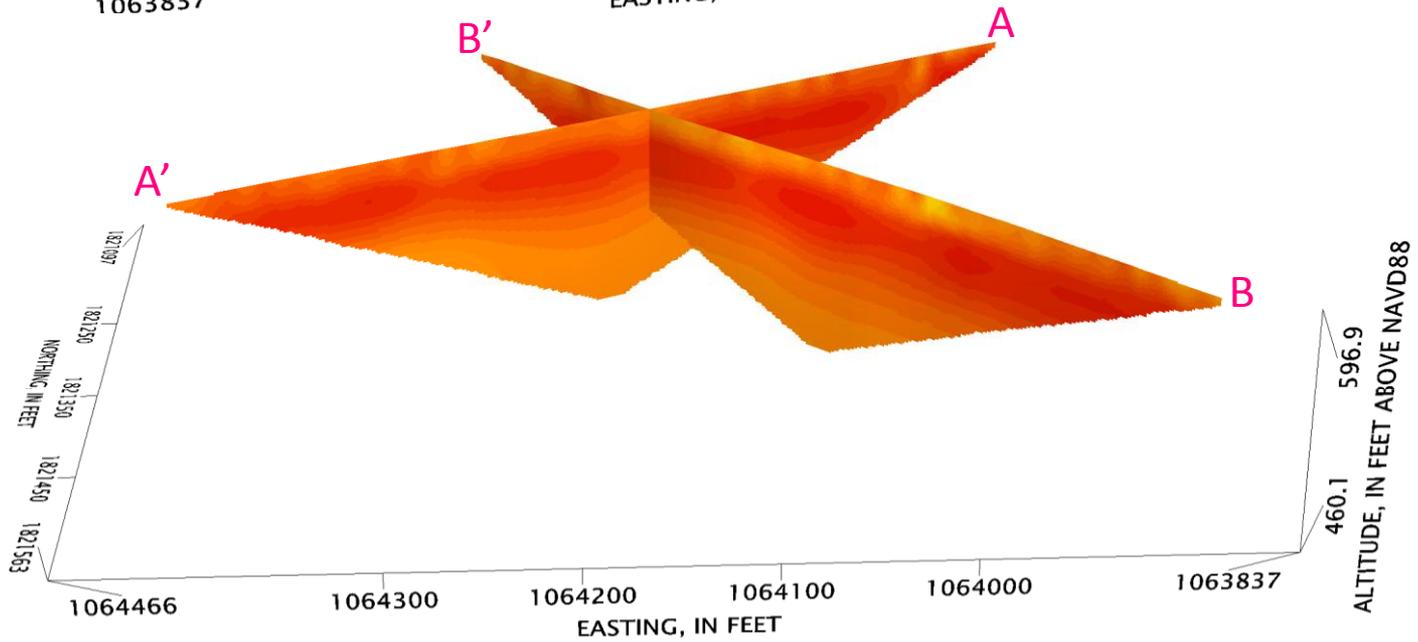
Site #5

Bedrock is met at surface.
 This is verified by the boring logs which show the bedrock altitude to be approximately 582 feet above NAVD88. There are some observable vertical features (white vertical lines on the profiles) which may represent fractures, but if they are fractures they would be insignificant in size.
