# Haw River near Benaja, N.C

**Study Reach.**--Section 4 is about 400 ft upstream from gage.

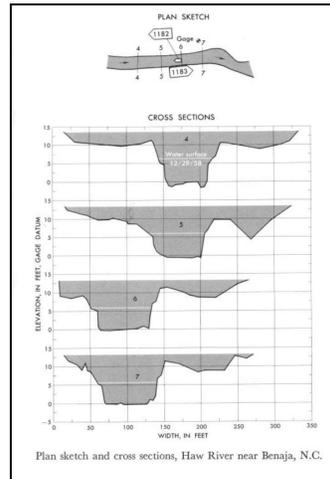
**Description of Channel.**--Bed is composed of coarse sand and a few outcrops. Banks on both sides are heavily lined with overhanging birch trees.
